**Proposed solar farm and battery energy storage system
on land adjacent to the A614,
Worksop, S80 3PA**

Report Type:
**Arboricultural Method Statement
inc. Impact Assessment**

Ref:
ARB/CP/3322

Date:
November 2024

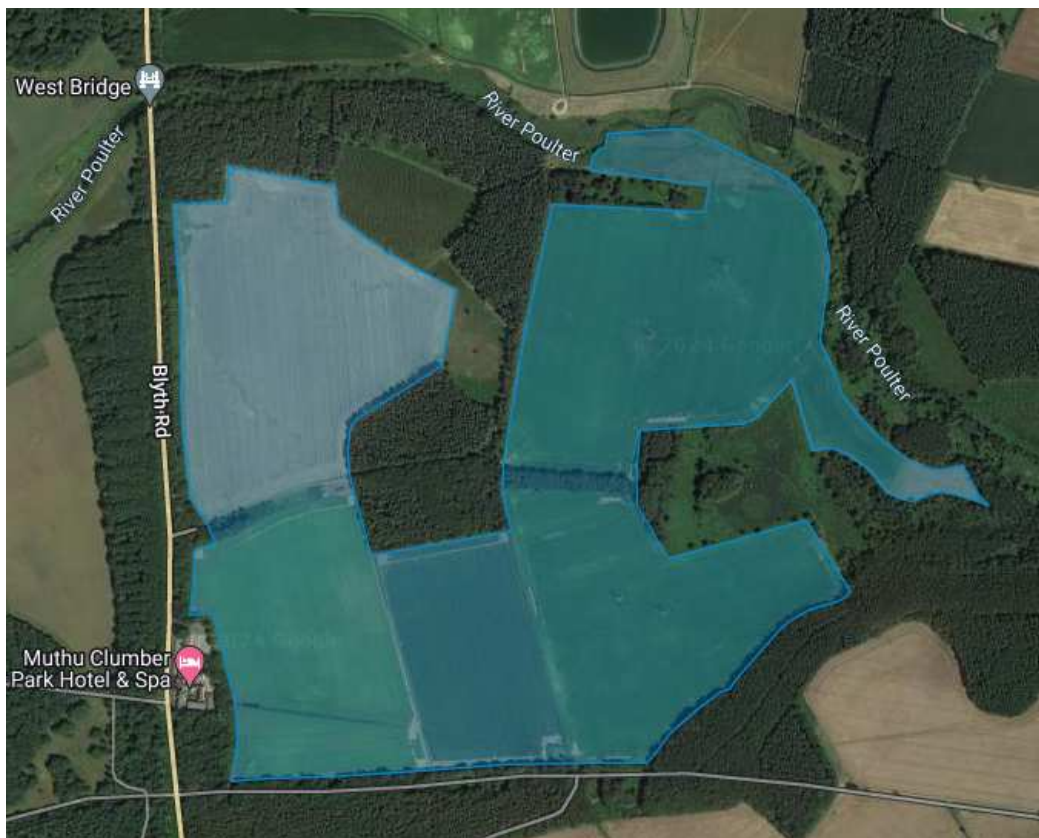
Figure 1: Area Surveyed (highlighted)

- 2.1 The area surveyed and the extent of which is covered by this method statement is the proposed solar farm and battery energy storage system on land adjacent to the A614, Worksop, S80 3PA. Figure 1 shows the extent of the area.

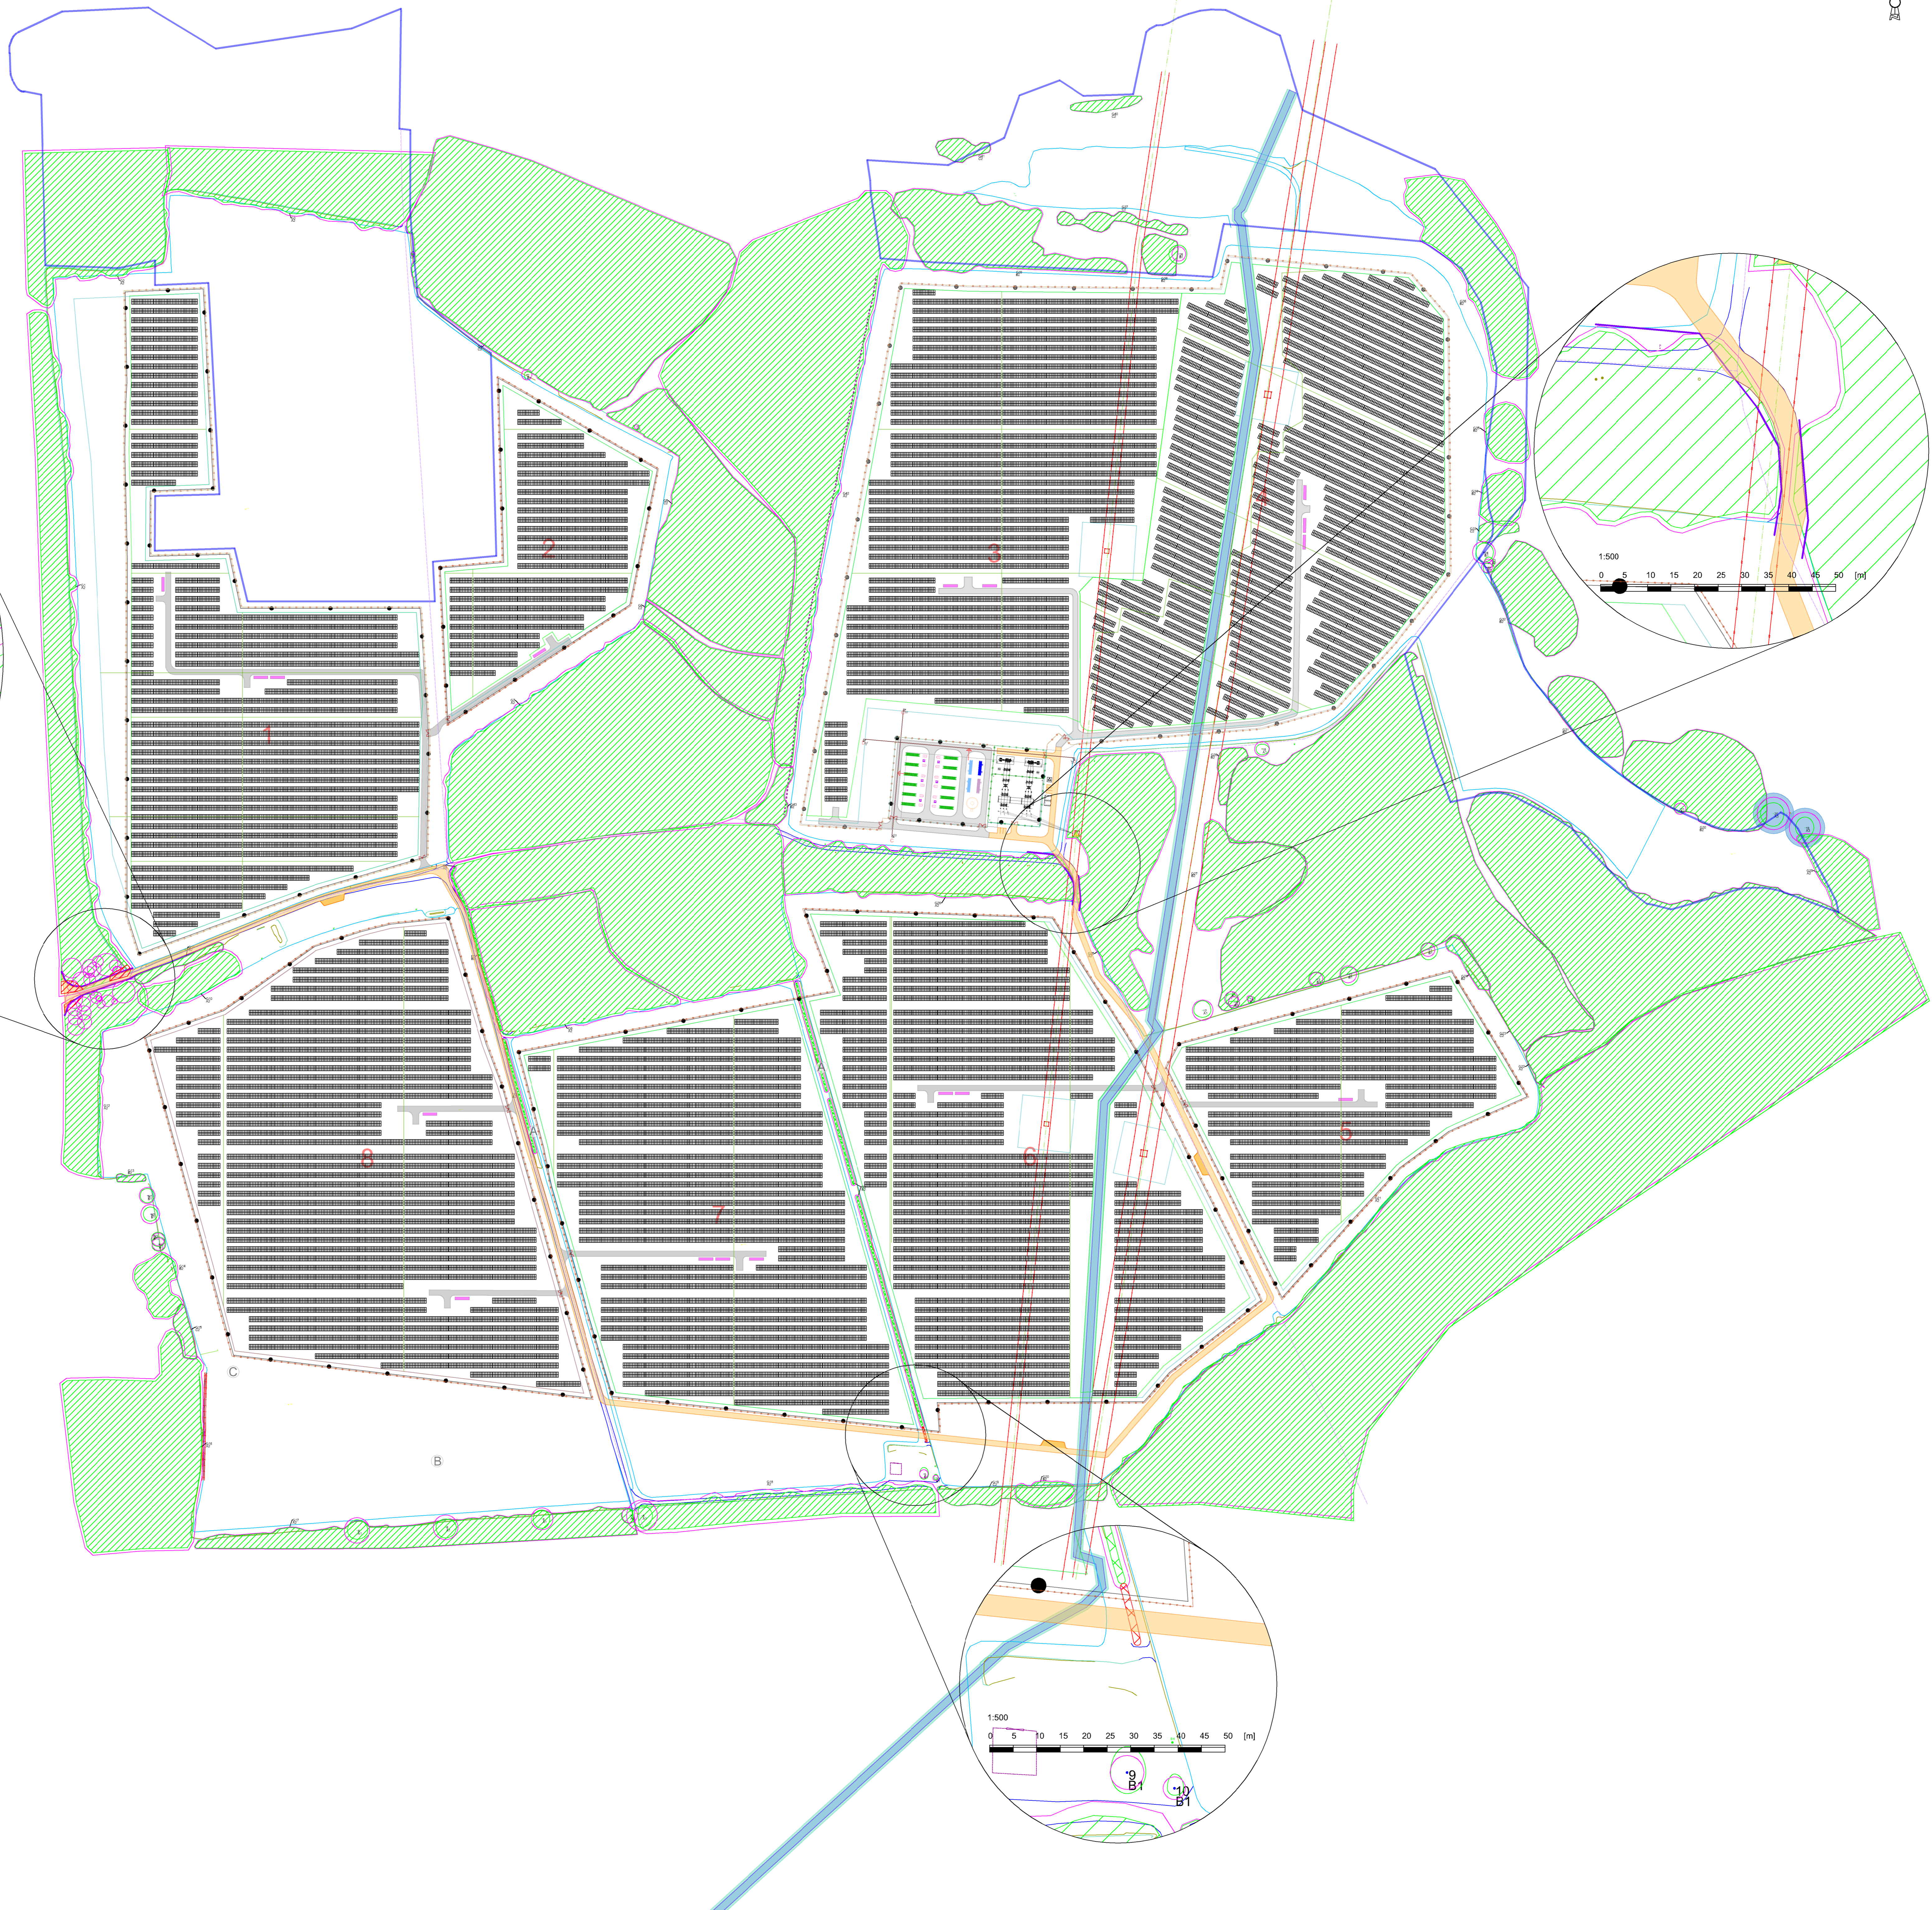
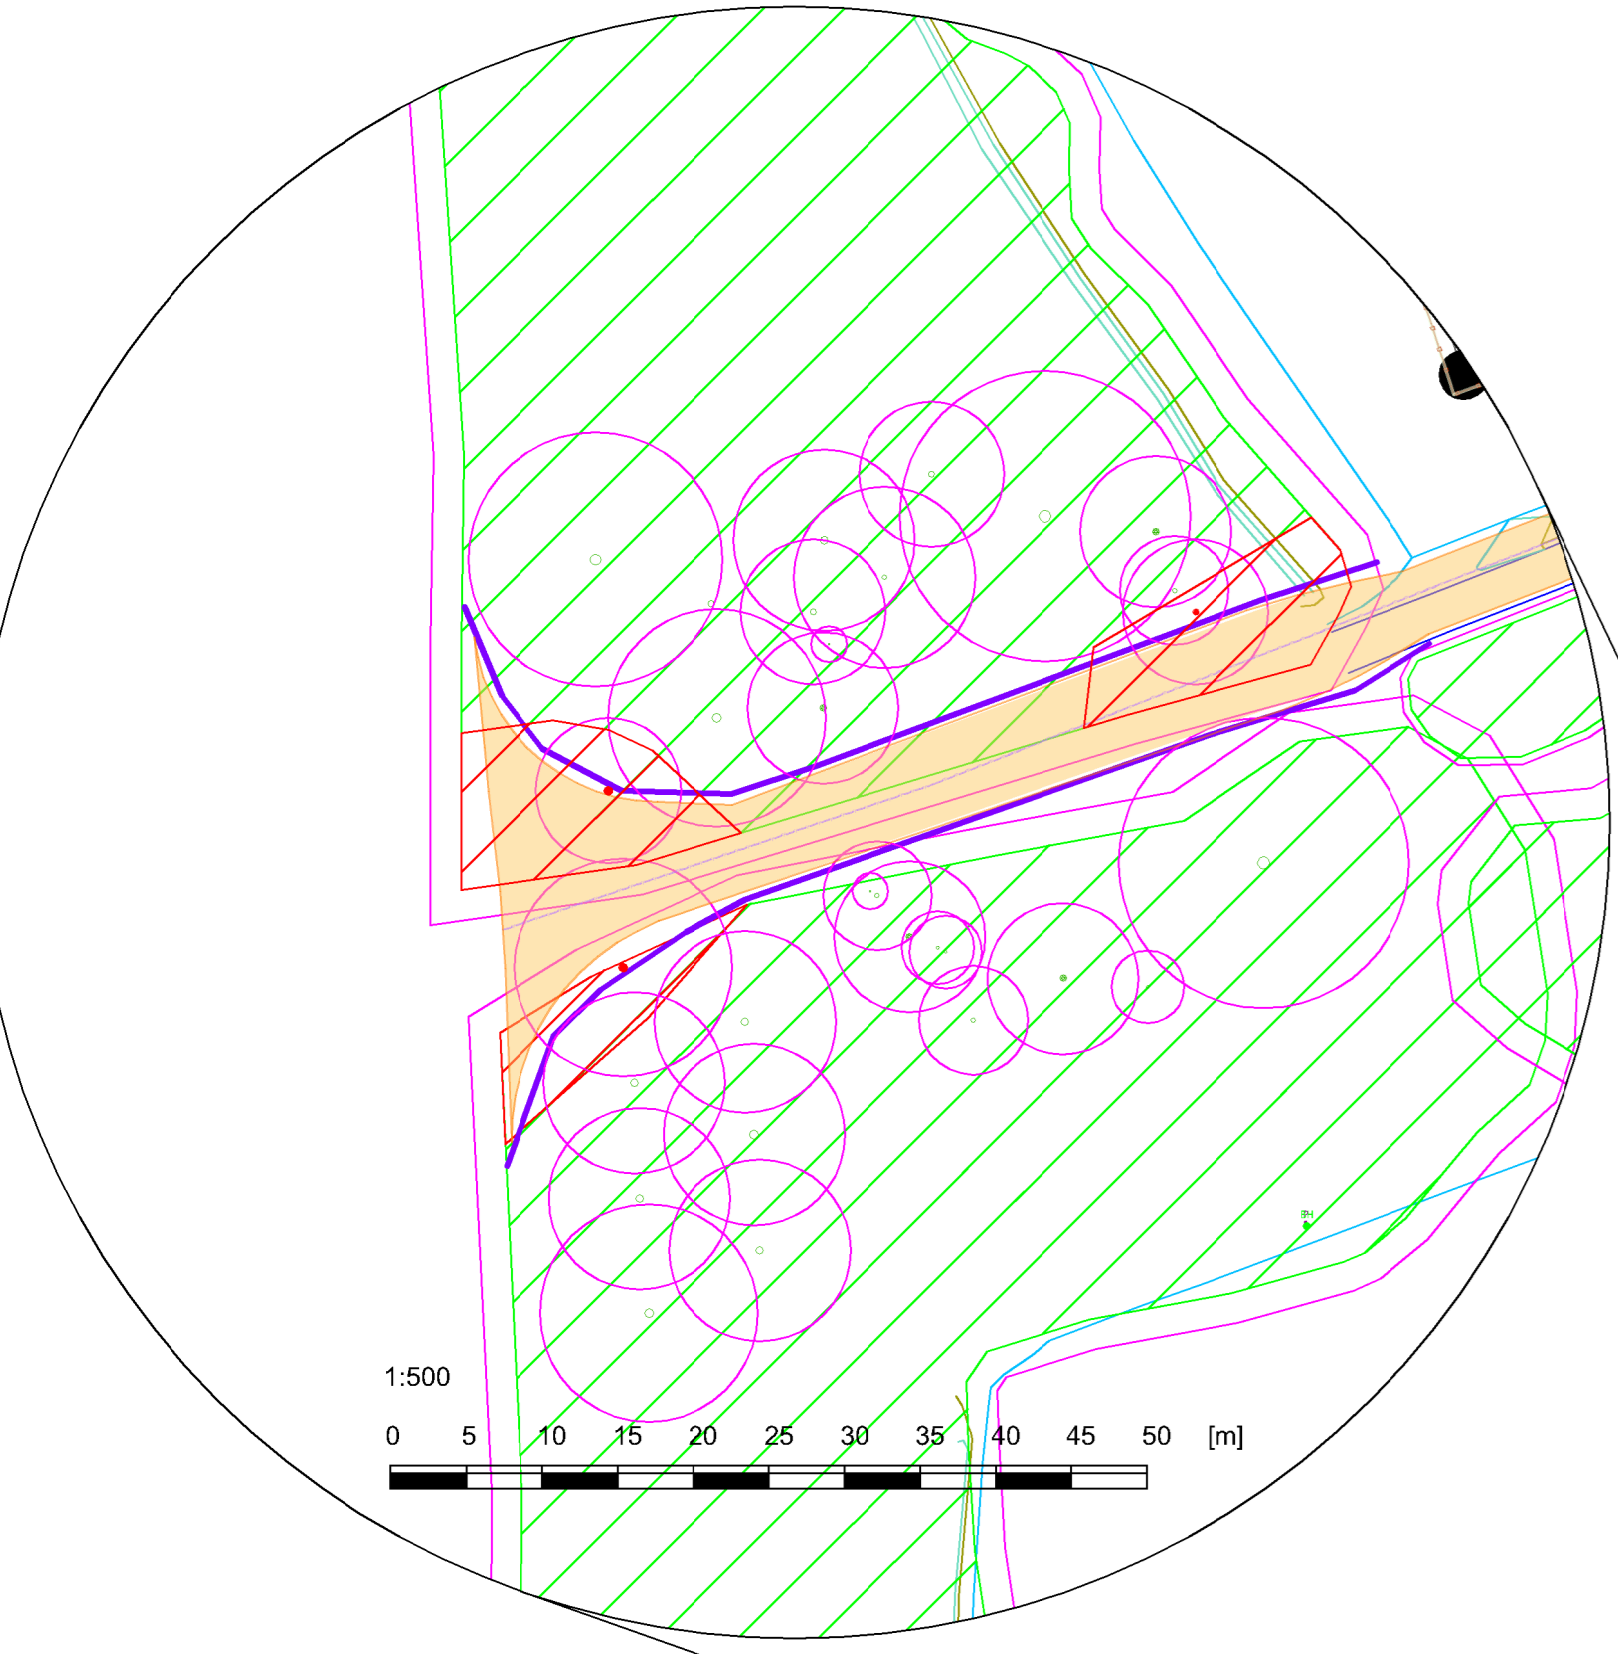
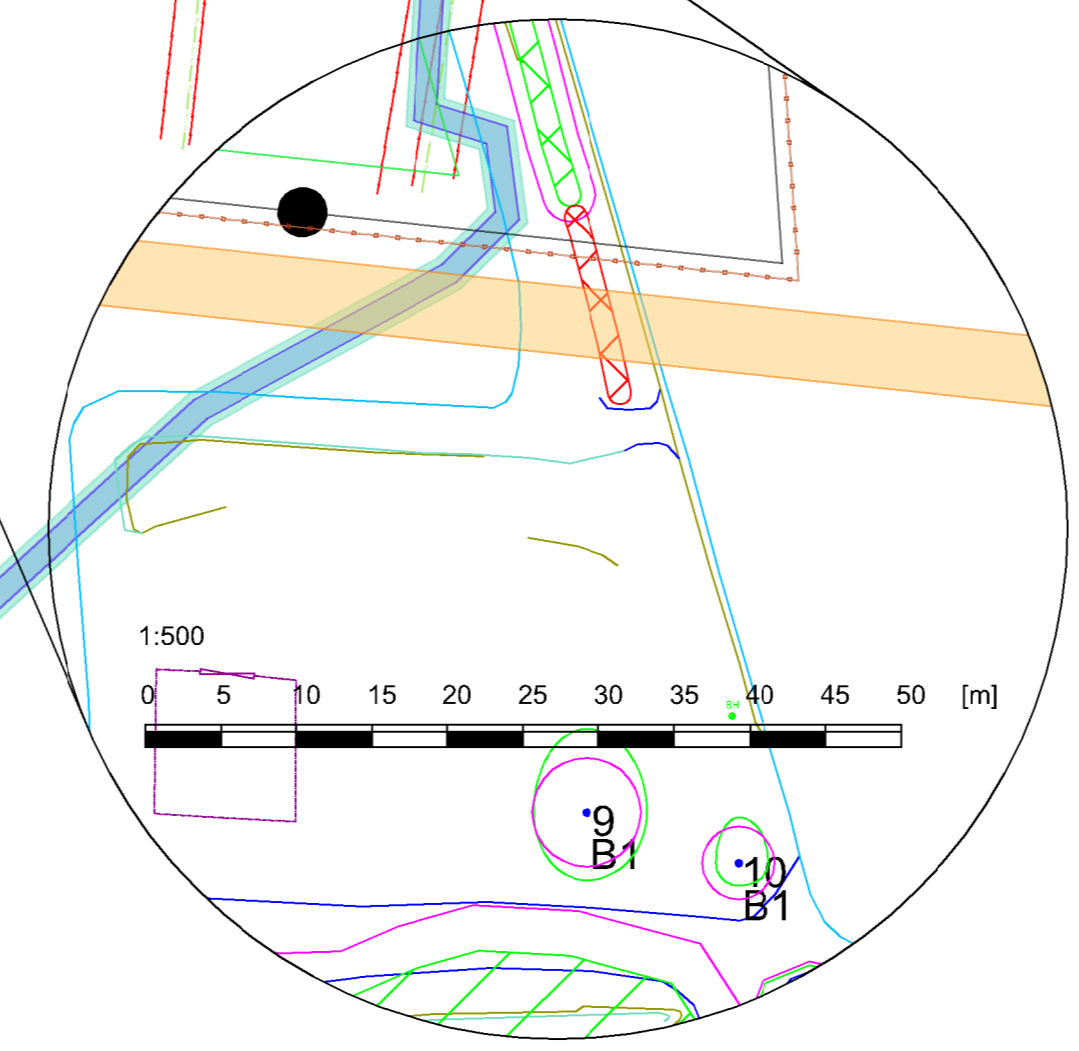
- Tree to be Retained
 - Tree to be Removed
 - Root Protection Area - to remain free from disturbance
 - Group of Trees to be Retained
 - Hedgerow to be Retained
 - Group of Trees to be Removed
 - Hedgerow to be Removed
 - Tree Protection Barrier (specification as per Appendix 5)
- 1/G1/H1 Tree/Group/Hedgerow Number
A1/B1/ C1/U BS5837 Retention Category

- 5.3 Once the aforementioned tasks have been completed and prior to any site work the tree protection barriers need to be erected as per the Tree Protection Plan (Appendix 4). The barrier must encompass the root protection areas and crown extents of the retained trees to ensure that these areas remain free from disturbance.

- 5.3.1 The barriers need to be installed according to the locations found on the Tree Protection Plan, Appendix 4 and conform to the specification within Appendix 5, unless a suitable alternative is agreed with the Local Planning Authority. All weather notices should be attached to the fencing marked with the following: '*Construction Exclusion Zone - Keep Out*' (a notice is provided within Appendix 8).
