East Markham Conservation Area Appraisal & Management Plan

December 2014

Title: Bassetlaw District Council: East Markham Conservation Area Appraisal and Management Plan.

Summary: This document is the Council's appraisal of the special architectural and historic interest of East Markham Conservation Area and a management plan with proposals for enhancement and preservation.

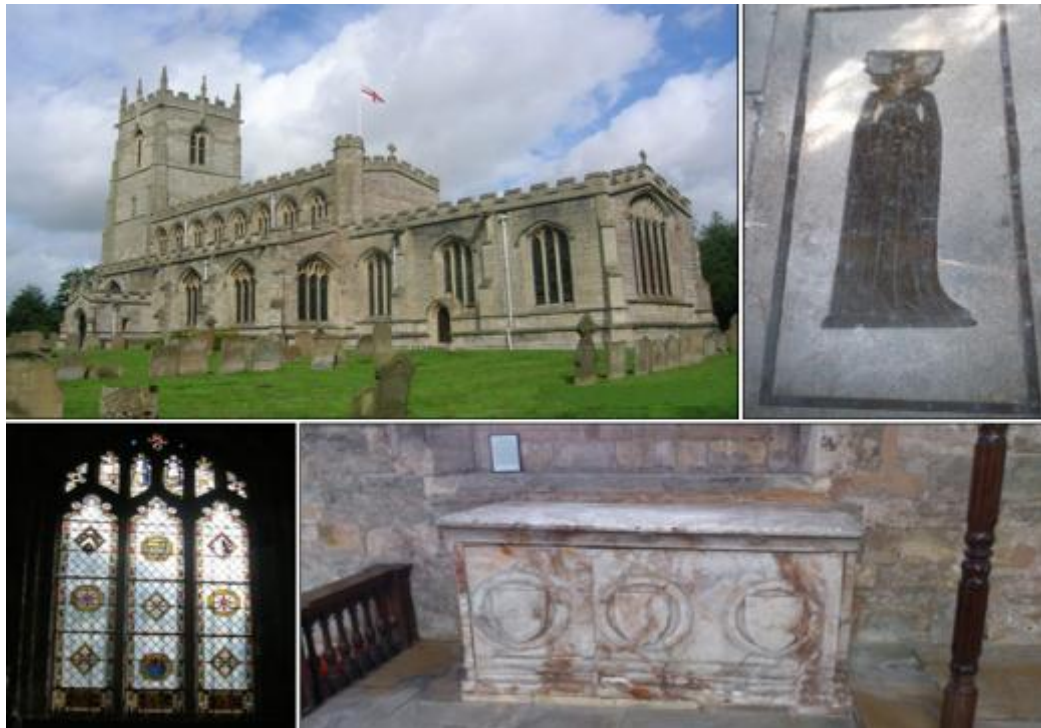
Figure 2.5: St John the Baptist Church, with view of south east (top left), brass of Dame Millicent Meryng (top right), memorial window to Sir John Markham (bottom left) and tomb of Sir John Markham (bottom right).

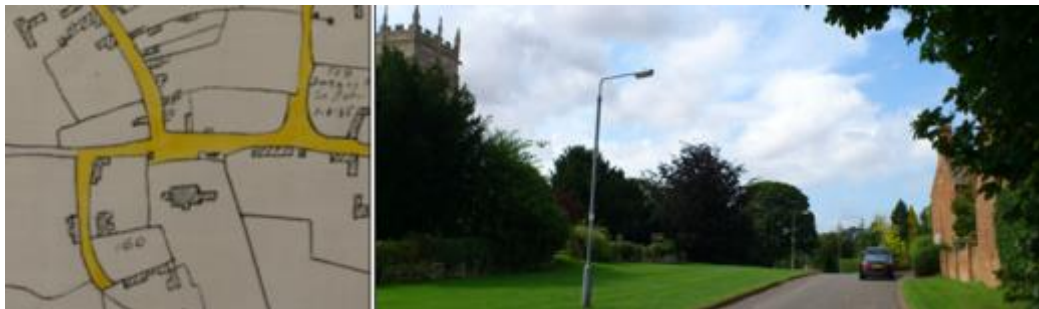
Map 6 (left): Extract from East Markham Enclosure Map, 1816, showing former market place to north of church (map source: Nottinghamshire Archives, accessed 2012); **Figure 2.6** (right): Former market place, present day.

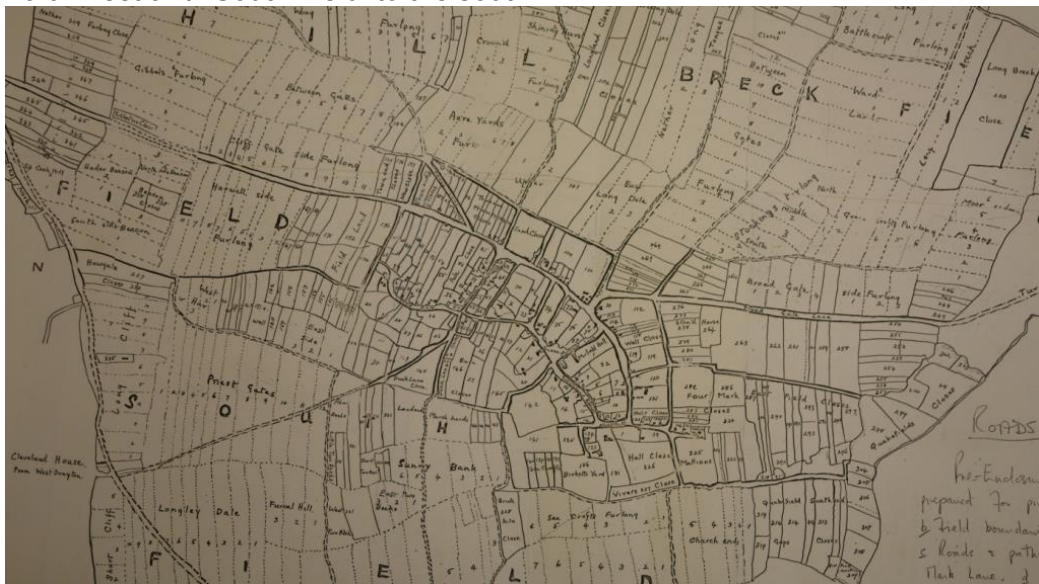
Map 7: Extract from 'A Plan of Land in East Markham', dated c1712, showing medieval 'toft and croft' plots throughout the village. Plan source: Nottinghamshire Archives, accessed 2012.

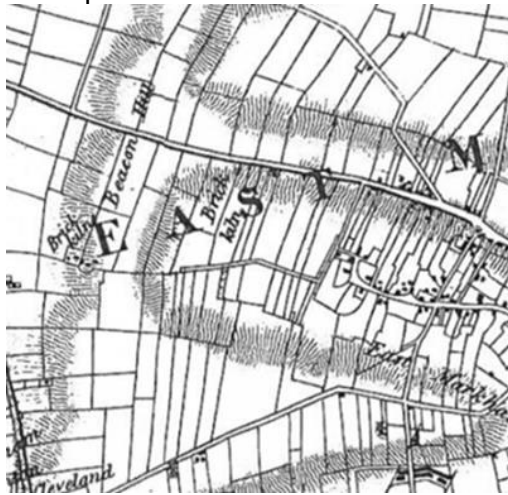
Map 8: Extract from Sanderson's 1835 Map, showing surviving strip fields. Map source: *Twenty Miles Around Mansfield* (Sanderson, G. 1835).

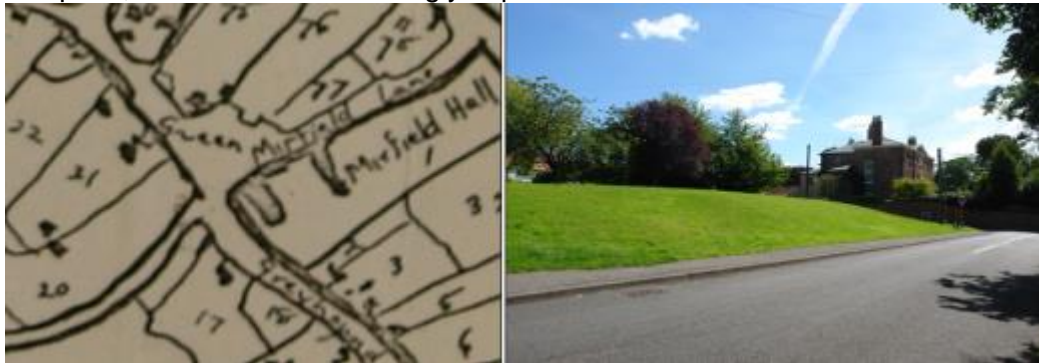
Map 10 (left): Extract from 'A Plan of Land in East Markham', dated c1712, showing medieval 'toft and croft' plots throughout the village. Also note the names 'Mirfield Hall' and 'Mirfield Lane' (Plan source: Nottinghamshire Archives, accessed 2012); **Figure 2.8** (right): Mound on Village Green with East Markham Hall (originally Mirfield Hall) in the background.

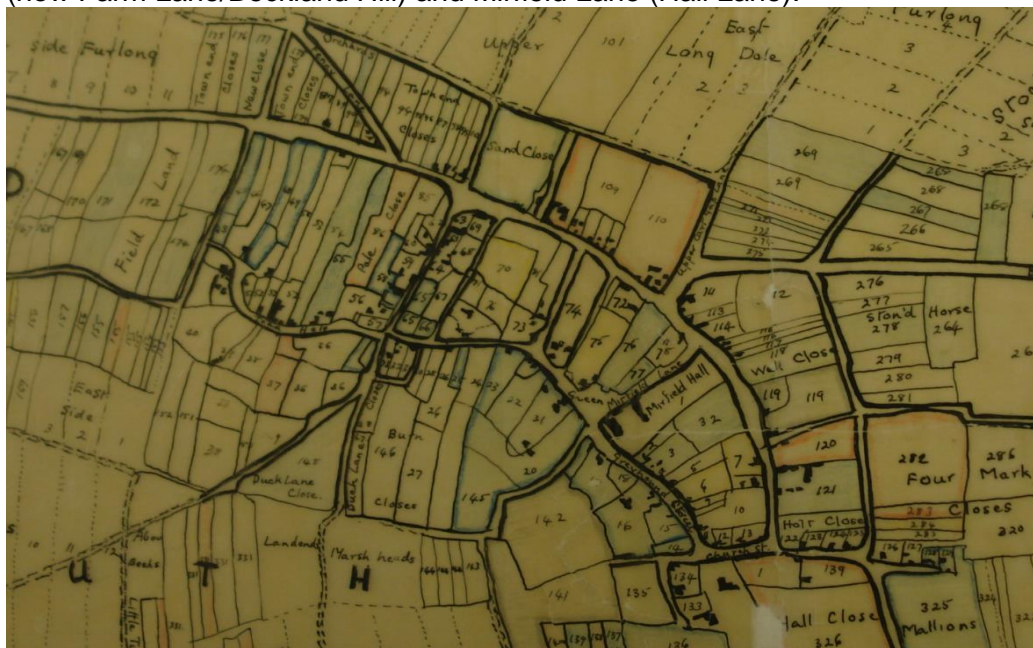
Map 13: Extract from 'A Plan of Land in East Markham', dated c1712, showing Toad Hole/Holt (top left), Duck Lane (centre left), Mirfield Lane (centre right) and Greyhound Street (bottom right). Plan source: Nottinghamshire Archives, accessed 2012.

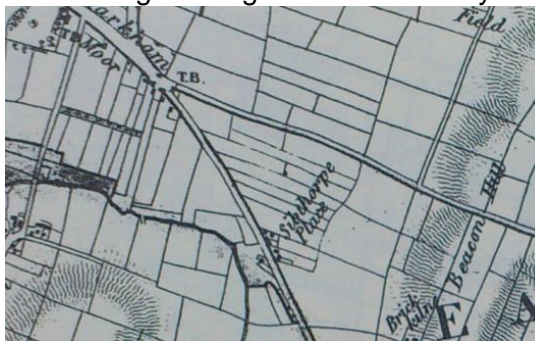
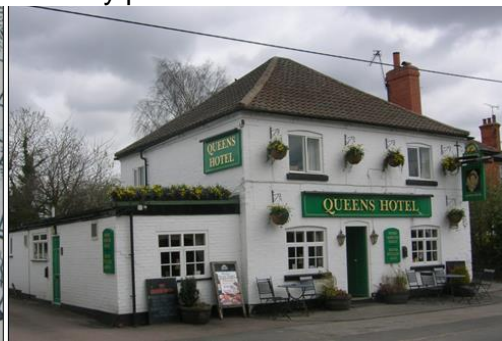
Map 14: Toll Bar ("T.B.") visible at Markham Moor Junction, on extract from Sanderson's 1835 Map. Map source: *Twenty Miles Around Mansfield* (Sanderson, G. 1835); **Figure 2.10:** Queen's Hotel, High Street, a late-18th/early-19th century coaching inn.

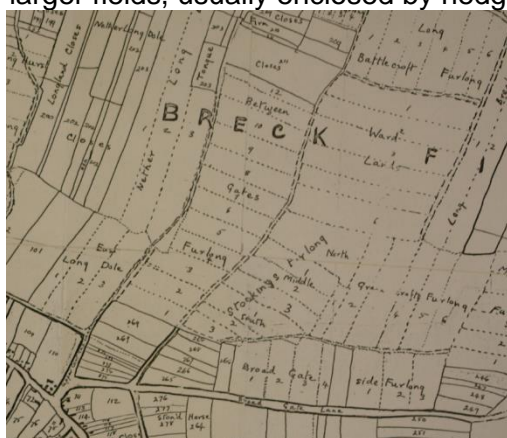
Map 16: Extract from 'A Plan of Land in East Markham', dated c1712, showing Breck Field before enclosure (Map source: Nottinghamshire Archives, accessed 2012).

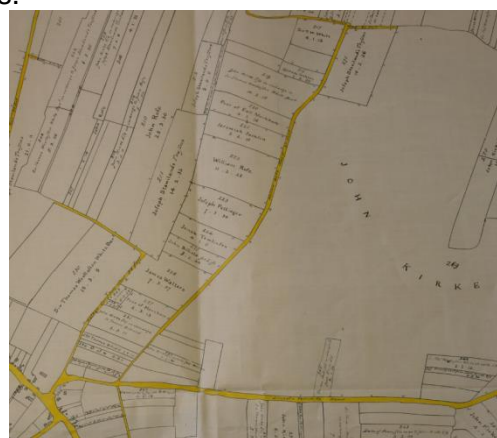
Map 17: Extract from East Markham Enclosure Map, 1816, showing Breck Field after Enclosure (Map source: Nottinghamshire Archives, accessed 2012).

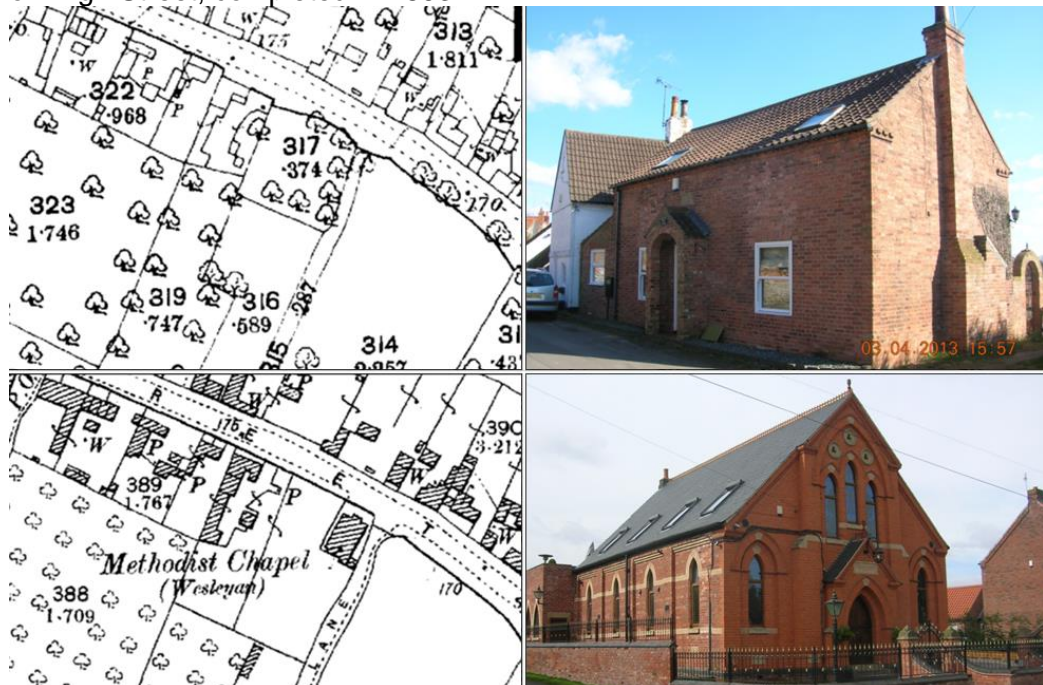
Map 18 (top left): Extract from 1886 O.S. Map, showing chapel site on High Street; **Map 19** (bottom left): Extract from 1898-1899 O.S. Map showing replacement chapel on High Street (Both reproduced from Ordnance Survey mapping with the permission of Ordnance Survey. © Crown Copyright 2013, Bassetlaw District Council. License No. 100019517) **Figure 2.12:** Top right: Original Wesleyan Chapel on Low Street (erected 1822); Bottom right: Replacement chapel on High Street (erected 1893).

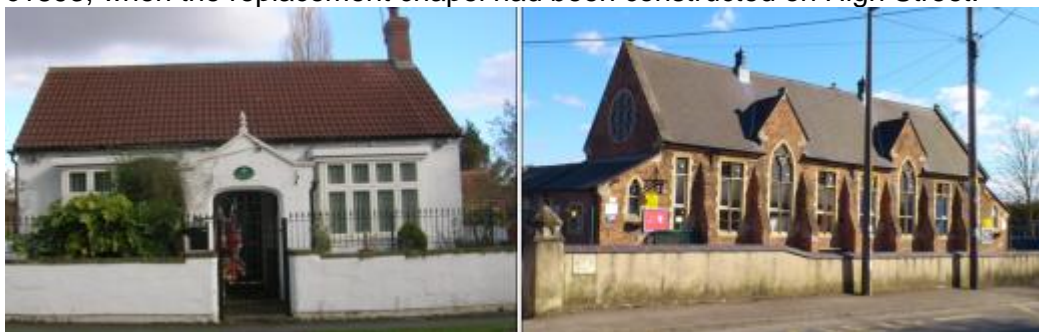
Figure 2.13: Left: Original village school, built 1842, on Church Street; Right: Replacement school, opened January 1878, on Askham Road.

- 2.30 The growth in Methodism in the 19th century was partly a reaction to the social problems associated with poverty across the country at that time. Alongside religious change, East Markham also saw changes to its educational provision. Partly backed by religious charities and other philanthropic benefactors, the village 'charity school' opened in 1842 on Church Street (now a residence called 'Fairfield'). This remained in use until a larger school was constructed on Askham Road in 1877 (opening on 7th January 1878). The former Wesleyan Chapel (discussed in the previous paragraph) was also used partly for educational purposes, eventually becoming the Wesleyan's Sunday school in c1893, when the replacement chapel had been constructed on High Street.

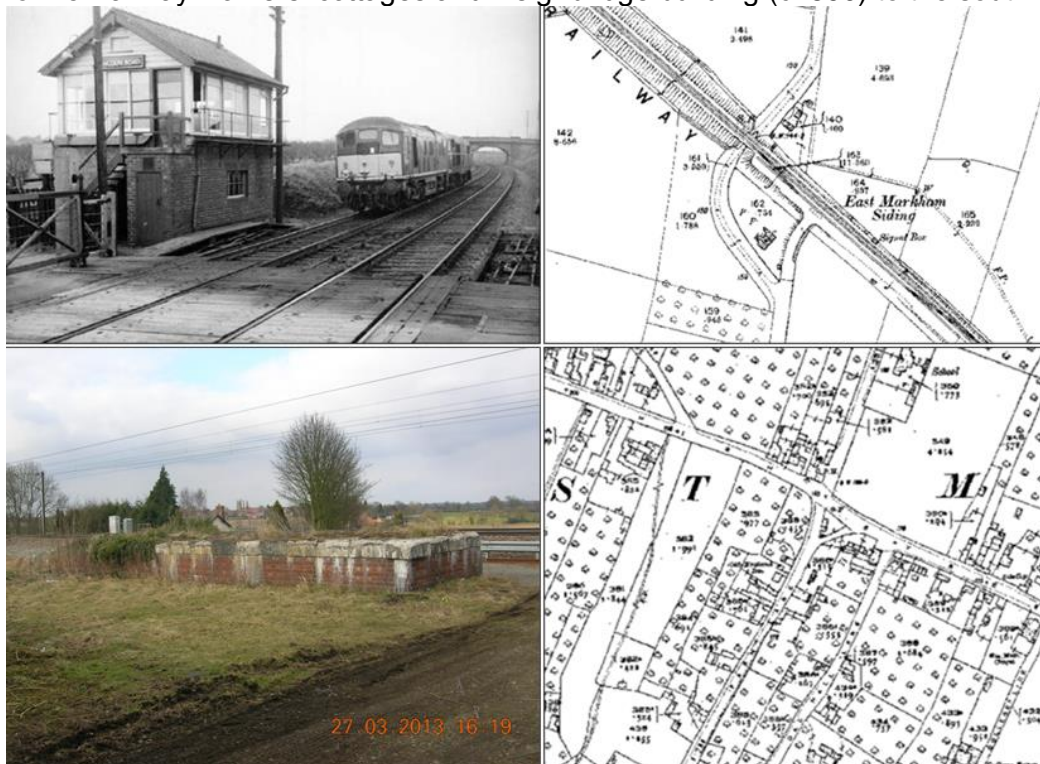
Figure 2.14: Top left: Level crossing and signal box on Lincoln Road, 1965 (image source: www.picturethepast.org.uk, accessed 2013); Bottom left: Former sidings at Askham Road, present day; **Map 20** (right): Extracts from 1898-1899 O.S. Map, showing East Markham Sidings (top) and orchards around the village (bottom) – Both reproduced from Ordnance Survey mapping with the permission of Ordnance Survey. © Crown Copyright 2013, Bassetlaw District Council. License No. 100019517.

- 2.31 The Victorian period saw the arrival of the railway to East Markham. The Great Northern Railway opened in 1852, passing immediately to the east of the village and crossing Lincoln Road. Whilst East Markham itself never had a formal passenger station, the sidings at Askham Road were used extensively to transport local produce to market. The surviving buildings adjacent to the sidings include the former plate layers' cottages (c1852) to the north and the former railway workers' cottages and weighbridge building (c1890) to the south.

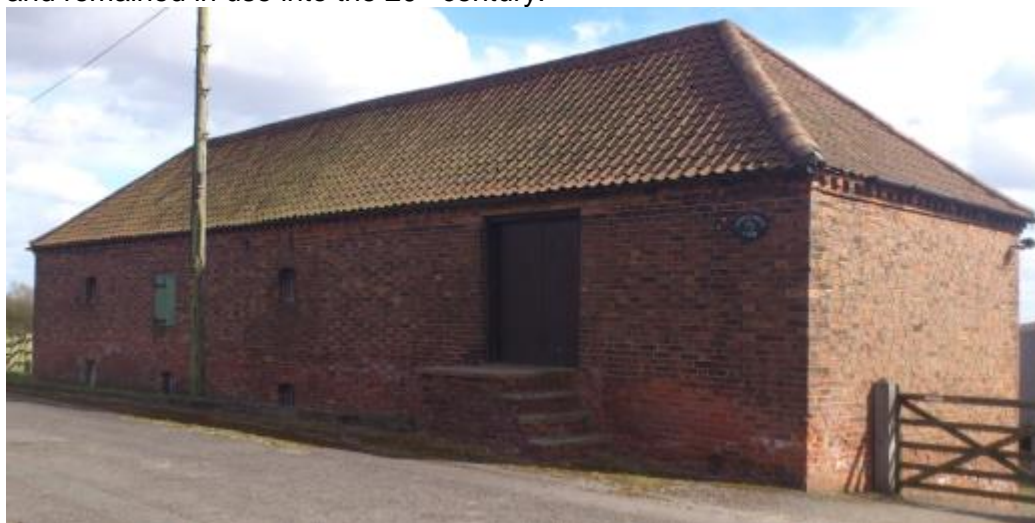
Figure 2.16: Former maltings at Harold House Farm, High Street.

East Markham also had its own malthouses, the most notable of which still survives at Harold House Farm. The building dates to the early-19th century and remained in use into the 20th century.

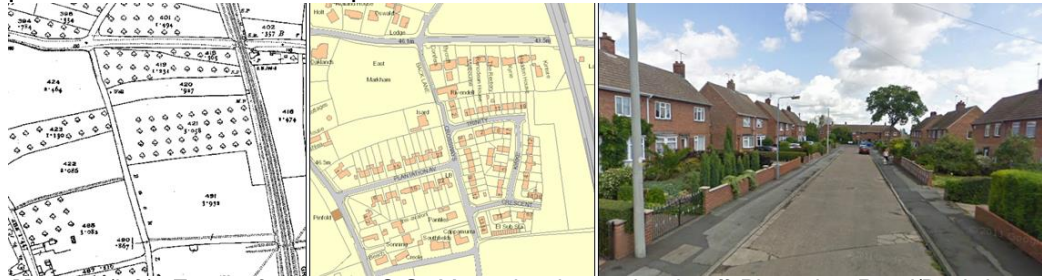
Map 23 (left): Extract from 1920 O.S. Map, showing orchards off Plantation Road/Back Lane; **Map 24** (centre): Extract from 2013 O.S. Map, showing 1950s housing development off Plantation Road/Back Lane; **Figure 2.17** (right) View along Plantation Avenue. Both maps reproduced from Ordnance Survey mapping with the permission of Ordnance Survey. © Crown Copyright 2013, Bassetlaw District Council. License No. 100019517.

2.36 Within and on the edge of the historic core, the construction of housing, often on the site of former orchards, began in the 1950s, particularly on the east side of the village off Plantation Road and Back Lane. These developments were typical of council housing schemes of that period and are seen in towns and villages across the district. Whilst the loss of historic orchards has had a lasting impact on the character of the village, more harmful has been the 'in-filling' of

smaller spaces between existing buildings, especially between narrow 18th and 19th century buildings sited perpendicular to the road. The development of housing of a modern scale and design is often at odds with this existing organic pattern and form of development.

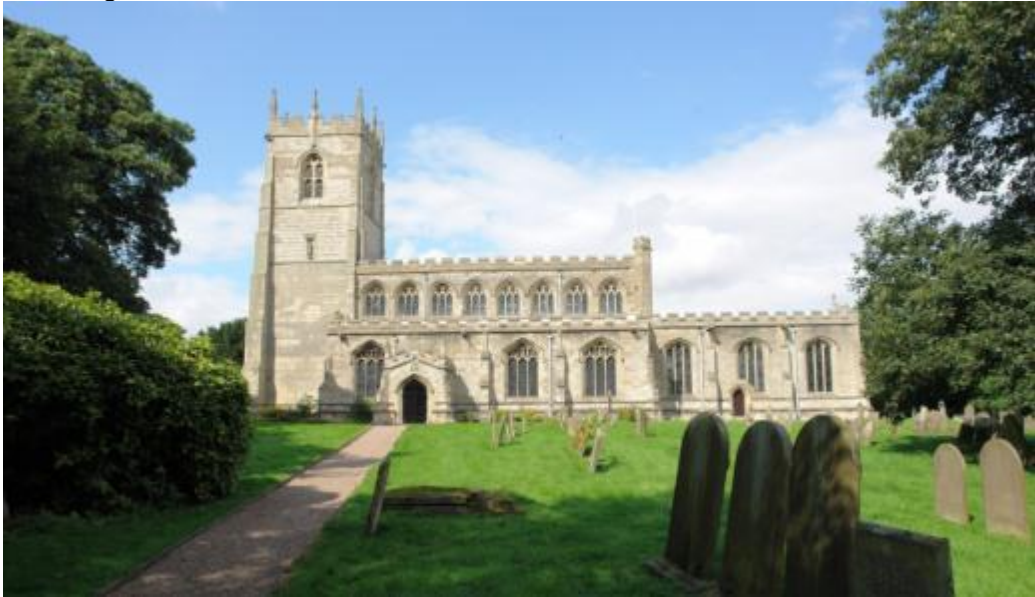
Figure 3.1: South elevation of the Church of St John the Baptist.

- 3.2 The most significant building is the Grade I listed Church of St John the Baptist, which is primarily 15th Century in date, although has 13th and 14th century fabric inside. Immediately to the west of the church is The Manor, probably the site of the medieval manor house, although rebuilt in brick in the 17th and 18th centuries. These sites aside, the majority of surviving historic buildings date to the 18th and 19th centuries, although several timber-framed structures from the 17th century also survive. Many are within earlier (usually medieval) narrow plots sited perpendicular to the road.

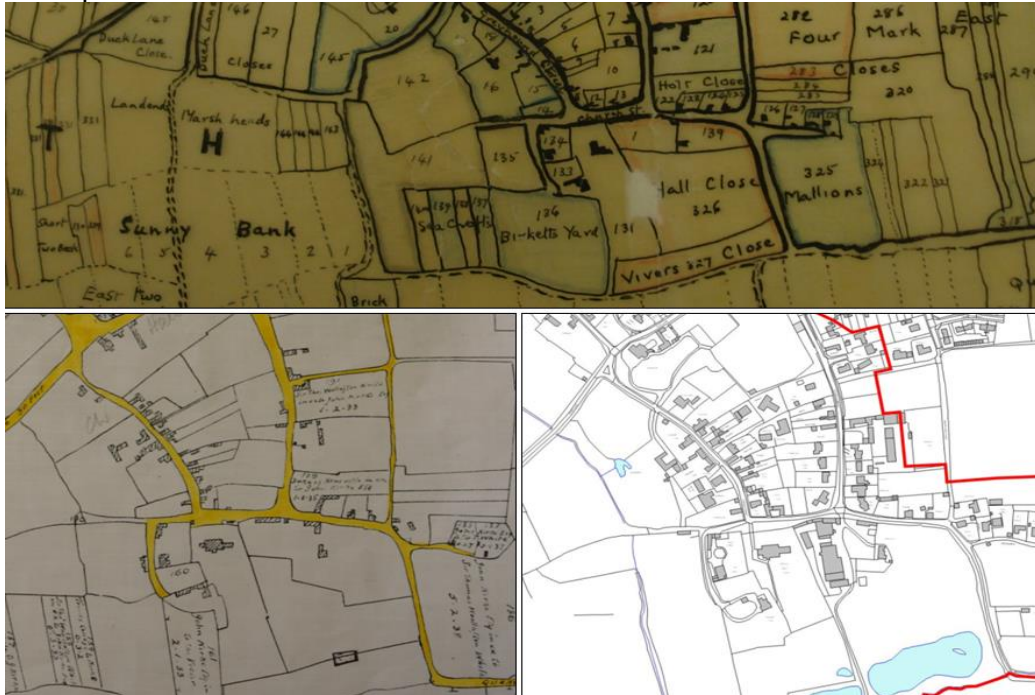
Map 27 (top): Extract from c1712 Map, showing early plots around church; **Map 28** (bottom left): Extract from East Markham Enclosure Map, 1816, showing isolation of church/manor site and clustering of main residential development on north-south section of Church Street (Map sources, Nottinghamshire Archives, accessed 2012); **Map 29** (bottom right): Extract from 2013 O.S. Map, showing present situation (reproduced from Ordnance Survey mapping with the permission of Ordnance Survey. © Crown Copyright 2013, Bassetlaw District Council. License No. 100019517).

- 3.3 Much of the layout of East Markham is typical of medieval villages in this area, with planned streets containing rectangular buildings within regular plots of land laid out perpendicular to the roads. It is likely that the first substantial settlement would have clustered around the church, particularly along the west-east section of Church Street and to the west, east and south of the church, probably with the market at the junction next to the northern entrance to the churchyard.
- 3.4 The present isolation of the church and manor site at the southern end of the village is peculiar. Topography may have played a part in this, with the land sloping sharply towards the watercourses to the south and west of the church.

However, local historical accounts suggest that most settlement around the church was abandoned following the plague of 1609, with new settlement being developed further north around the Low Street area. Certainly the surviving buildings suggest a period of growth around Low Street during the mid-17th century (see map 13). There are several long and narrow plots visible on historic maps to the west and south-west of the church/manor site, which may relate to abandoned parts of the settlement. Settlement may also have existed to the east/south-east of the church. Further archaeological investigation would be required to reach a definitive conclusion on this issue however.

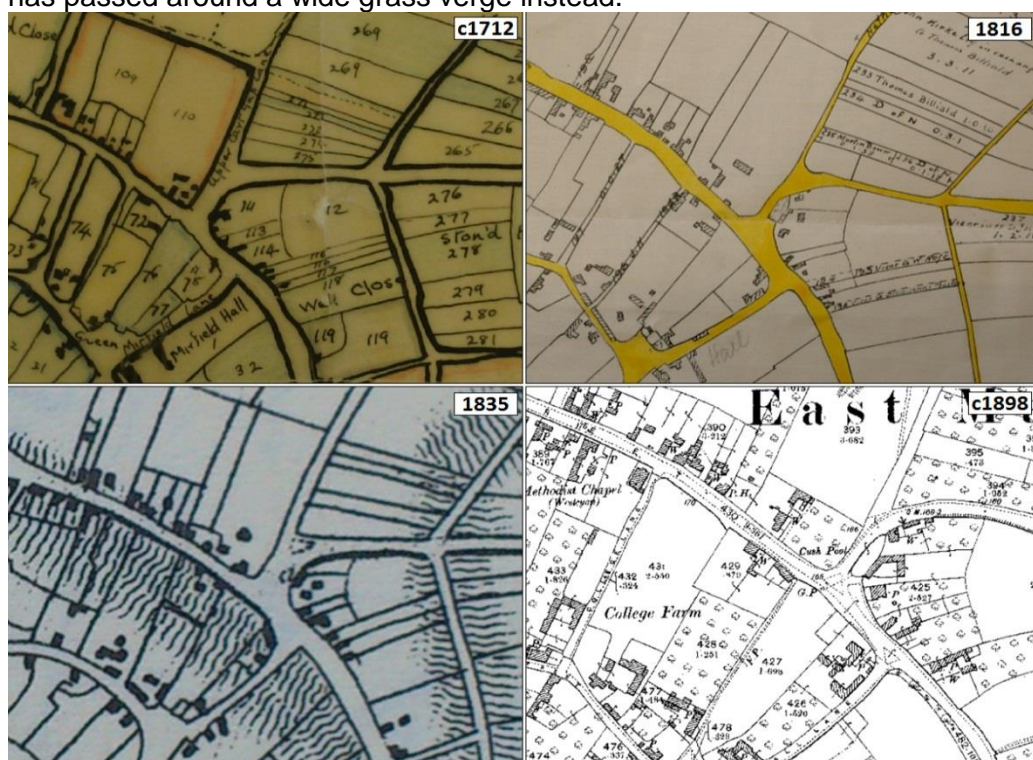
Maps 31-34: Extracts from c1712 (top left), 1816 (top right), 1835 (bottom left) and 1898-1899 (bottom right) maps, showing junction of High Street and Lincoln Road. Map sources: c1712 & 1816 maps – Nottinghamshire Archives (accessed 2012); 1835 – Twenty Miles Around Mansfield (Sanderson, G. 1835); 1898-1899 O.S. Map – Reproduced from Ordnance Survey mapping with the permission of Ordnance Survey, © Crown Copyright 2013, Bassetlaw District Council. License No. 100019517.

- 3.7 Whilst the general layout of the village is quite regular, several sites within the Conservation Area are of note for their peculiar layout. The unusual junction of High Street and Lincoln Road (known locally as ‘Pond Corner’) is one such example. The land form at this point has had a lasting effect on the road and plot layouts, with this section of Lincoln Road effectively skirting around the northern edge of a historic former pond¹⁸ (which was filled in during February 1922, resulting in the present wide grass verge to the front of Pond Farm). This pond would have originally formed within a natural low point (a similar arrangement can be seen in Carlton in Lindrick off The Green). This peculiar arrangement is visible on all historic maps, including the c1712 map, which also shows a series of buildings in the open space at Old Well Cottages (north west of the junction) – These buildings had gone by the 1880s. The course of the road was still suitable for the increase in movements after the completion of the Dunham Bridge in 1830 (due to the vehicles’ relatively slow speed), although became more problematic during the early-20th century with the growth in motorised transport and the desire for travelling at a higher speed. A series of accidents led to the pond being filled in February 1922 and since then, the road has passed around a wide grass verge instead.

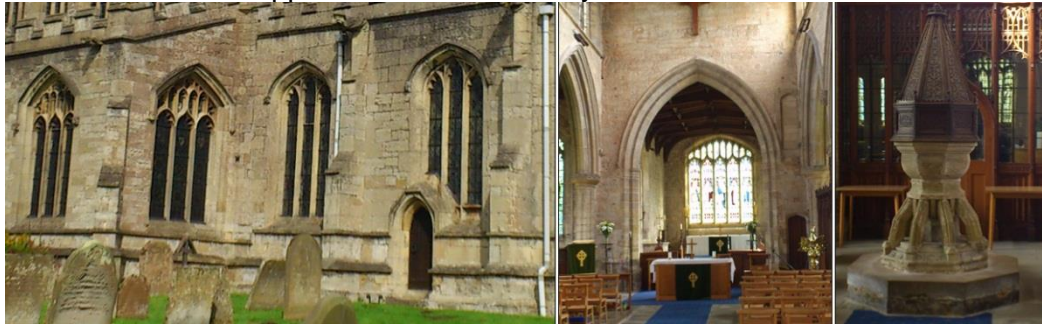
Figure 3.3: Left: Early-14th century windows (right) and 15th century style windows, as restored in the 1880s (left); Centre: Early-14th century chancel/nave arch; Right: 14th century font with distinctive flying buttresses (with font cover dating to 1686).

- 3.11 The earliest visible phase of the church is found in the chancel, with the north and south windows (differentiated from the later aisle/nave windows by the simpler tracery) and the double-chamfered arch into the nave (which is without capitals at the termination of the jambs) all being of an early-14th century style. The font base also appears to be 14th century in date.

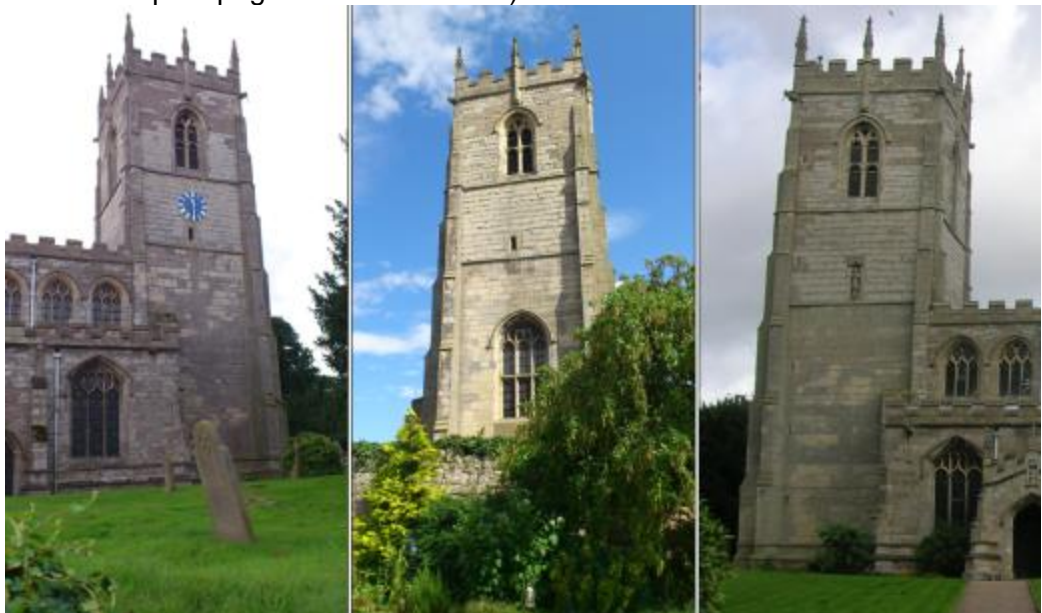
Figure 3.4: Views of western tower of church, showing north elevation (left), west elevation (centre) and south elevation (right).

- 3.12 Elsewhere the building is visibly 15th century, the most iconic portion of which is the western tower of three stages, with its moulded arched doorway, corner buttresses, eight crocketed pinnacles (similar in style to those at West Retford), arched bell chamber openings, corner gargoyles, high (internal) arch and on the north side a clock face. One unusual feature is the niche on the south side, which contains a worn (possibly mutilated) figure. The tower is one of the most prominent structures along this section of the River Trent valley, being visible from a considerable distance in most directions, particularly along both the original Great North Road and Lincoln Road/A57. The prominence of the tower is also in part due to the very deliberate siting of the church, being on a promontory of higher ground which dominates the immediate landscape (the contour map on page 11 illustrates this).

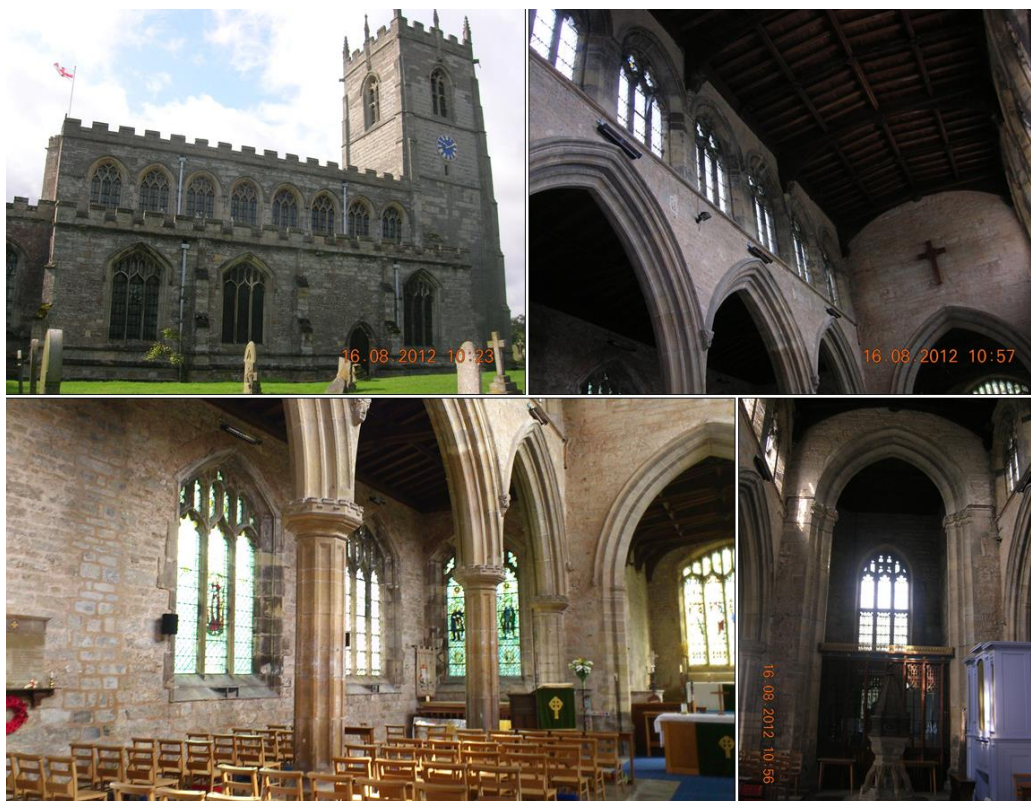
Figure 3.5: Views of church, showing north face of nave (top left), internal side of nave clerestory window openings (top right), octagonal columns within the nave (bottom left) and high arch through to the western tower (bottom right).

- 3.13 The nave is also 15th century, the clerestory window openings and form of the battlements on the parapet being especially diagnostic. The eight-bays of the nave are particularly eye-catching, both externally and internally, a further indication of the wealth of the Markham family in the 14th/15th century period.

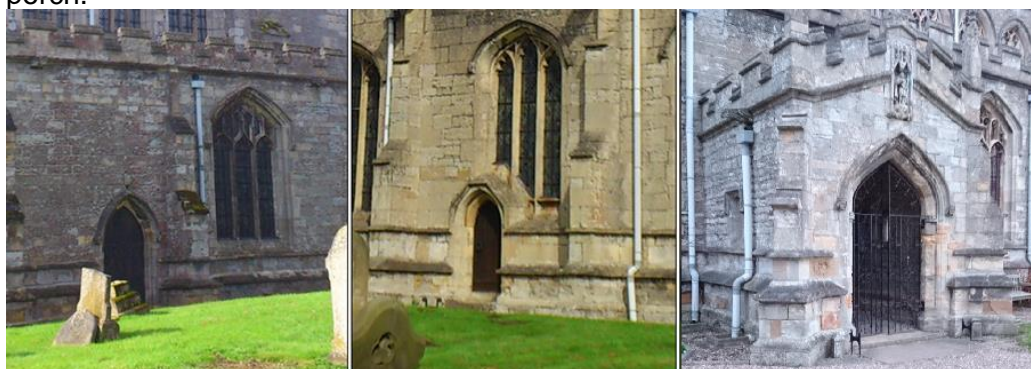
Figure 3.6: Doorway into north aisle (left), doorway into south side of chancel (centre) and south porch (right).

- 3.14 The north and south aisles were partially rebuilt during the restoration of 1883-7 although the reconstructed elements imitate the perpendicular style of the nave and tower. A substantial amount of the original 15th century work remains however, including the north doorway, a small south doorway and the south porch.

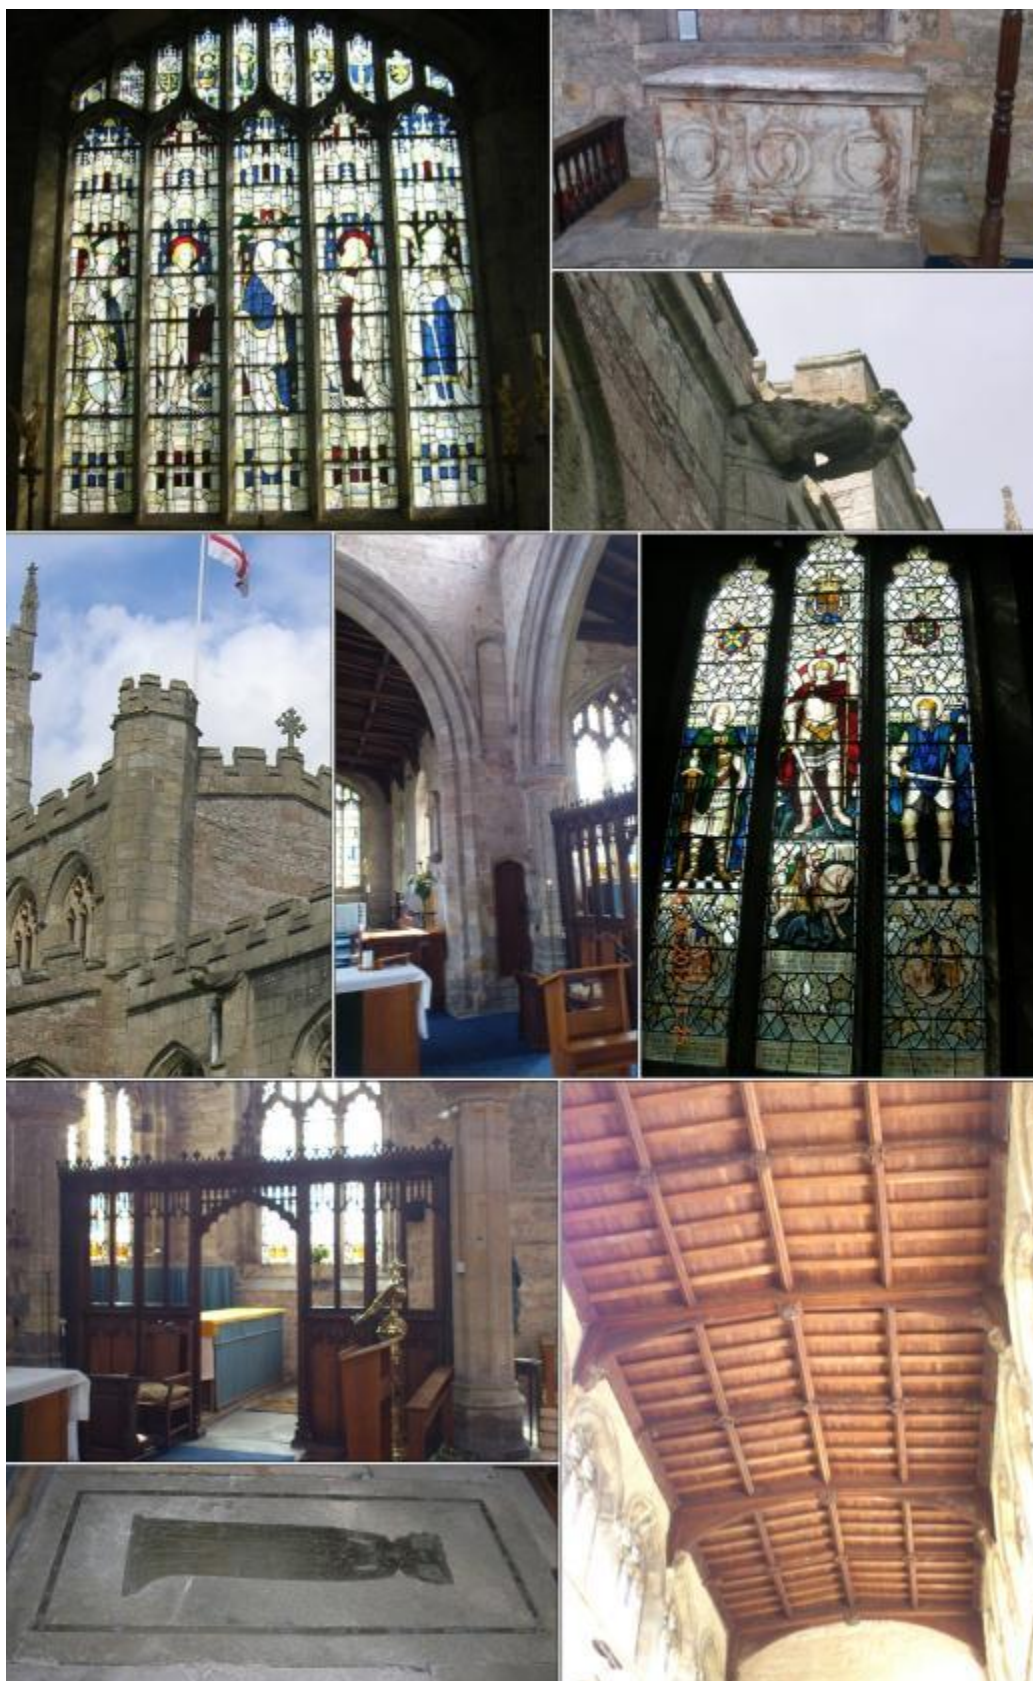
Figure 3.7: Various significant features at the church, including: Comper east chancel window (top left), Judge Markham Tomb within the chancel and external gargoye (top right), rood turret with internal stairway (centre left and centre), Markham family window in the chancel (centre right), rood screen and Dame Millicent Meryng brass (bottom left) and timbered roof with 15th century bosses (bottom right).

- 3.15 Given the age and prominence of the building, there are many noteworthy features not yet mentioned. Amongst the most significant of these are the south west rood turret (see Pevsner for a detailed description), the decorated alabaster tomb of Sir John “Judge” Markham (died 1409), the fine brass of Dame Millicent Meryng (died 1419), the grave stones of several of the Williamson, Kirke and Markham families, the timber roof, the internal and external carvings and the south aisle screen. There are also numerous stained glass windows, including the east chancel window by Ninian Comper dating to 1896 (which contains fragments of a heraldic scene of c1380).

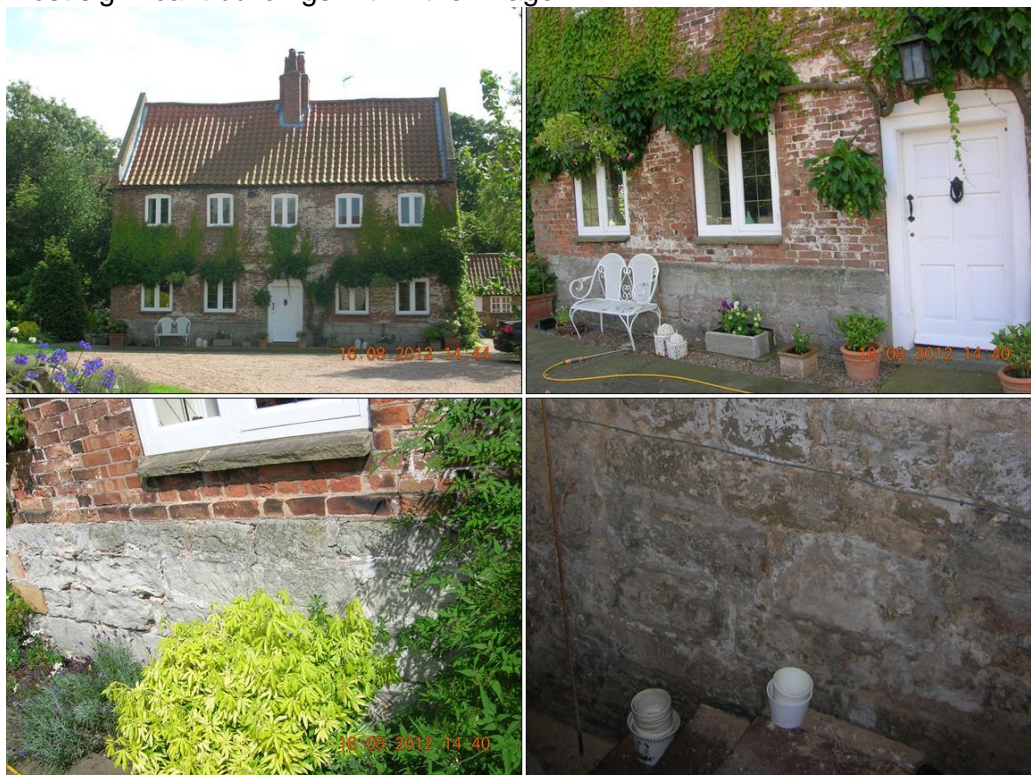
Figure 3.8: Views of Skerry Sandstone foundations at The Manor, including north elevation/frontage (top), east elevation (bottom left) and cellar (bottom right).

- 3.16 Whilst there are no other complete buildings from the medieval period within the Conservation Area, the large house immediately to the west of the church does appear to contain late-medieval (possibly 14th century) foundations. Although The Manor (grade II listed) is primarily a 17th and 18th century red brick house incorporating a 17th century timber frame, it is set on a very substantial Skerry Sandstone plinth of four visible courses of large ashlar blocks. Underground, the stonework continues within the cellar of the house, the construction of which matches that visible on the outside, with large ashlar blocks typical of the late-medieval period¹⁹. It is likely that the medieval plinth/foundations would have originally supported a timber-framed building. This site is reputedly the family home of Sir John “Judge” Markham (died 1409) and is one of the oldest and most significant buildings within the village.

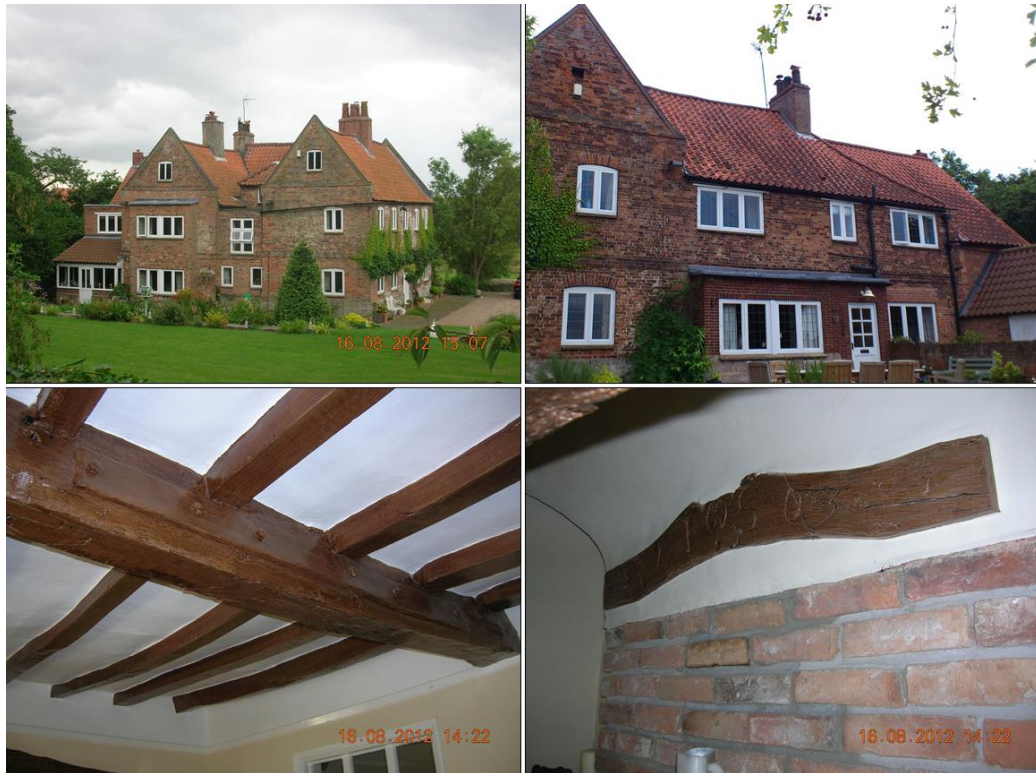
Figure 3.9: Evidence of 17th century plan form and construction, including external views of 2 ½ storey elements from north east (top left) and north west (top right), with internal 17th century timber beams supporting first floor (bottom left); timber beam with “1703” inscription on ground floor (bottom right).

- 3.17 Above ground, the building has a red brick outer skin typical of the 18th century in this area, constructed using locally-made red bricks (with a mix of brick bonds including Flemish, English Garden Wall, Flemish stretcher and areas with an irregular bond – perhaps relating to repairs) with a near-symmetrical frontage (north elevation) of two storeys and five bays. There is, however, significant evidence of an earlier timber frame (17th century) and early-18th century alterations (including a beam inscribed with “1703”) throughout the interior. Brick string courses/bands exist around most of the building at first and second floor level, these possibly relating to the floor joists of the 17th century timber frame. The off-set fenestrations at certain points around the building also indicate the extent of the timber frame, as the siting of window/door openings were constrained by the position of the supporting timbers.

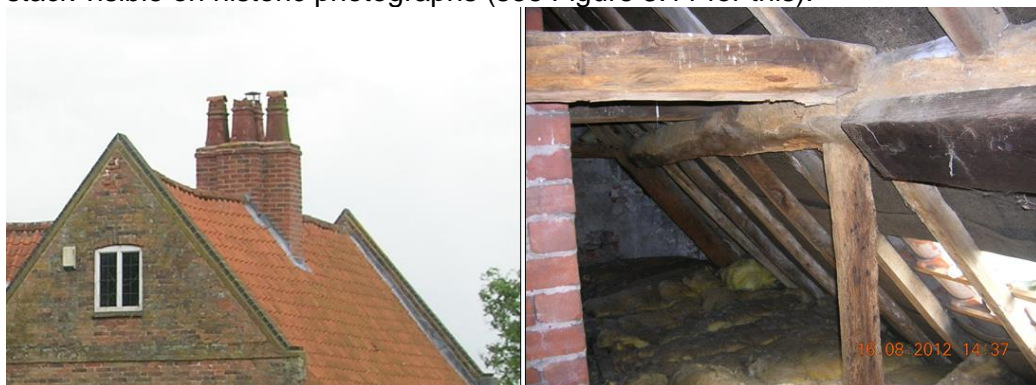
Figure 3.10: Steep roof pitch, central cross-plan chimney stack, raised and coped gables and internal roof timbers, all evidence of the 17th century phase.

- 3.18 The roof is covered in non-interlocking natural clay pantiles²⁰, although it is likely that the 17th century portions would have originally been covered in thatch, as indicated by the relatively steep roof pitch, the raised and coped gables (although partially rebuilt in 1919) on the west and east elevations and the internal roof timbers. The main front (north elevation) also has a late-17th/early-18th century central quadripartite chimney stack (with a cross-plan resembling a cluster of four square shafts) which, although has been substantially rebuilt in the late-20th century, does closely resemble the original stack visible on historic photographs (see Figure 3.11 for this).

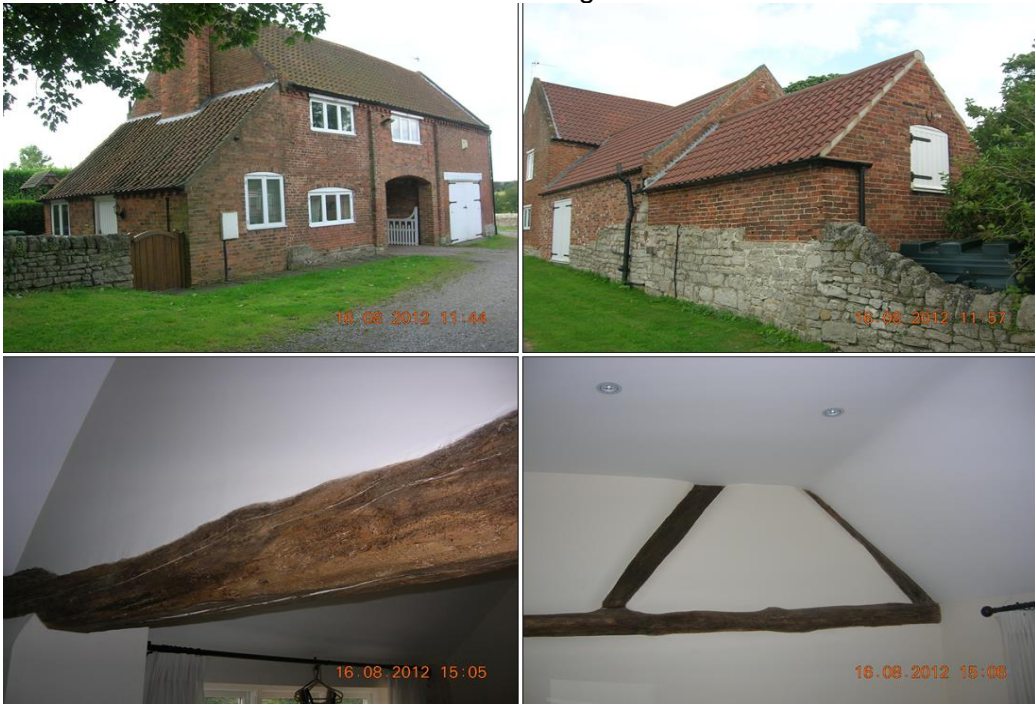
Figure 3.12: Views of exterior of Manor Cottage (top); 17th/18th century timbers inside Manor Cottage (bottom).

- 3.20 At the front of The Manor is Manor Cottage, which, similar to The Manor, is primarily an 18th century brick and pantile building (originally a threshing barn), although contains fragments of an earlier timber frame and is set on an earlier Skerry Sandstone plinth. This plinth appears to be somewhat later than that at The Manor (its less-regular construction suggests this) and is reported (in local history texts) to be the base for a timber-framed gatehouse built in the Tudor period. The interior contains fragments of a timber frame which are similar to 17th/18th century buildings nearby. The brickwork is also similar in external finish to The Manor, with a mixture of Flemish, English garden wall, Flemish stretcher and irregular bonds found around the building.

- 3.21 The exterior of Manor Cottage shows evidence of the building being constructed (or adapted) for agricultural purposes, with ventilation slits visible on both front and rear elevations. It is likely that the building was once a threshing barn for Church Farm (the name for this site until the mid-20th century). The front elevation of the central portion (containing the arch) appears

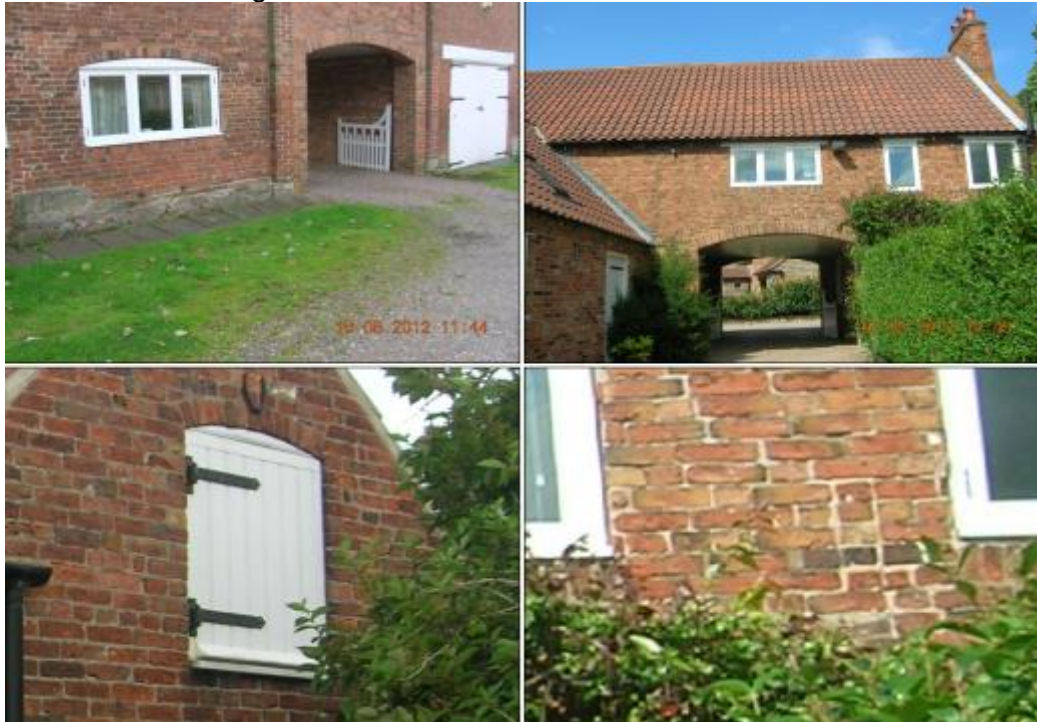
to have been rebuilt at some point and had buttresses added (most likely to hide the joins in the brickwork), this work probably being undertaken when the building was converted to a dwelling. The lean-to extension on the east side and the former outbuilding on the south side (now joined by a recent extension) also relate to this agricultural use of the site.

Figure 3.13: Central section with archway, possibly indicating the previous use as a threshing barn, from frontage (top left) and rear (top right); timber hay loft-type door in 19th century former outbuilding (bottom left); in-filled ventilation slits on the rear of the building (bottom right).

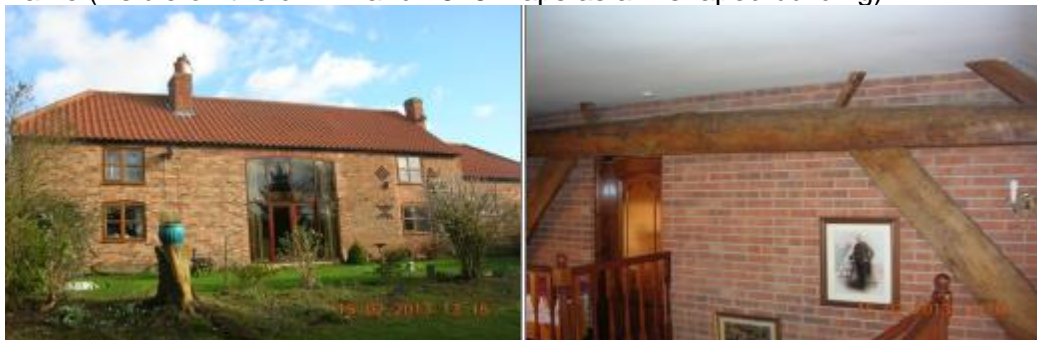
- 3.22 The Conservation Area has a large number of 17th century timber-framed buildings (when compared to other settlements within Bassetlaw District), with 24 identified, all of which seem to have been remodelled in the 18th/19th century. Most of these buildings are centred on Low Street, which seems to have been the new focus of settlement following the plague in the early-17th century in an area closer to the Lincoln and Tuxford roads, although some 17th century buildings also exist on Church Street. The grade II listed Springfield Barn (named after springs which emerge in the nearby fields to the west/north-west) appears on the outside as a typical late-18th century threshing barn, constructed from the local red brick (English garden wall bond), with diamond-pattern ventilators, shallow brick arches, dentilated eaves and a clay pantile roof. However, the interior contains a large proportion of the 17th century timber frame (visible on the c1712 and 1816 maps as a T-shaped building).

Figure 3.14: Views of Springfield Barn, including south west/rear elevation and internal 17th century timber frame.
