East Markham Conservation Area Appraisal & Management Plan

December 2014

Title: Bassetlaw District Council: East Markham Conservation Area Appraisal and Management Plan.

Summary: This document is the Council's appraisal of the special architectural and historic interest of East Markham Conservation Area and a management plan with proposals for enhancement and preservation.

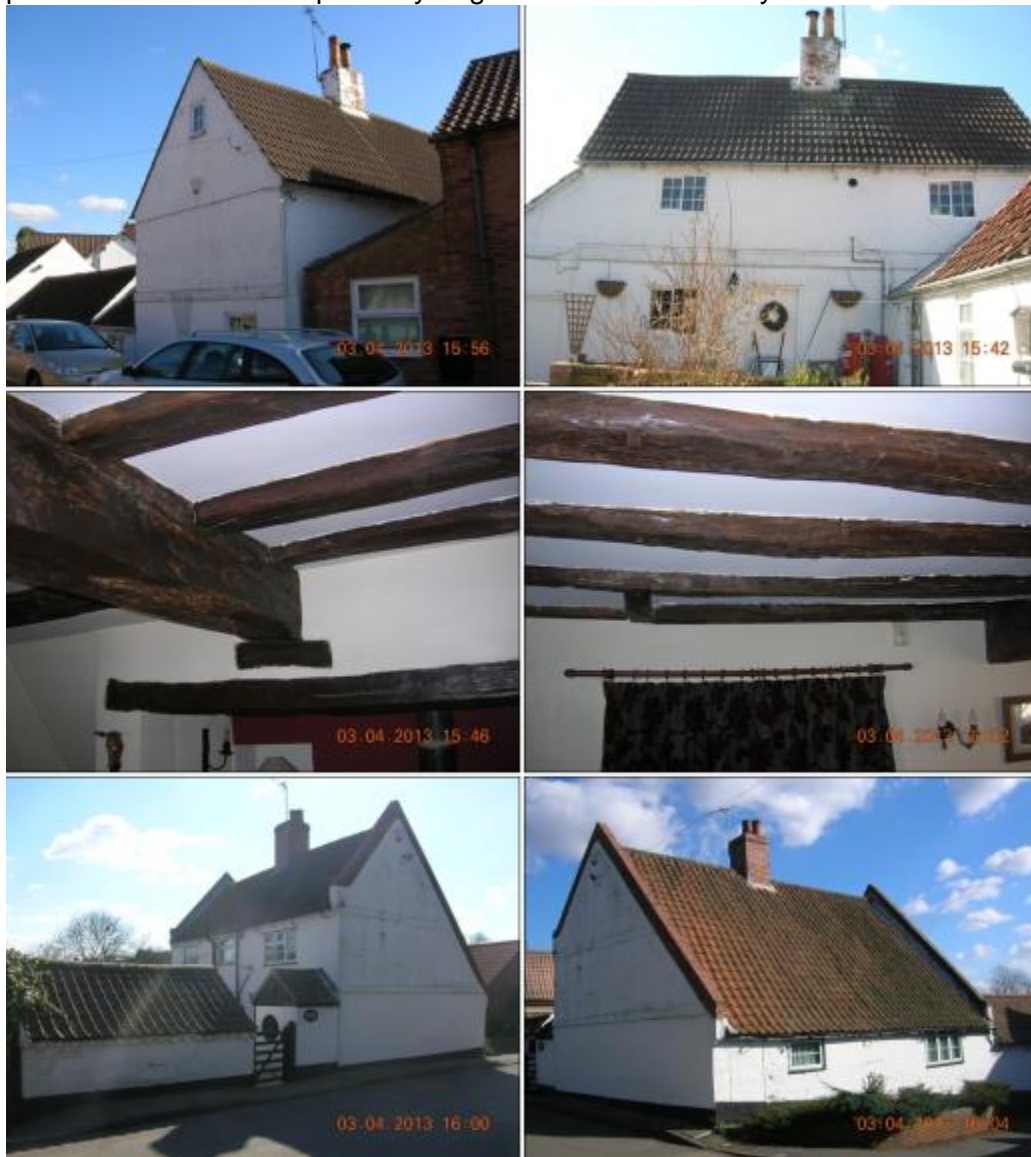
- 3.23 A cluster of mid-17th century timber-framed buildings exist around Low Street, including The Old Hall, The Green, Blyth Cottage, The Rookery, December Cottage (grade II listed) and Markham Cottage. On the exterior, these differ in appearance and form, with December Cottage and Markham Cottage being the most obvious given their form. Both have steep roof pitches, later red brick outer skins (Flemish bond) with a string course at first floor level (marking the position of the earlier floor joists), stone plinths, raised coped gables (these originally supported thatched roofs) and central chimney stacks (early-18th century additions), all of which are diagnostic of a timber frame. Internally, the timber frames of both buildings are visible throughout, particularly around the fireplaces, the ceilings and in the roof spaces. Both buildings also have gypsum plaster floors which are probably original to the 17th century construction.

Figure 3.15: December Cottage (top and centre) and Markham Cottage (bottom), on Low Street.

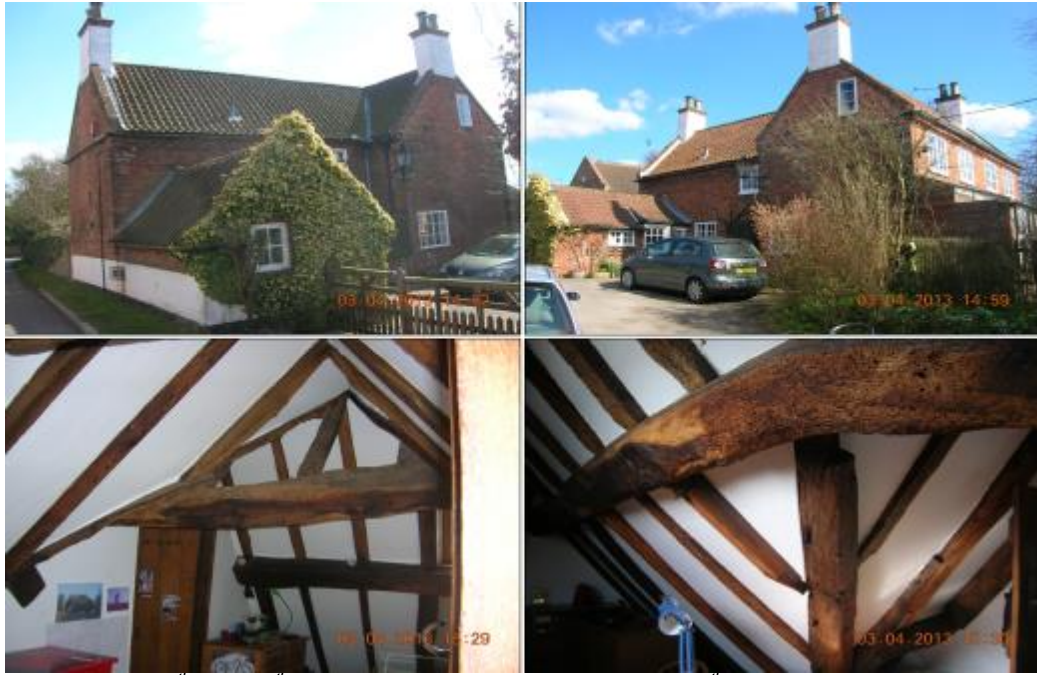
- 3.24 One of the most complete timber-framed buildings within the Conservation Area is The Rookery, which appears on the outside as an 18th and 19th century red brick (primarily Flemish bond) farmhouse. However, much of the internal frame remains in situ, particularly in the ground floor ceilings, in the stairways, the upper floor walls, around the doorways and especially in the roof space.

Figure 3.16: 18th and 19th red brick century exterior (top) and 17th century internal timber frame (bottom) at The Rookery, Low Street.

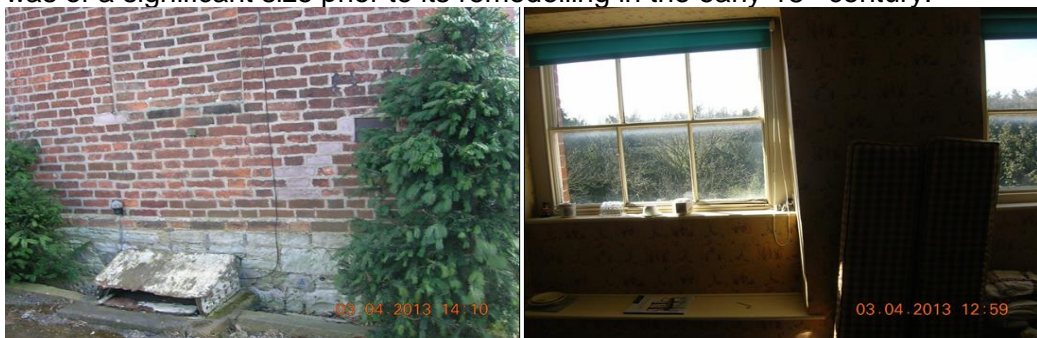
- 3.26 Whilst the extent of the original 17th century house is not fully visible, the outline of the cellar, the extent of the Skerry Sandstone plinth, the central chimney stack (typically inserted in the early-18th century into an earlier building), the string course on the north west elevation and certain internal features (such as irregular window openings and curved sections of wall) suggest the building was of a significant size prior to its remodelling in the early-18th century.

Figure 3.17: Skerry Sandstone plinth (left) and internal view of window placed within earlier irregular opening probably set in timber frame (right).

- 3.27 The early-18th century (c1701) phase is the most substantial in terms of the footprint of the building, incorporating much of the visible fabric on both side elevations and on the rear. The central quadripartite chimney stack, which is very similar to that at The Manor, probably dates to this phase. The near flush-fitting sashes, the roughly-made bricks with wide mortar joints (see figure 3.17) and a number of timbers within the roof space also appear to be of this date.

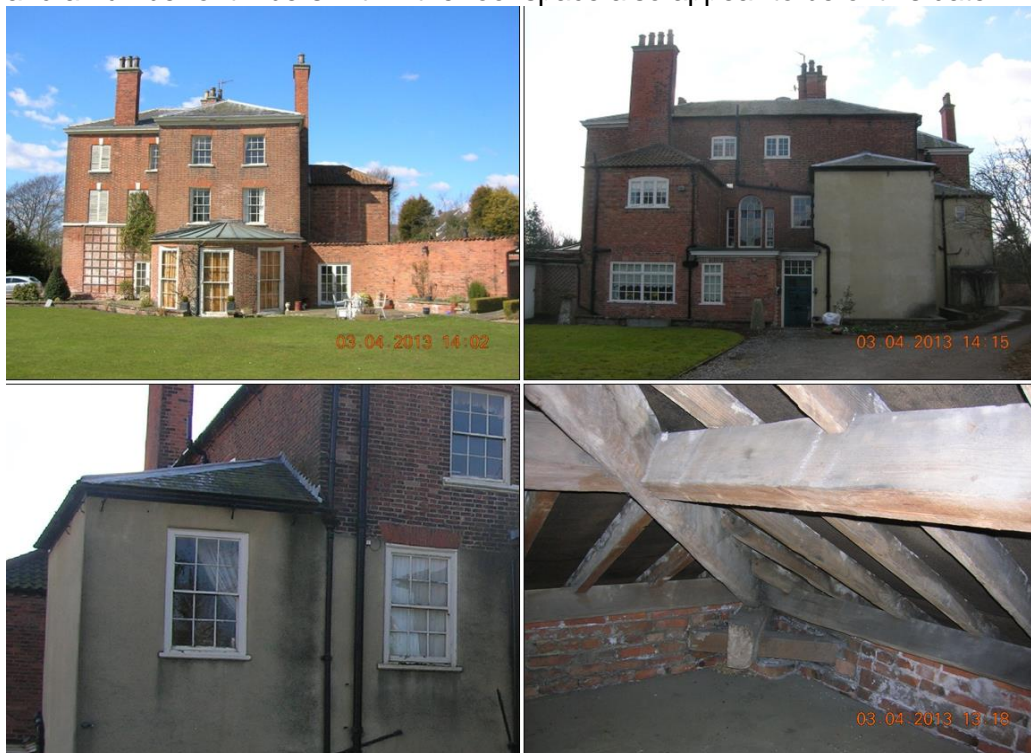
Figure 3.18: Early-18th century features at East Markham Hall including the quadripartite chimney stack (top), the flush-fitting sash on the north west side (bottom left) and the dragon beams in the roof space (bottom right).

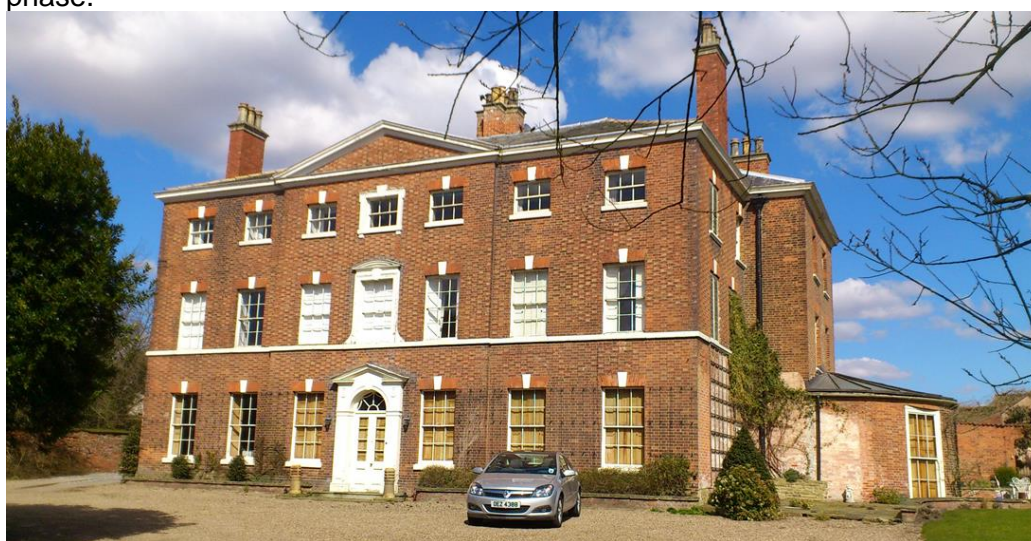
Figure 3.19: Main south west frontage at East Markham Hall, added in c1777.

- 3.28 The most prominent phase is the c1777 work, the key part of which is the decorative frontage (south west elevation). This façade contains seven bays, the central three of which are under a triangular pediment. The windows consist of rubbed brick arches with central keystones, plain stone cills and '6 over 6' and '3 over 3' sashes within much deeper reveals than found on the c1701 phase.

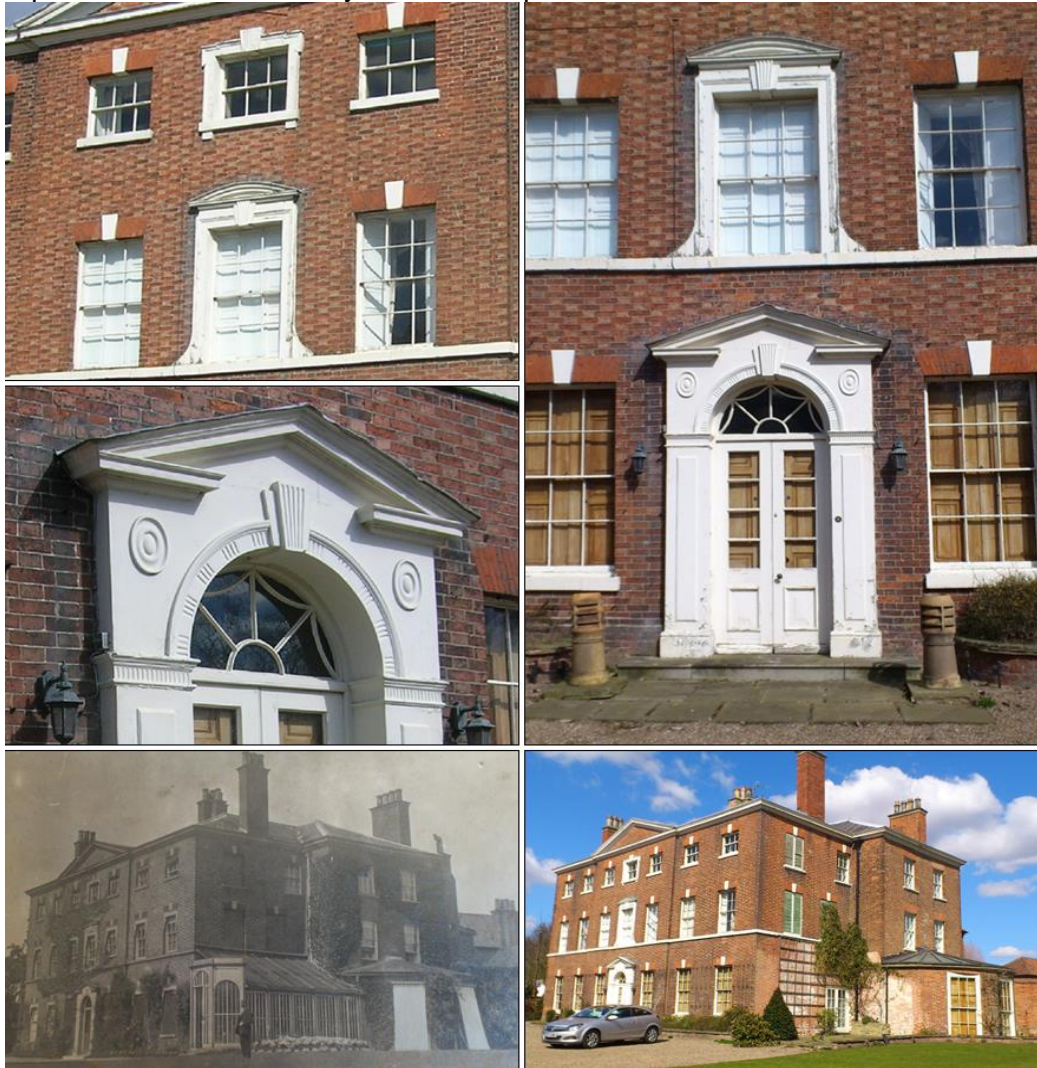
- 3.29 The openings within the central bay are more decorative than elsewhere on the frontage. The main doorway has an ashlar surround with pilasters, arched triangular pediment with paterae (dish-like circular decorative features) on each side and with half-round fanlight with tracery. The doorway contains a pair of timber panelled and part-glazed doors. The first floor central window has shouldered architrave with a fluted keystone and rounded pediment. A painted band exists at first floor level, partly forming the cills to windows on that floor. The second floor window is similarly decorated, although with eared architrave and keystone. Many of the internal shutters on the upper floors probably relate to the c1777 phase, although those on the ground floor appear to have been replaced in the 20th century and are not painted.

Figure 3.20: Main c1777 façade of East Markham House, including decorative doorway with paterae, pediment and traceried fanlight (centre left), first floor window (top right), second floor window (top left) and comparative views from c1909 (bottom left) and present day (bottom right). Image source: East Markham Hall owners, accessed 2013.

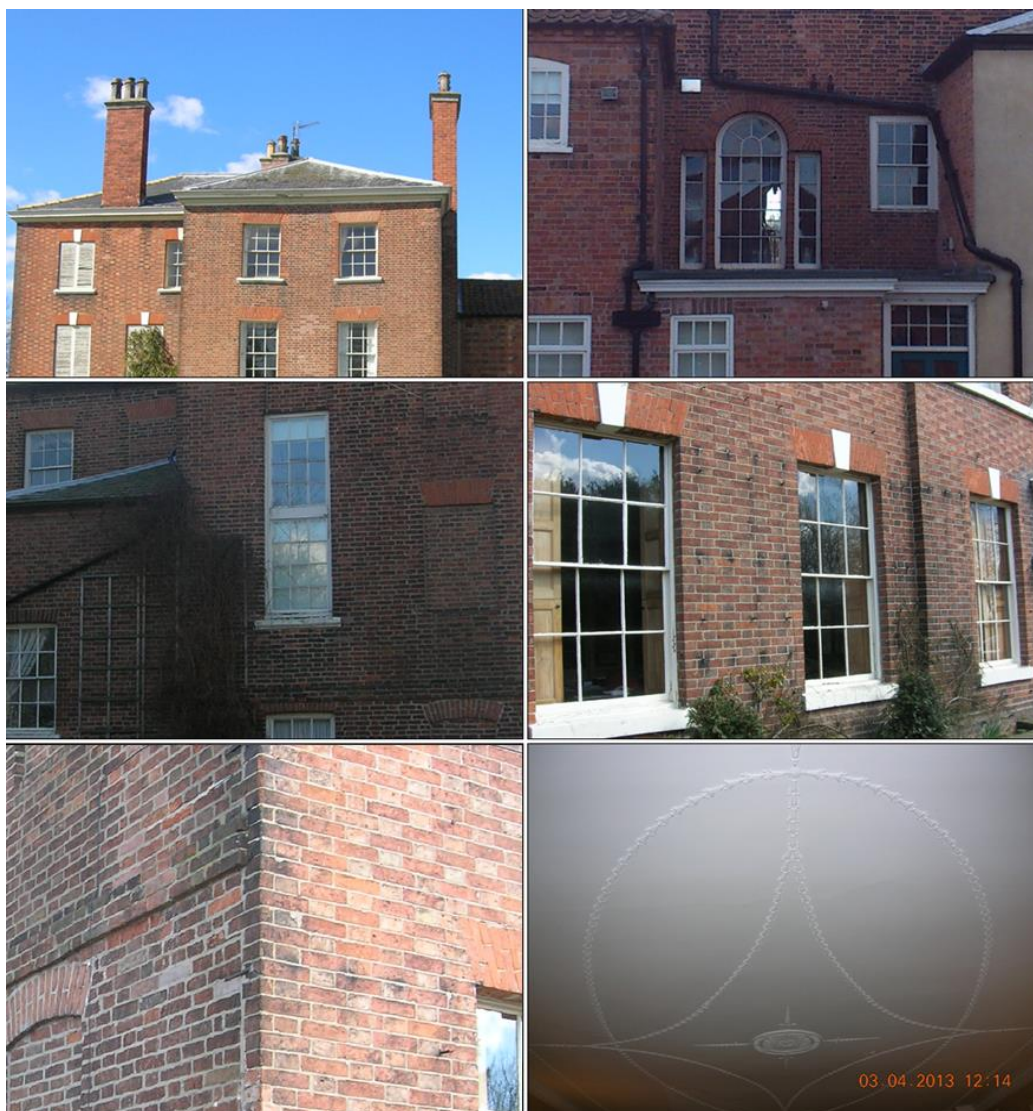
Figure 3.21: Other significant features from the c1777 phase, including the tall chimney stacks (top left), Palladian window (top right), remodelled window heads (centre left), deeply-recessed sashes (centre right), the join between the c1701 building and the c1777 façade (bottom left) and decorative internal plasterwork (bottom right). The centre left image also shows an early-18th century brick arch, which uses rectangular bricks and thicker mortar joints at the top.

- 3.30 Other features around the building from the c1777 phase include the tall rectangular chimney stacks, the Palladian window on the rear (north east elevation), the numerous remodelled window openings on the north west elevation (where flat arches of wedge-shaped rubbed bricks replaced the earlier simpler brick arches with their rectangular bricks and different thicknesses of mortar allowing for the arch), the sash windows set in deep reveals, the internal Robert Adam-style plasterwork and the scar on the south west corner of the building showing the join between the c1701 brickwork and the c1777 façade.

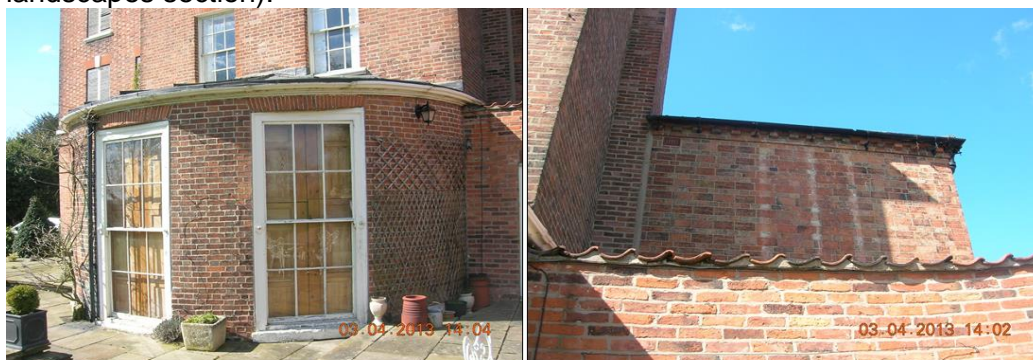
Figure 3.22: Early-19th century bow (left) and first floor addition with Dearne's bond brickwork.

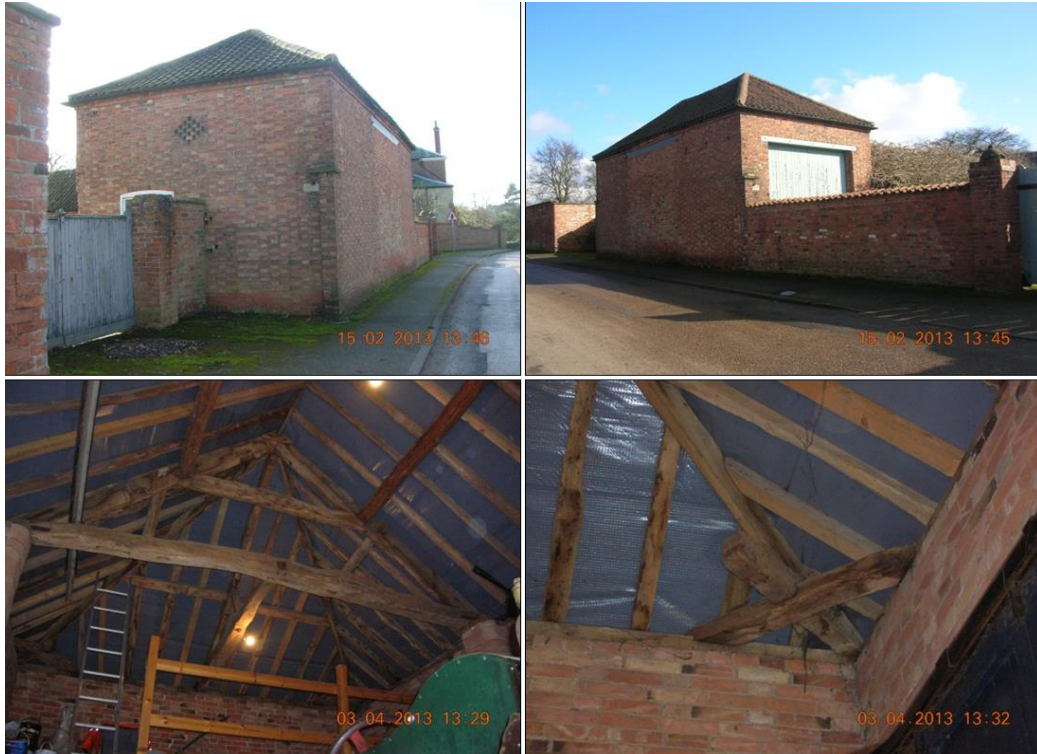
Figure 3.23: Late-18th/early-19th century barn with 17th century timber roof structure. The distinctive dragon beams (bottom right) exist in each of the four corners.

- 3.32 Adjacent to East Markham Hall on its north side is a range of brick and pantile outbuildings. The building fronting Hall Lane is the most significant, as it contains roof timbers which appear similar to 17th century ones found elsewhere within the Conservation Area. If from an earlier building, these roof timbers might be re-used from the building shown on this site on the c1712 map. However, the exterior of the building is distinctly late-18th/early-19th century, particularly the west elevation (facing Hall Lane), which contains an in-filled opening (probably for a pair of barn doors) and the north gable which contains a diamond ventilator.

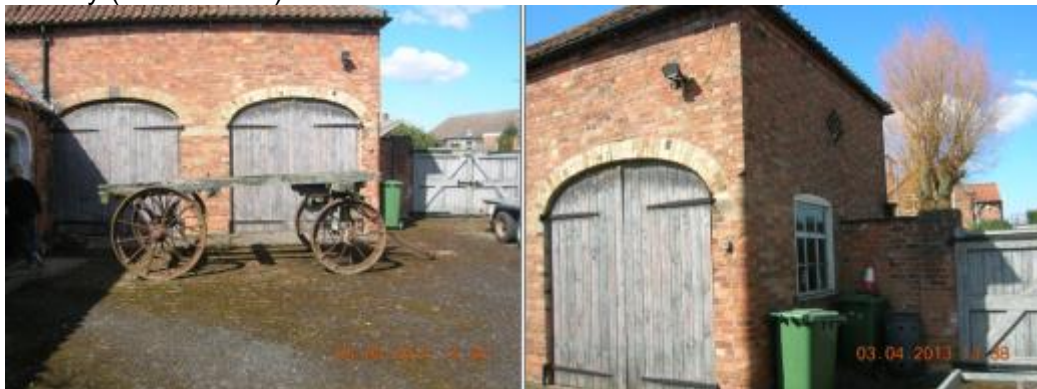
- 3.33 The east elevation (facing into a small courtyard) shows that the building may have been converted into a coach house in the mid-19th century, with the installation of a pair of arched openings with pairs of side-hung timber doors. The recessed door arches are diagnostic of their being installed in the mid-19th century (c1820-1840).

Figure 3.24: East elevation of building showing mid-19th century conversion to coach house.

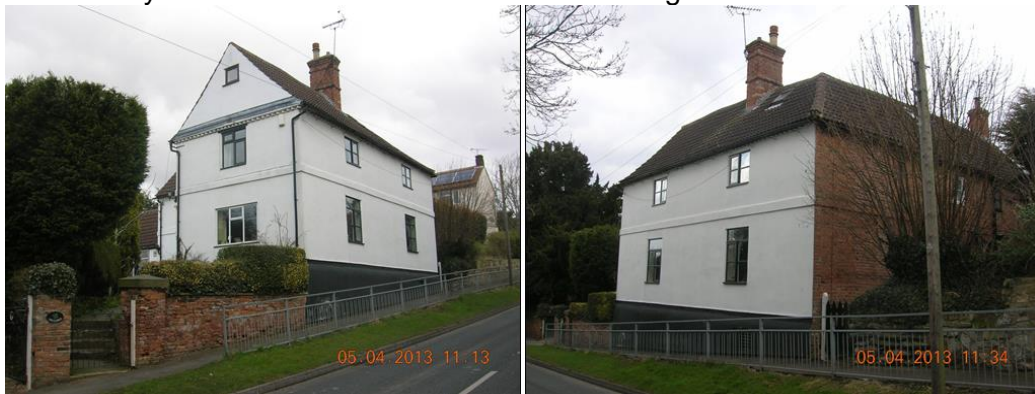
- 3.34 Other prominent 17th century buildings of note include Haycorns on Farm Lane, Markham House on York Street, Norwood Cottage on Church Street and The Old Hall on Low Street. Haycorns has a number of external features common to

other buildings of this type and age nearby, including a first floor string course, stone plinth, central chimney stack and steeply-pitched roof. However, very little 17th century fabric remains visible within the building.

Figure 3.25: Views of Haycorns, Farm Lane.

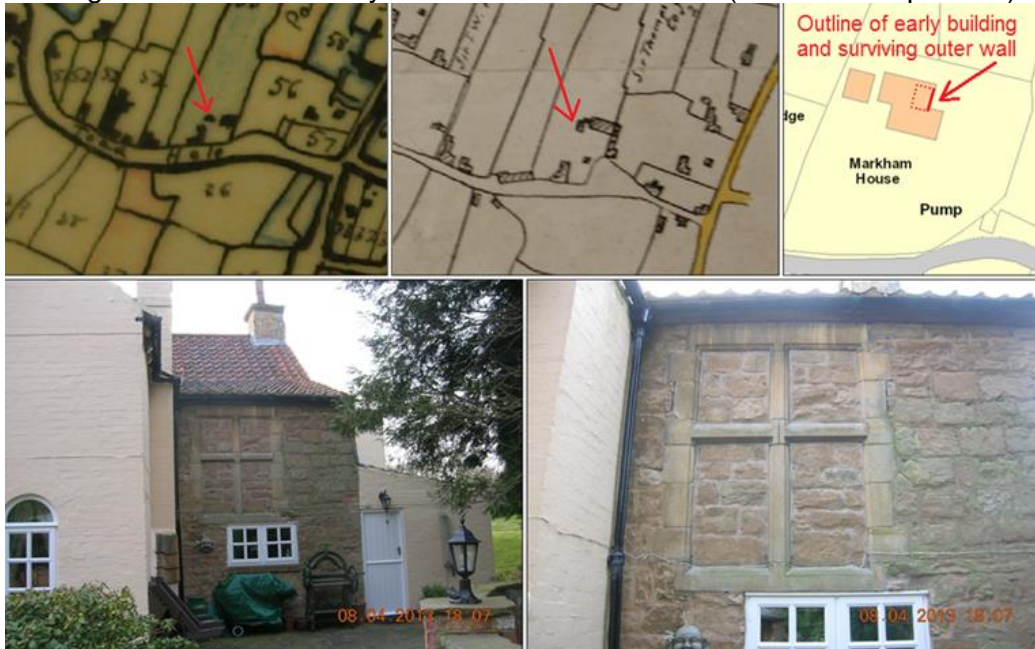
- 3.35 Markham House on York Street contains one of the most interesting 17th century (or possibly 16th century) structures within the Conservation Area. The north east corner of the house contains the remains of a building which was associated with a much larger building to the east during the 17th-19th century period, possibly a large barn or maltings given its apparent size (see maps below). The surviving building, possibly built as a house associated with the larger building, is unique in the village (other than the church tower) as it is constructed of Magnesium Limestone and also contains an in-filled cross window of 16th or 17th century date. It is not known, however, whether this window has been inserted at a later date or whether it is in its original position. This near-square building was extended southwards in the 19th century and then again in the 20th century to form the current house (see 2013 map below).

Figure 3.26: Probable 17th century portion of Markham House, York Street, as shown on **map 39** from c1712 (top left), **map 40** from 1816 (top centre) and **map 41**, present day (top right); Views of east elevation with in-filled 16th/17th century cross window (bottom). Historic map source: Nottinghamshire Archives, accessed 2012; 2013 O.S. Map – Reproduced from Ordnance Survey mapping with the permission of Ordnance Survey, © Crown Copyright 2013, Bassetlaw District Council. License No. 100019517.

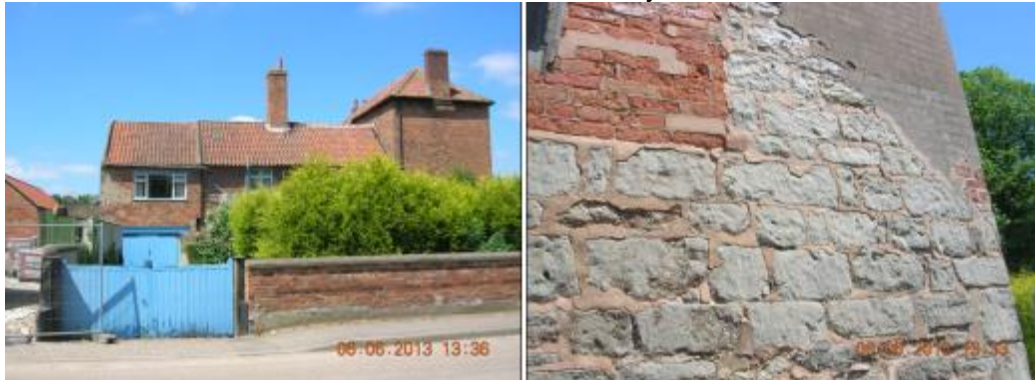
- 3.36 Similar to Markham House, Cushpool House (grade II listed) also has a large area of stonework within an earlier phase. The rear section of this building contains a substantial portion of a Skerry Sandstone structure, this being the largest amount of Skerry visible on one building other than the church. The south-west gable of the building is almost entirely constructed from Skerry. Other large areas are visible on the south east elevation. It is likely that the Skerry portion of the building dates to the 17th or early-18th century. The rest of this rear wing of the house appears to be early/mid-18th century, judging by the construction, form and scale. Sadly the large threshing barn associated with the farmhouse was demolished in the mid-20th century.

Figure 3.27: 17th and early-18th century rear wing at Cushpool House.

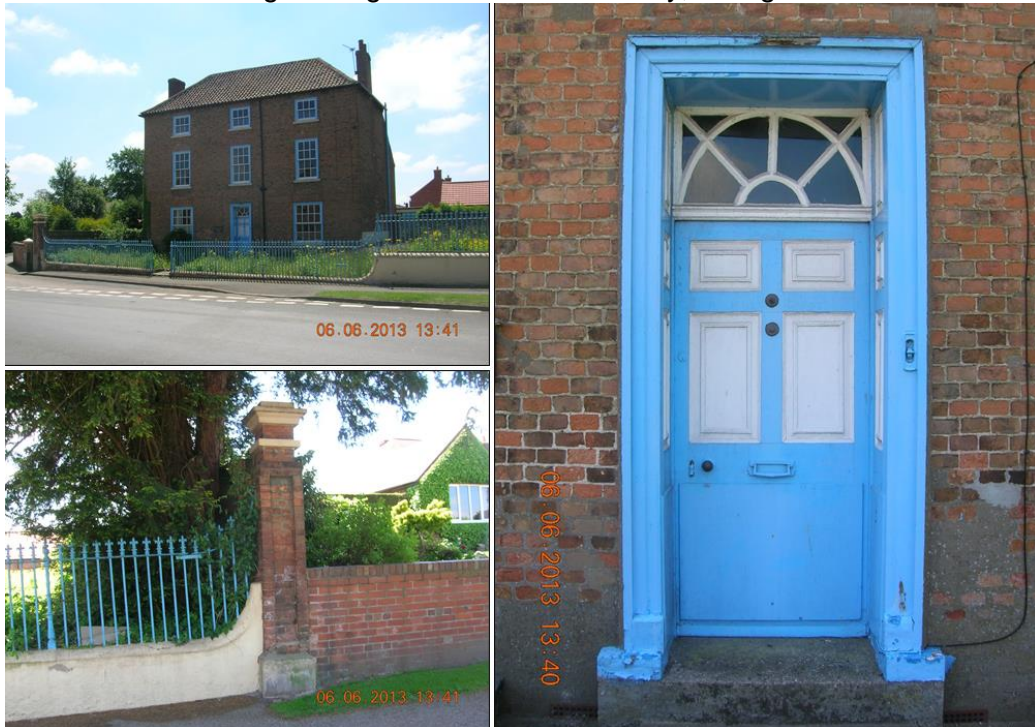
- 3.37 The front façade would have been added in the later-18th century, as the farm became more prosperous during the latter half of that century. The front is typical of the period, with three storeys and three bays, containing vertical sashes in diminishing sizes ('8 x 8s' on the ground floor, '6 x 6s' on the first floor and '3 x 3's on the second floor) and an ornate door with surround. One rare element of this building is the brick bond on the frontage, with consists entirely of headers (the most expensive of brick bonds at the time). The site also has a dwarf wall and railings dating to the late-19th century, also grade II listed.

Figure 3.28: Later-18th century façade at Cushpool house, with ornate doorway and header brick bond visible (right).

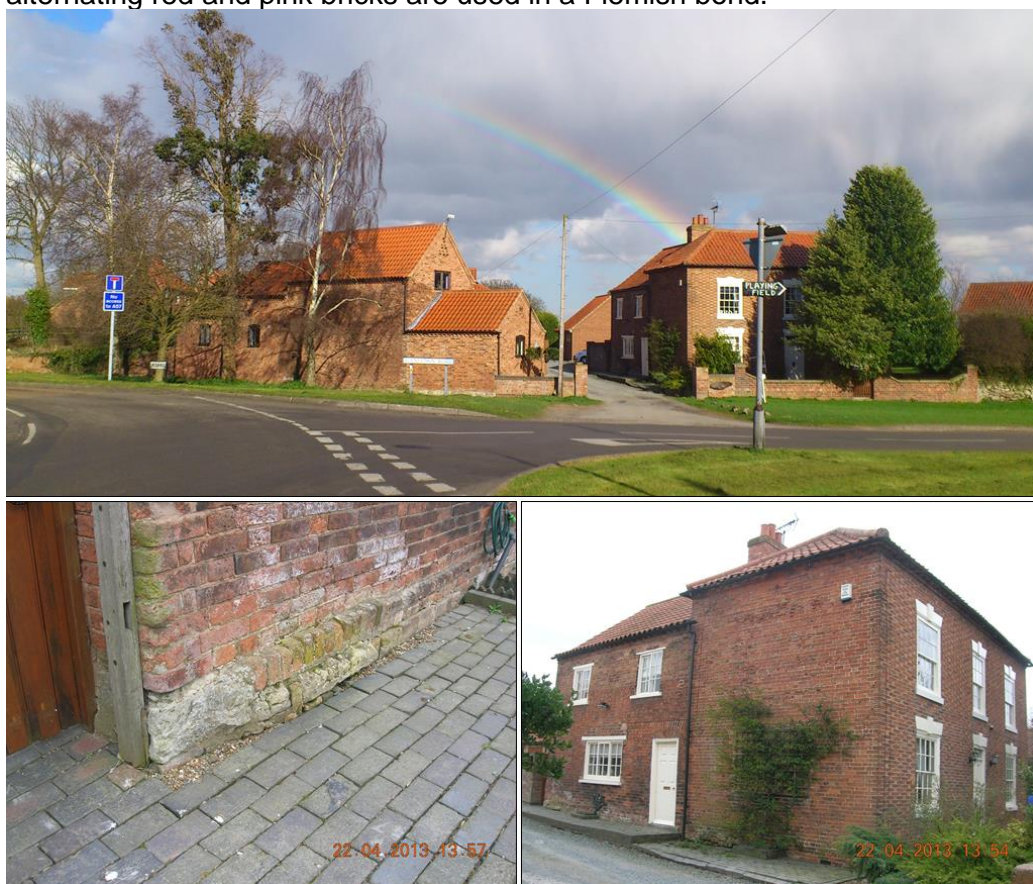
Figure 3.29: Pond Farm (top), with earlier Skerry Sandstone foundations (bottom left) and distinction between 18th and 19th century portions (bottom right).

3.39 Pond Farmhouse (grade II listed) is one of the most prominent sites of this type, being on the intersection of Lincoln Road/High Street and Plantation Road, sited next to the largest of the historic village pond sites and being at the head of an area of higher ground. Again, the rear section of the main farmhouse contains Skerry foundations and when compared with map evidence (from 1712), this was probably part of the 17th century farm. The remainder of the rear section indicates an early/mid-18th century date of construction/remodelling. The façade, similar to Cushpool House, is late-18th/early-19th century. As with Cushpool House, the brickwork on the frontage is decorative, although here alternating red and pink bricks are used in a Flemish bond.

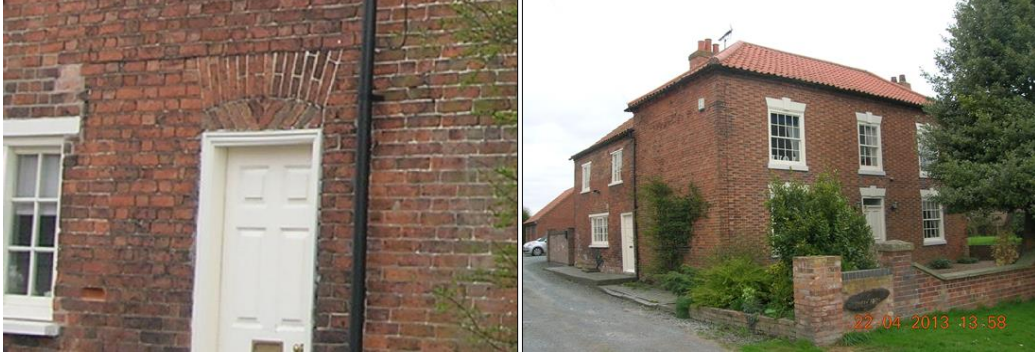
Figure 3.30: Distinctive 18th century door arch (left) and 19th century stone lintels with keystones (right) at Pond Farmhouse.

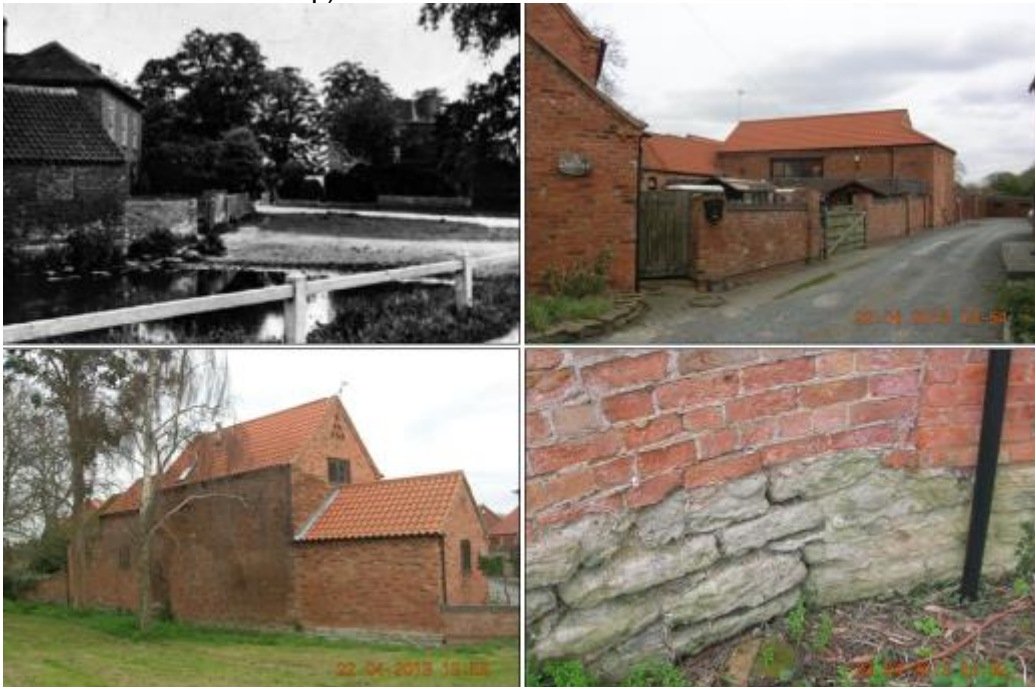
- 3.41 Adjacent to Pond Farmhouse are the former agricultural buildings associated with it (also grade II listed) including a former stables, threshing barn and dovecote. Whilst parts of these have been partially rebuilt recently, a large part of the original fabric remains and those rebuilt sections have sought to replicate the original features (such as the bird flight holes in the dovecote). One of the most notable features of this building range is the distinction between the Skerry Sandstone foundations adjacent the former pond (visible below, filled in the 1920s) and the brickwork above, again probably indicating an earlier phase visible on the c1712 map).

Figure 3.31: Views of former agricultural buildings at Pond Farm, as seen in c1920 (top left) and showing threshing barn and stables (top right), former dovecote with reconstructed flight holes (bottom left) and Skerry Sandstone foundations adjacent the former pond (bottom right).

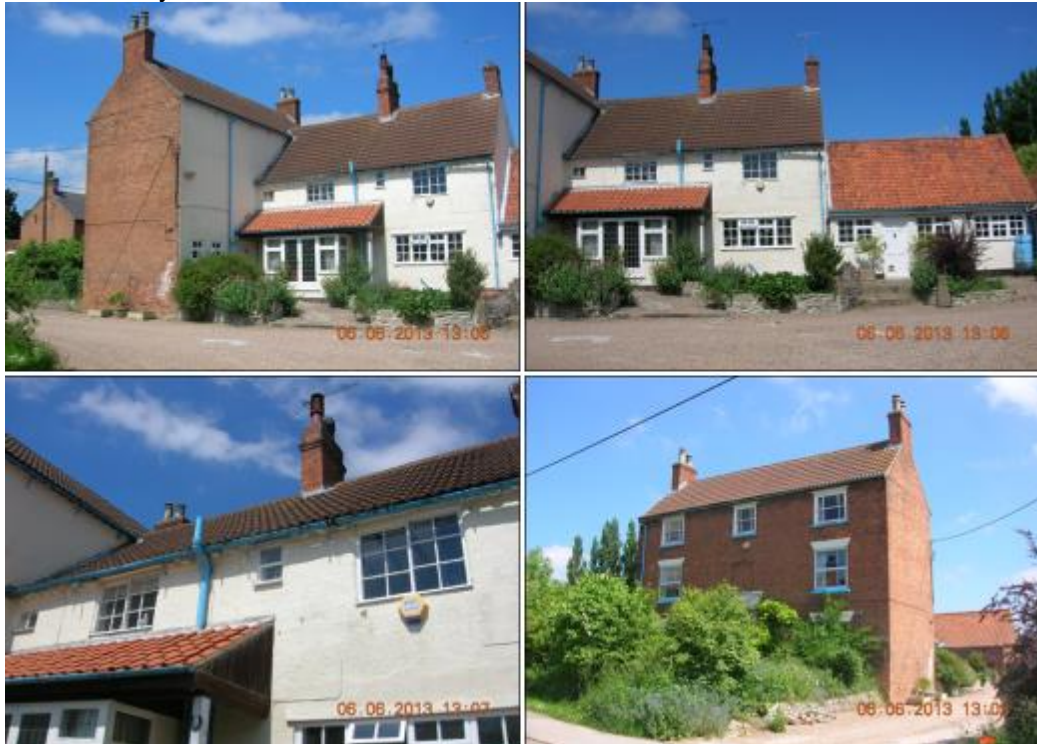
- 3.42 Woodward Farm is of a similar scale to Cushpool House, with an earlier 17th or early-18th century rear house (visible on the 1712 map) and a later-18th/early-19th century façade. Later alterations to the window openings on the rear

portion have resulted in part of the significance being lost. However, the overall scale and remaining detailing (such as dentilated eaves) are very similar to those phased sites discussed earlier. Again, the Regency period appears to have been prosperous for this farm, judging by the phases of development which clearly date to that time.

Figure 3.32: Woodward Farmhouse, showing 17th/early-18th century portion (top and bottom left) and later-18th/early-19th century façade (bottom right).

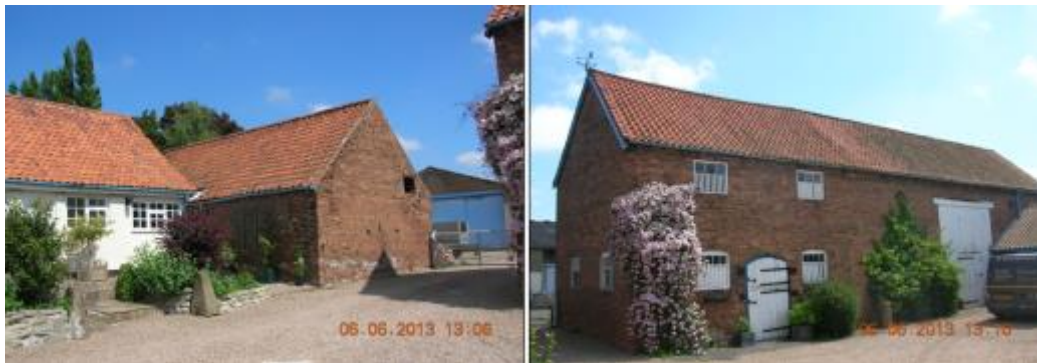
- 3.43 Unlike Cushpool House, Woodward Farm has its large late-18th/early-19th century threshing barn in situ, with very few later alterations visible other than the installation of a large lintel within the large door opening. Features of note include the door and window arches, the timber windows and doors and the diamond ventilators. A 19th century outbuilding also exists immediately to the rear of the house, with much of its historic character (including rainwater goods) intact.

Figure 3.33: 19th century outbuilding (left) and threshing barn (right) at Woodward Farm.

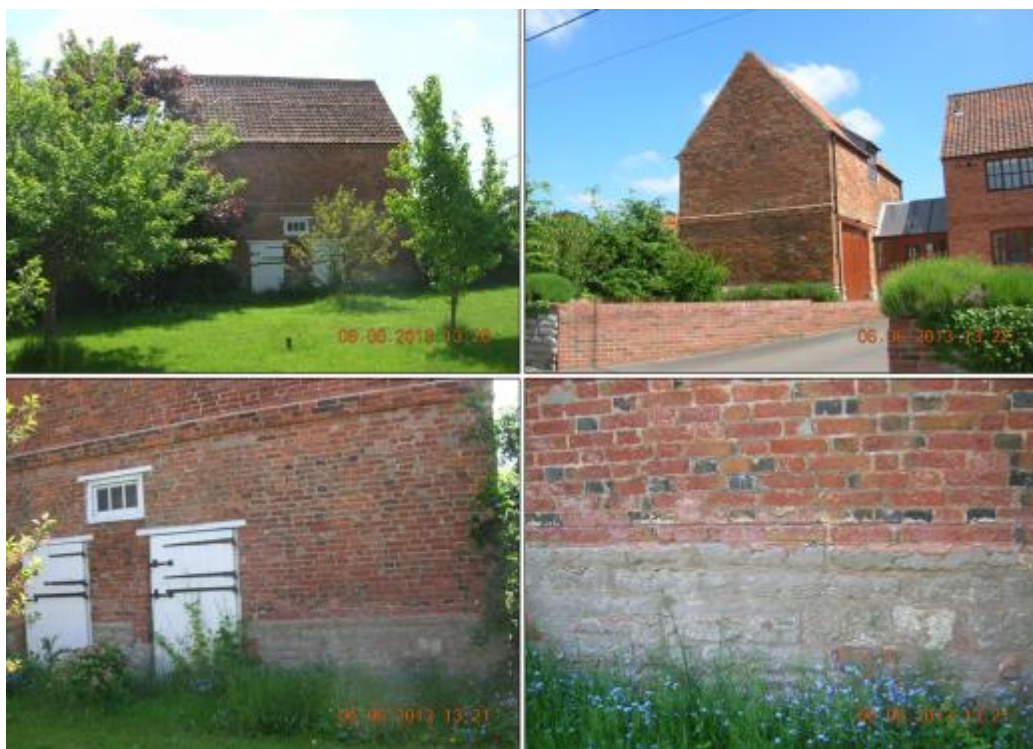
- 3.44 Adjacent to Woodward Farm is The Old Dovecote (grade II listed), which is now attached to a modern house although was originally part of Woodward Farm. The building is primarily red brick and dates to the late-18th century, although the Skerry plinth and projecting brick band at first floor level indicates an earlier phase, probably one of the buildings visible on the c1712 map.

Figure 3.34: Former dovecote to Woodward Farm, showing earlier Skerry plinth (bottom), surviving timber joinery (left) and recent alterations as part of conversion to living accommodation and garage (top right).

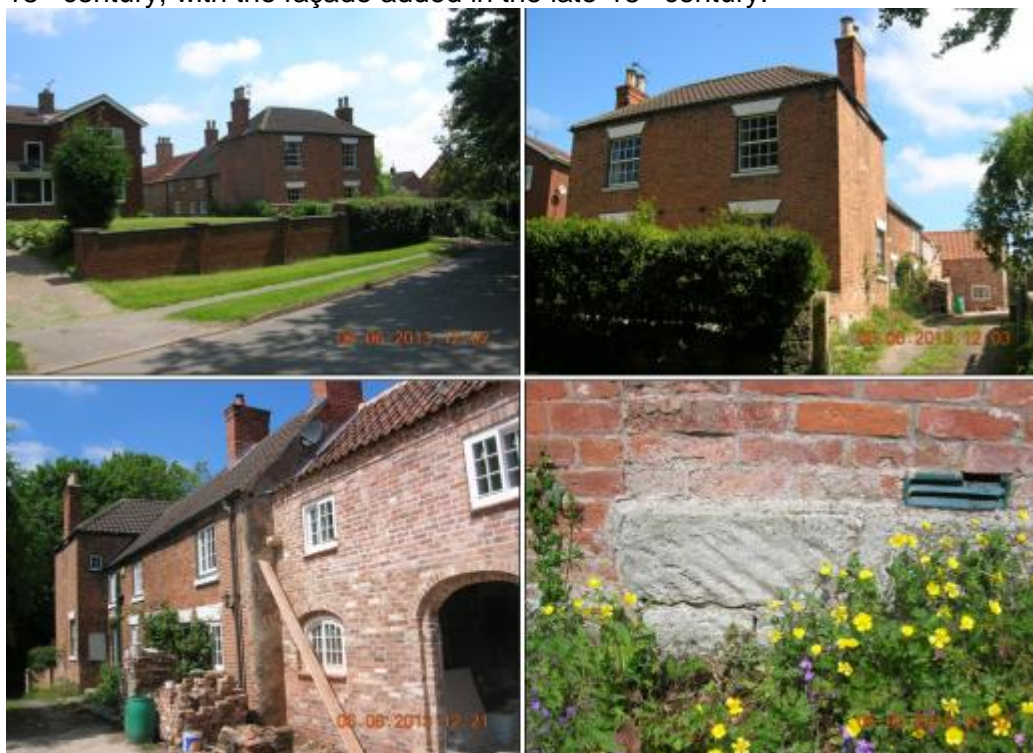
- 3.45 To the north, Ashlea shows evidence of early brickwork on the rear part of the house, in addition to sections of Skerry at plinth level, probably dating to the 17th or early-18th century. The remainder of the rear portions appears to be mid-18th century, with the façade added in the late-18th century.

Figure 3.35: Views of Ashlea, showing earlier phases to rear (bottom) and late-18th century façade (top).

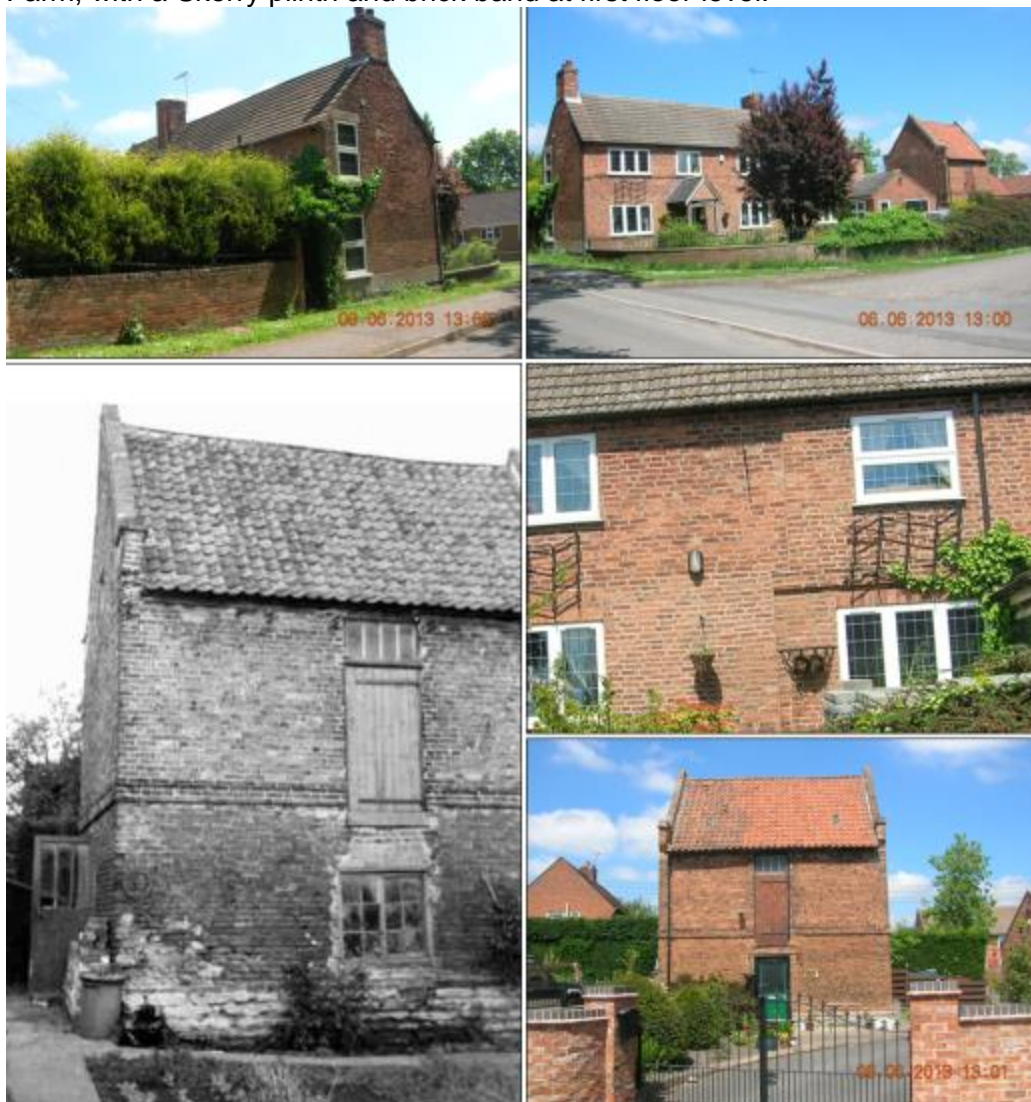
- 3.46 The last of the phased farms on Plantation Road is Bowerhayes. This is the least ornate of the cluster of farmhouses, although the different periods of construction and alteration visible on the south side of the house are amongst the clearest examples of phased historic development within the Conservation Area (at least three distinct historic phases of brickwork are visible at the eastern end of the south elevation). On the east side of the house is a grade II listed Dovecote, which is similar in scale and construction to that at Woodward Farm, with a Skerry plinth and brick band at first floor level.

Figure 3.36: Bowerhayes as viewed from Plantation Road (top), showing distinct phases of brickwork including projecting brick band on south side (centre right) and listed dovecote with stone plinth in 1981 (bottom left) and present day (bottom right). Image source: Bassetlaw Museum, accessed 2013.

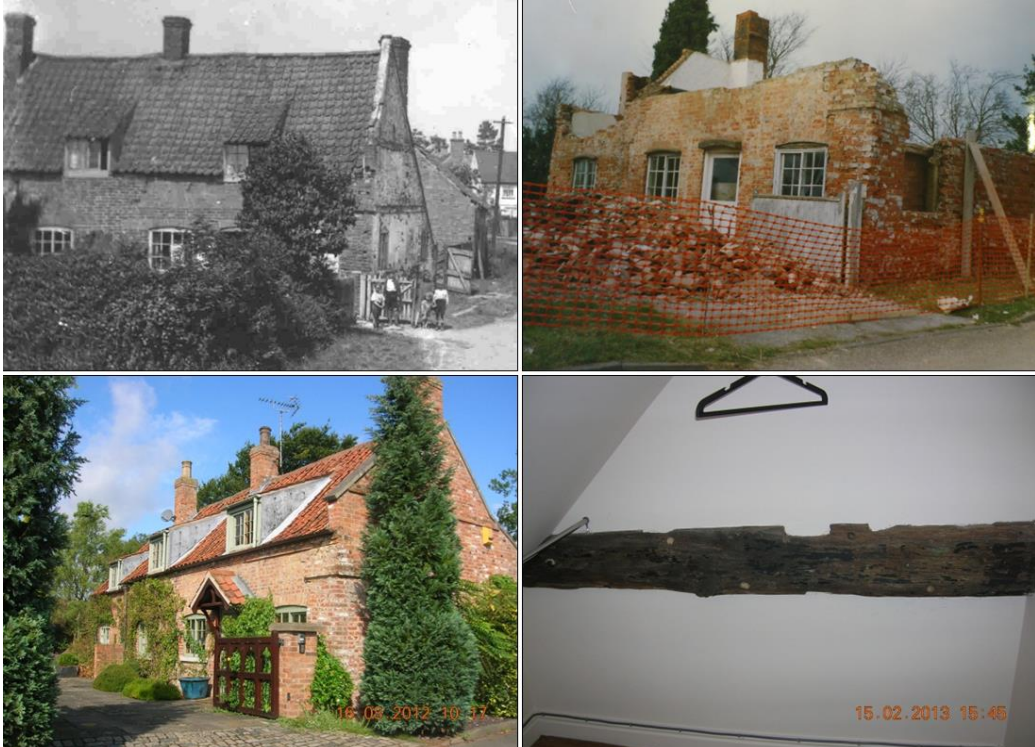
- 3.47 Away from the larger farms, other buildings which appear to have 17th century origins exist across the Conservation Area. The Old Hall, Flowerdale, Emmadale, The Nookin, The Green, The Mount, Manor Farm, Kiln Cottage and Blyth Cottage all contain features which are associated with a pre-18th century origin, such as a projecting first floor brick band, stone plinth, central chimney stack and a steeply-pitched roof.
- 3.48 Of those other 17th century buildings, only Norwood Cottage is listed. The building is a typical vernacular timber-framed cottage, remodelled in brick in the

18th century. It was, however, substantially rebuilt in the late-20th century, although does still contain an amount of 17th century fabric.

Figure 3.37: Norwood Cottage, as shown in c1915 (top left), in 1994 during reconstruction (top right), in present day (bottom left) and surviving 17th century timber in upper floor (bottom right). Image source: Bassetlaw Museum, accessed 2013.

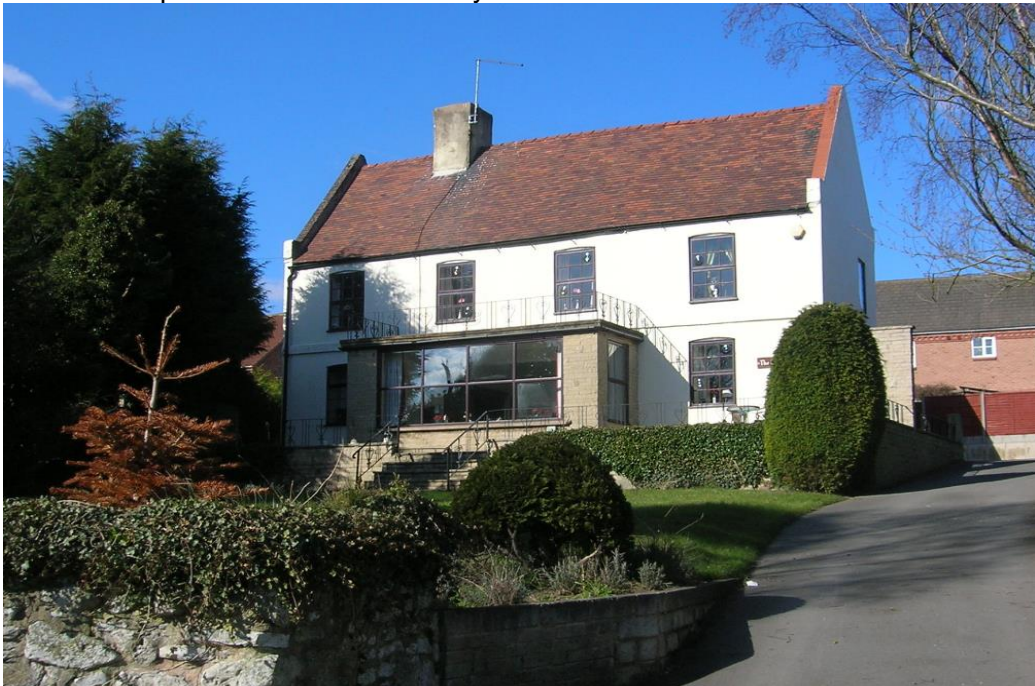
- 3.49 The Old Hall on Low Street (reputedly a service building to a large house that existed close to the road frontage in the 17th and 18th century) also has the indications of a 17th century building. The string course, steep roof pitch, coped gables, off-centre chimney stack and off-centre windows all indicate a timber frame. The existing façade however is 18th century, although the windows and roof were replaced in the 20th century.

Figure 3.38: The Old Hall, Low Street.
