East Markham Conservation Area Appraisal & Management Plan

December 2014

Title: Bassetlaw District Council: East Markham Conservation Area Appraisal and Management Plan.

Summary: This document is the Council's appraisal of the special architectural and historic interest of East Markham Conservation Area and a management plan with proposals for enhancement and preservation.

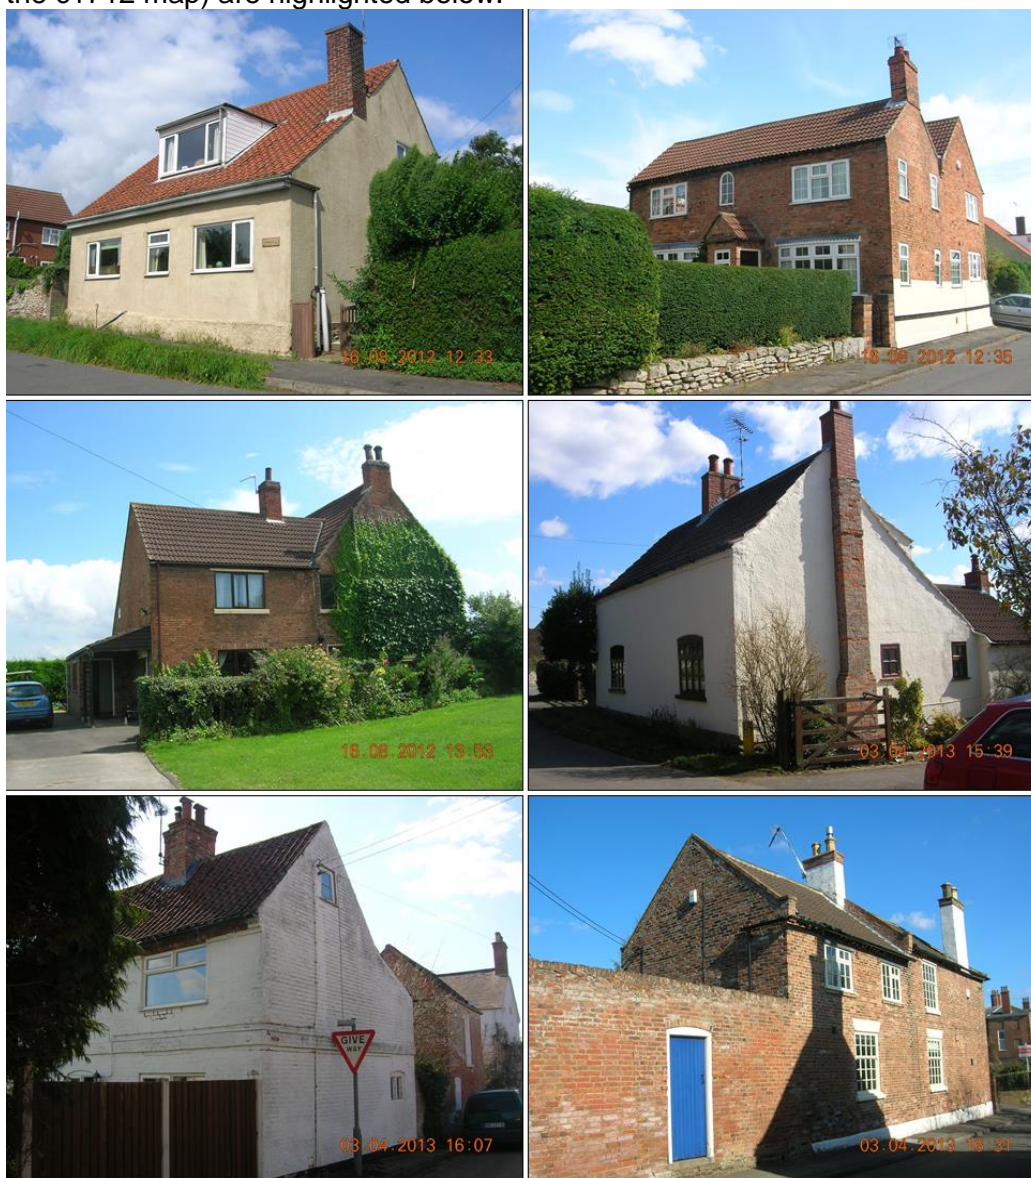
3.50 In addition to those already shown, further examples of cottages/farmhouses with an apparent 17th century origin (as listed in paragraph 3.47 and shown on the c1712 map) are highlighted below.

Figure 3.39: Other buildings in East Markham Conservation Area with 17th century origins, including Emmadale (top left), Flowerdale (top right), Manor Farm (centre left), Kiln Cottage (centre right), Blyth Cottage (bottom left) and The Green (bottom right).

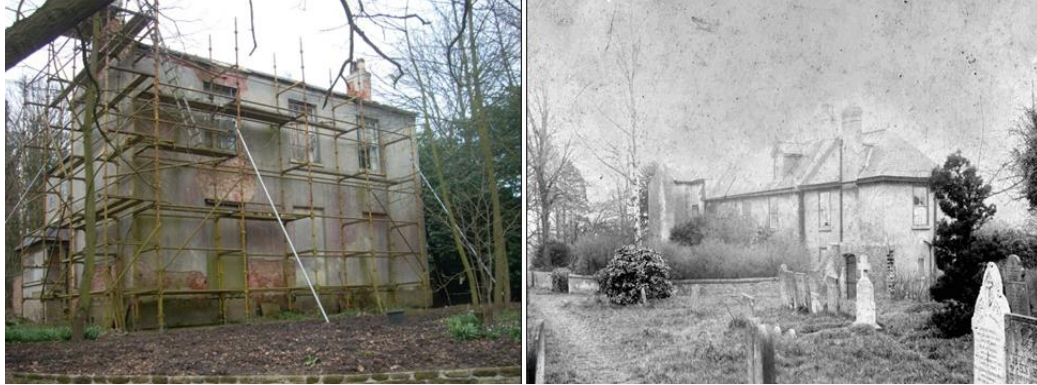
- 3.53 The Old Vicarage (grade II) is primarily 18th century, although is on the site of an earlier (probably 17th century) building and incorporates a small part of that earlier structure. The building was mostly rebuilt around 1760, with the main façade of that phases at the southern end. The façade contains two storeys of three bays with '8 over 8' vertical sashes. This building is currently undergoing extensive repairs.

Figure 3.40: Georgian portion of the former Vicarage, south elevation (left) and view of east elevation of building from c1920 (right). Image source: Bassetlaw Museum, accessed 2013.

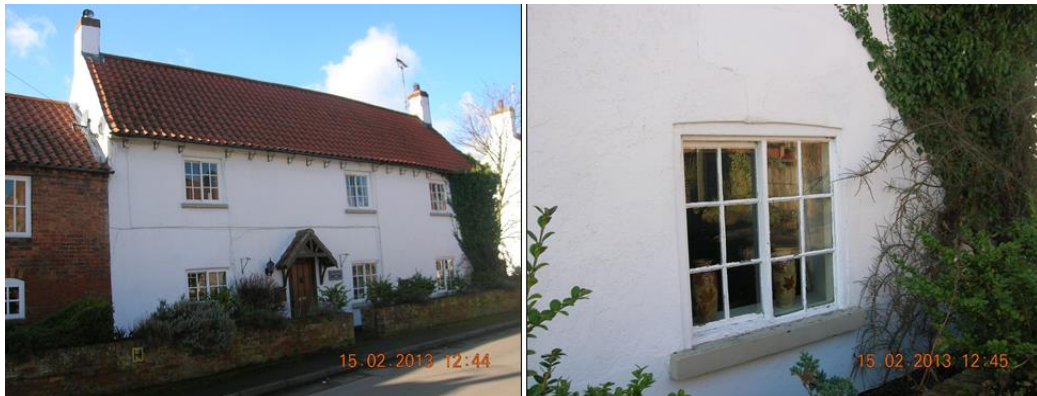
- 3.54 The majority of 18th century houses are of a smaller scale than those discussed previously and can be found throughout the Conservation Area. The wealth brought following the turnpiking of the Great North Road (in 1725) and the Lincoln Road (in 1765) would have influenced the development of farms and cottages during this period. Whitehouse Farm on Church Street is one of the most prominent examples of such a site. The building was once a public house called the Greyhound Inn, although has been a farmhouse for at least a century. Yorkshire (horizontal sliding) sashes feature throughout, together with metal gutters on rise and fall brackets, a clay pantile roof and gable chimney stacks.

Figure 3.41: Views of Whitehouse Farm, Church Street.

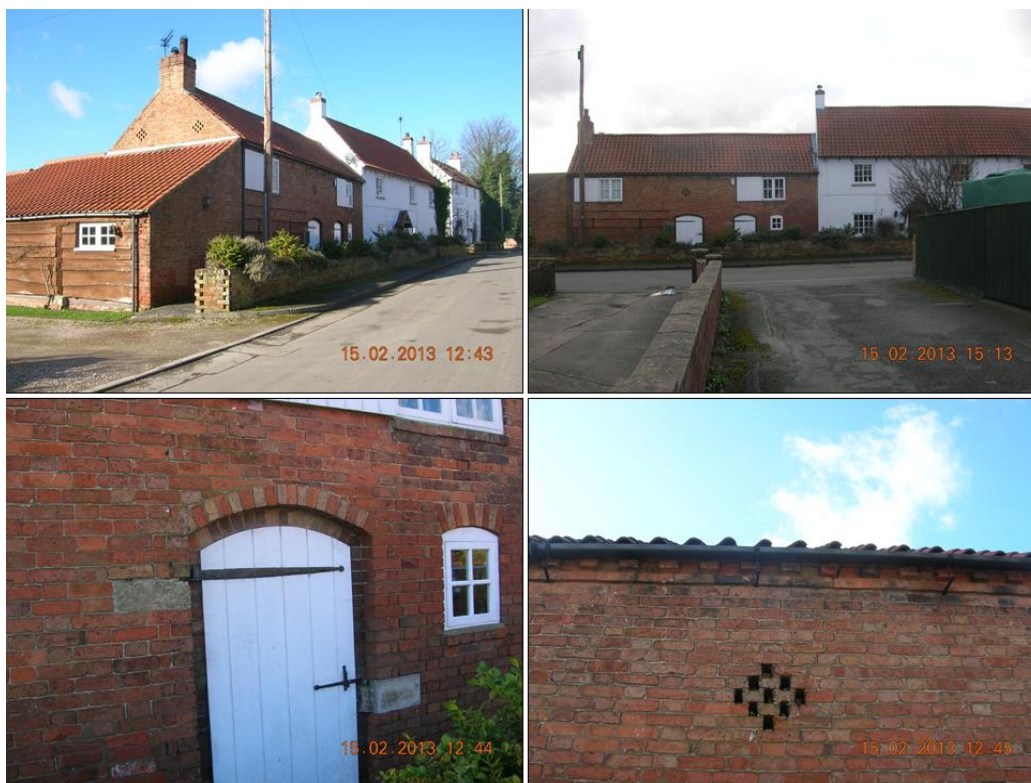
- 3.55 Attached to the south east side of the house is an 1820s/30s former stable building, similar in construction to the coach house structure at East Markham Hall. Distinctive architectural features include the dentilated eaves, timber plank and brace doors with iron brackets set within recessed openings, diamond ventilators and door/window arches with alternating red and yellow bricks. This building was incorporated into the house in the late-20th century. A former open cart shed exists on the south side, although this is also now part of the main house.

Figure 3.42: Views of 19th century stable building at Whitehouse Farm, including alternating brick arch (bottom left) and diamond ventilator (bottom right).

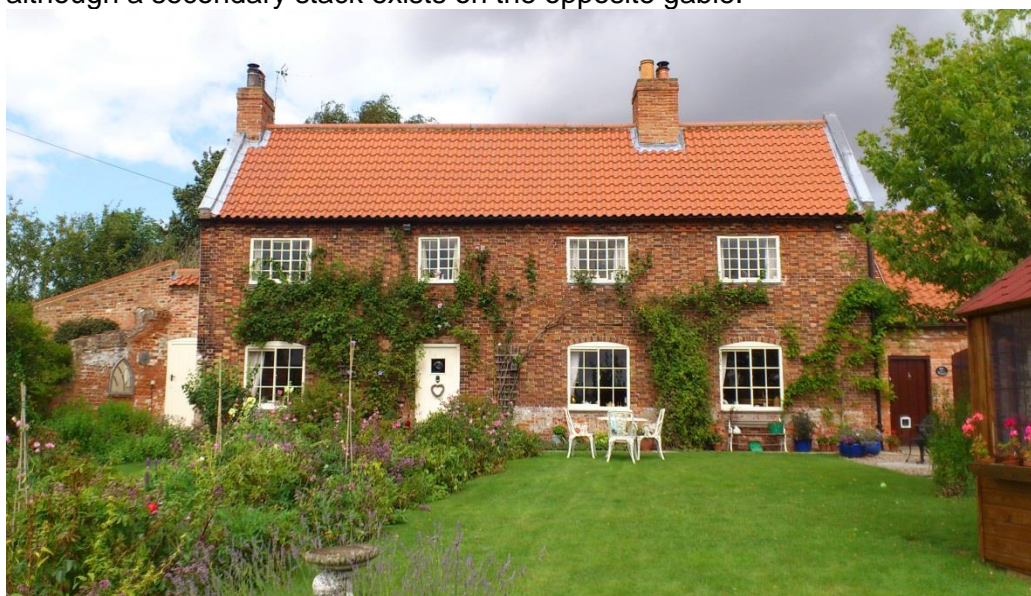
- 3.56 The Rosary (grade II) on Church Street is of a similar scale to Whitehouse Farm. It appears that this building was originally part of a larger L-plan building, the earliest part of which would have sat towards the front of the plot, similar to Flowerdale and Emmadale. The present building would have effectively replaced that earlier house, the remains of which were demolished in the mid-20th century. The frontage is faced in alternating red and pink bricks in Flemish bond, with clay pantiles on the roof. The main chimney stack is off-centre, although a secondary stack exists on the opposite gable.

Figure 3.43: Frontage of The Rosary, Church Street.

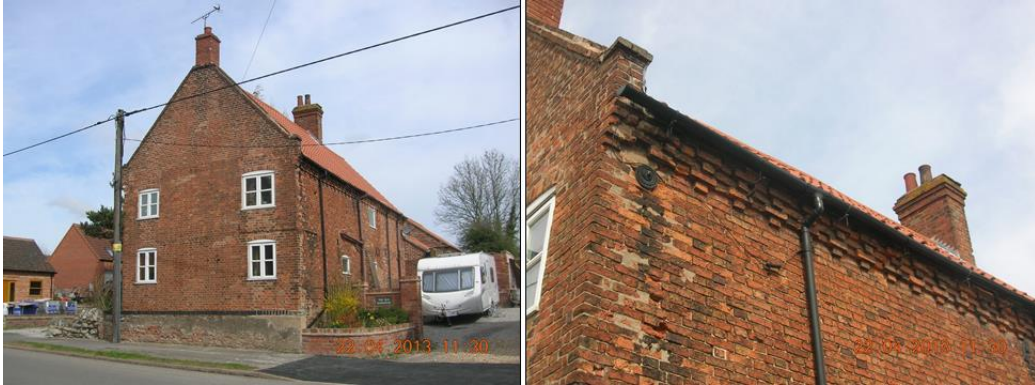
- 3.57 Several of the 18th century houses are orientated perpendicular to the road (also discussed in the 'Layout and Plan Form' section), such as Northview, High

Street. Although much of the fenestration has been altered, this building is one of the most distinctive within the Conservation Area, due to the ornate dentilation at the eaves. Here, the dentilation comprises four projecting rows of bricks, laid in a Flemish pattern.

Figure 3.44: Views of Northview, High Street.

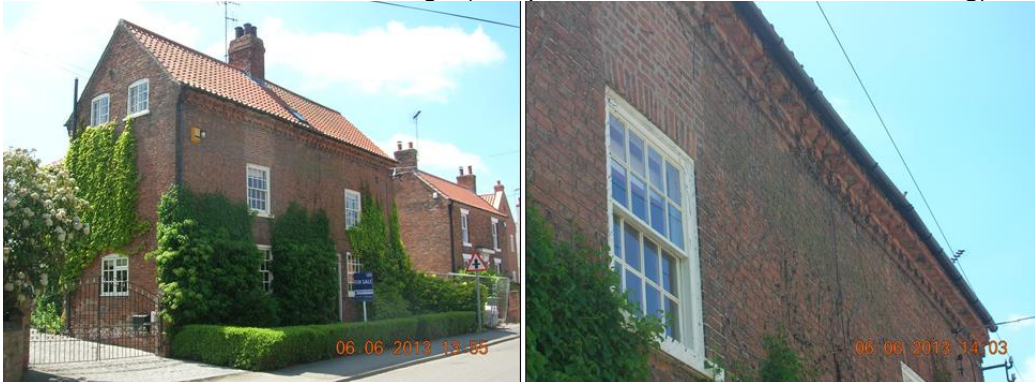
- 3.58 This type of dentilation is also seen on the opposite side of High Street at East Markham House. At that site, however, the dentilation comprises a row of projecting stretchers, above which is a row of headers with alternating projection, then a row of stretchers, then a row of bricks laid in a saw tooth pattern, finished with a layer of stretchers. This building also has an unusual lack of fenestration on the frontage (compared with the scale of the building).

Figure 3.45: Views of East Markham House, High Street.

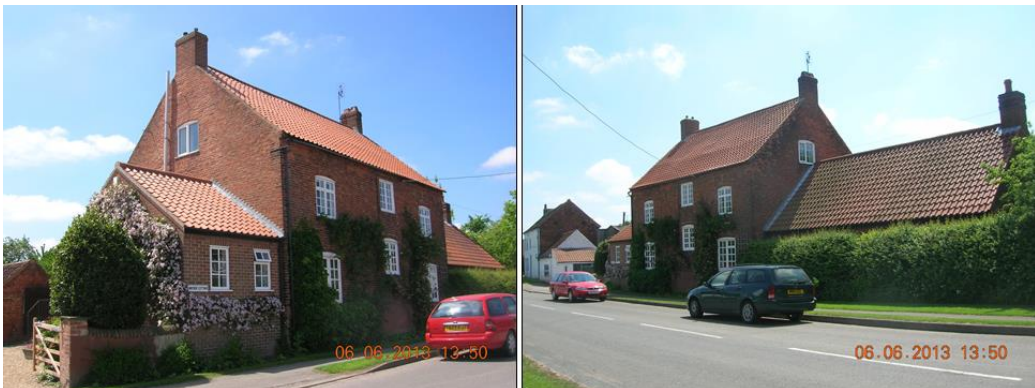
- 3.59 Wayside Cottage (also on High Street) has a similar appearance to East Markham House, although has much simpler dentilation. This building is notable for the position of its central windows, which are higher than those either side.

Figure 3.46: Views of Wayside Cottage, High Street.

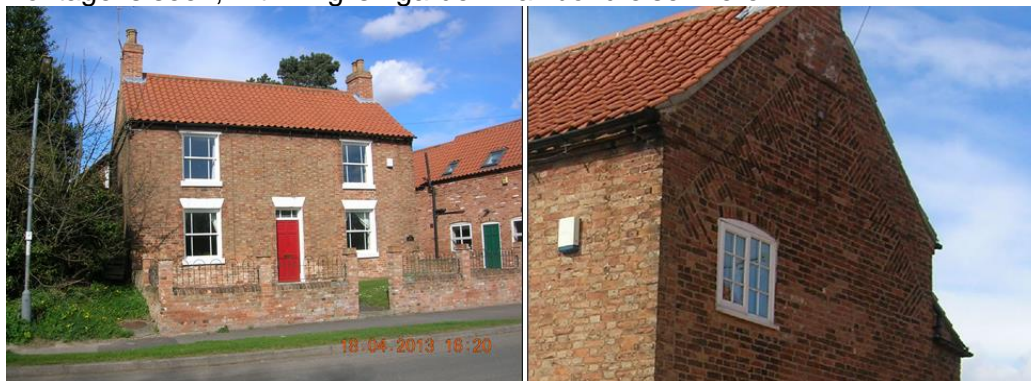
- 3.60 East Markham contains a number of 18th century buildings which have undergone later alterations. Ivy House on High Street is perhaps the clearest example, with the earlier house visible on each gable with tumbling-in detailing (rare in East Markham, only seen here and at Haycorns on Farm Lane), enclosed by the 19th century additions. Again, the use of a Flemish bond for the frontage is seen, with English garden wall bond elsewhere.

Figure 3.47: Ivy House, High Street, with distinctive tumbling-in detail of original 18th century house (right).

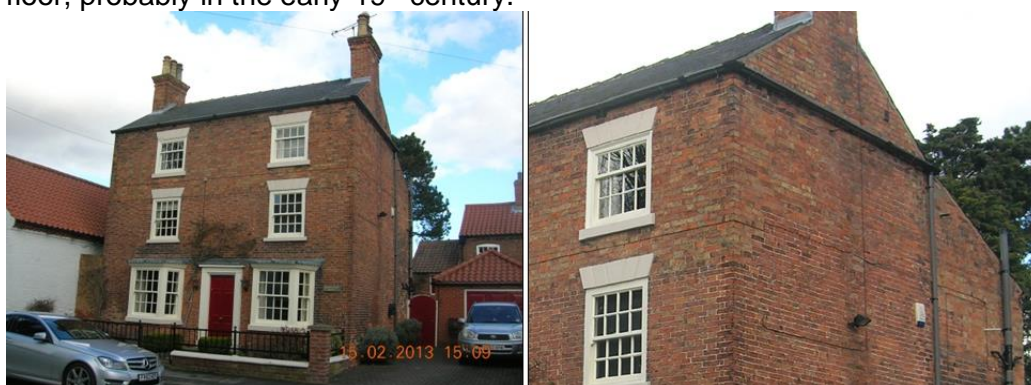
- 3.61 Wood-Dene House on Church Street, originally a two storey house, has a different type of alteration than that seen at Ivy House. Here, a third storey was added to the top of the building and window bays were added on the ground floor, probably in the early-19th century.

Figure 3.48: Views of Wood-Dene House, Church Street, with image on right showing change in brickwork demarking upper storey addition.

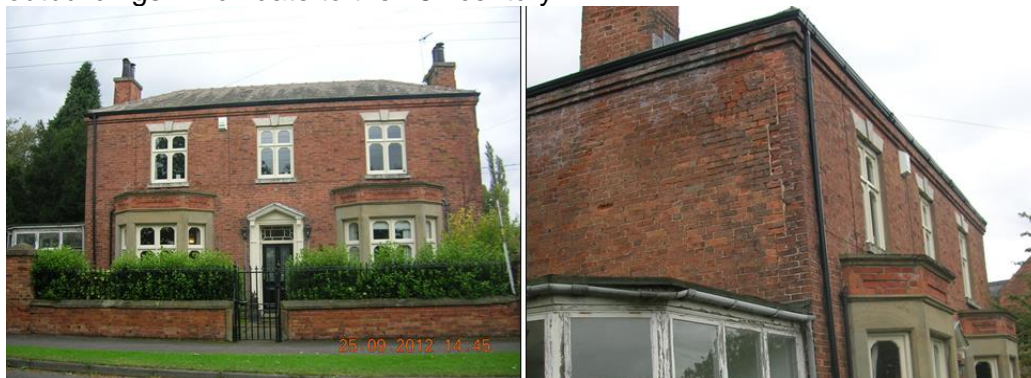
- 3.62 A common 19th century alteration found in the village is the addition of a new façade. Buildings such as Holly House (High Street) and The Old England (Farm Lane) both feature mid-19th century frontages, although the original buildings are clearly 18th century. Holly House also has a number of outbuildings which date to the 18th century.

Figure 3.49: Views of Holly House, with join clearly visible on west elevation (right).

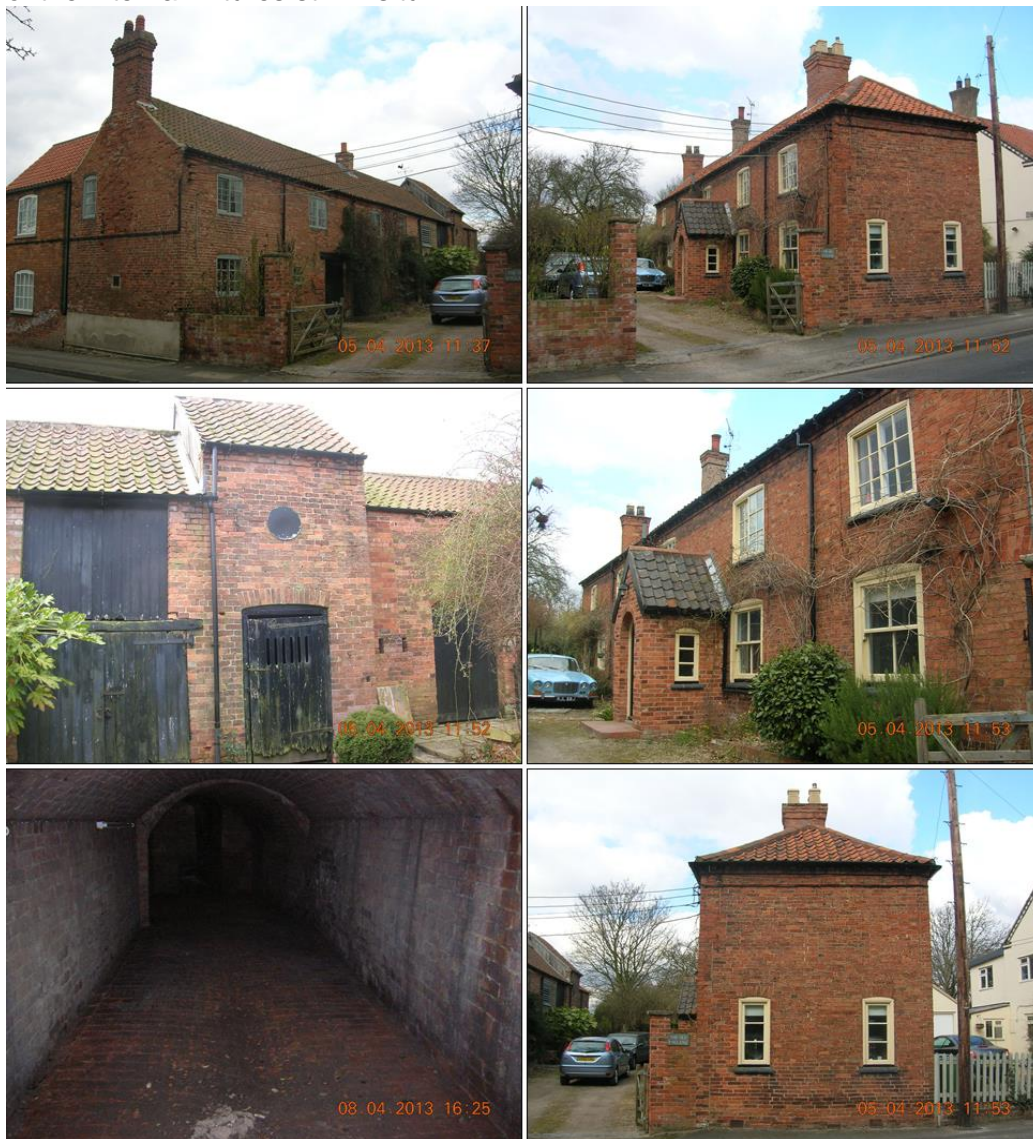
- 3.63 The 19th century alterations to The Old England, which at that time was a public house, included the creation of an underground tunnel linking the building with the brewery building adjacent. The front of the house contains timber '2 over 2' sashes on the ground floor and Yorkshire sliders on the first floor. The adjacent brewery building has several phases, the oldest of which appear to be at the western end. The central portion contains the 19th century brewery, with many of the internal fixtures still in situ.

Figure 3.50: Views of The Old England (right) including the join in the brickwork clearly visible on the east elevation (bottom right); Views of the former brewery building adjacent to the house (left), including connecting tunnel between the two buildings (bottom left).

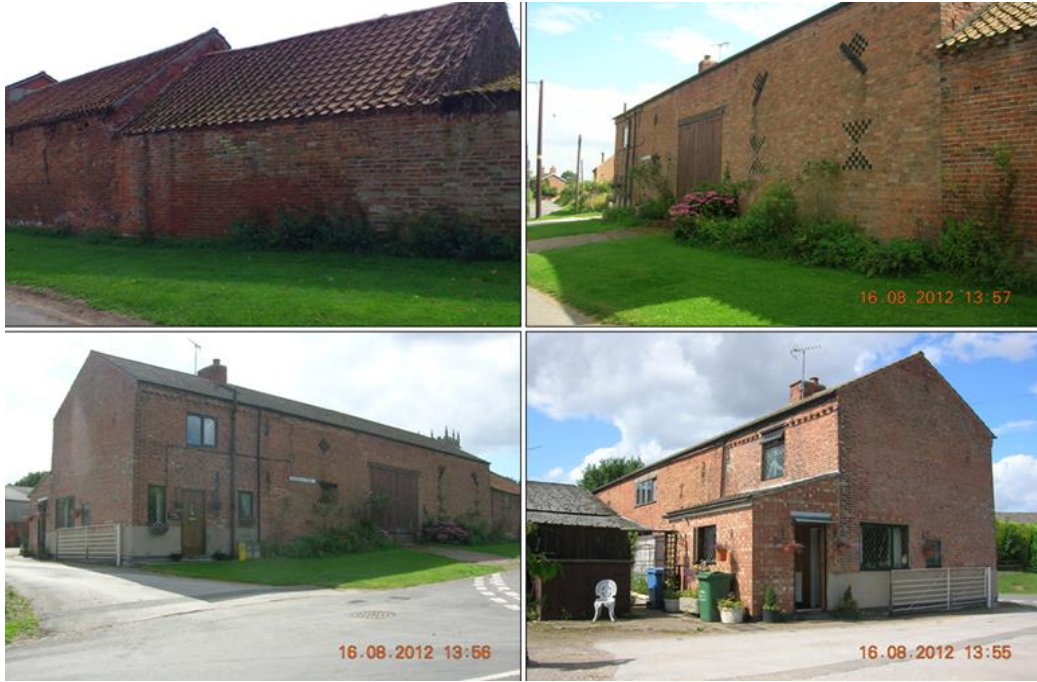
- 3.64 The Conservation Area contains various agricultural buildings dating to the 18th century. Other than those attached to earlier sites (discussed previously), a substantial number can be identified dating to this period. One of the more prominent 18th century agricultural ranges is on Church Street at Manor Farm. The site contains two rows of buildings adjacent the road, both of red brick with pantile roofs. The westernmost building, Manor Farm Barn, comprises part of an 18th century range, although with an early-19th century threshing barn inserted into the centre (replacing part of the earlier structure). The threshing barn features diamond ventilators (seen elsewhere in the village) and the more uncommon wheat sheaf pattern ventilators (two opposing equilateral triangles).

Figure 3.51: Manor Farm Barn, Church Street.

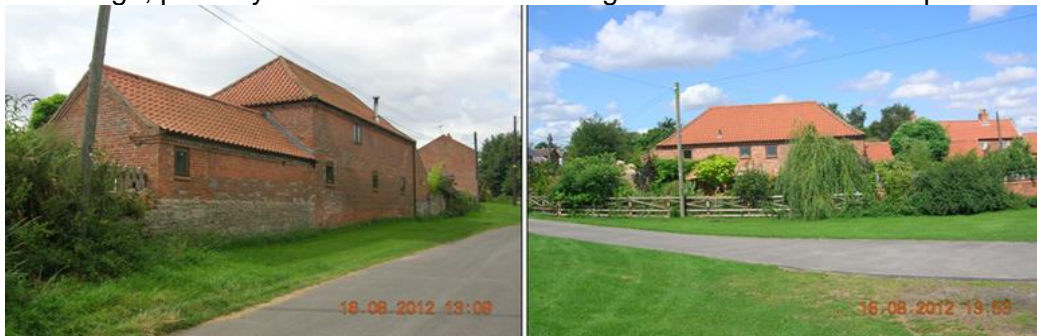
- 3.65 East of Manor Farm Barn is a further 18th century barn, now a dwelling (Oak Barn). The building has a typical rectangular plan form with a two storey hipped roof element, with single storey elements either side. The single storey additions are 19th century and are both set onto Skerry plinths approximately a metre high, possibly the remains of the building shown on the 1712 map.

Figure 3.52: Views of Oak Barn, Church Street.

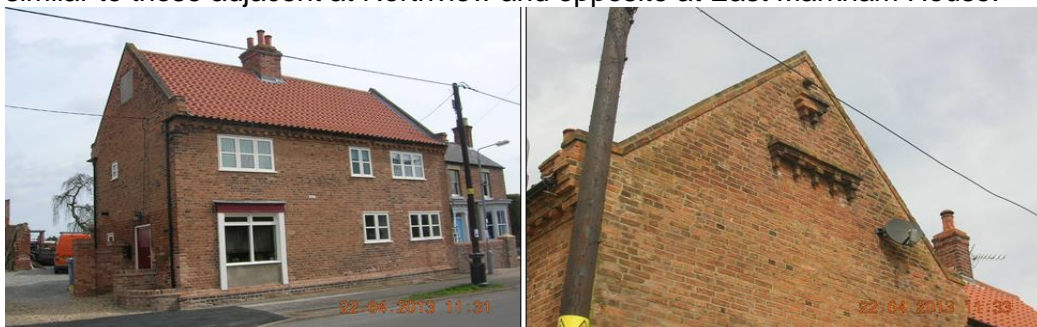
- 3.66 The Old Bakehouse on High Street also dates to the 18th century and appears to have originally been an agricultural building, notably with a dovecote in the upper floor (the brick ledges and flight holes are visible on the east elevation). The building was converted to a commercial unit (bakery) in the mid/late-19th century and the timber shopfront dates to that period. The dentilated eaves are similar to those adjacent at Northview and opposite at East Markham House.

Figure 3.53: The Old Bakehouse, High Street, including the dovecote ledges on the east gable.

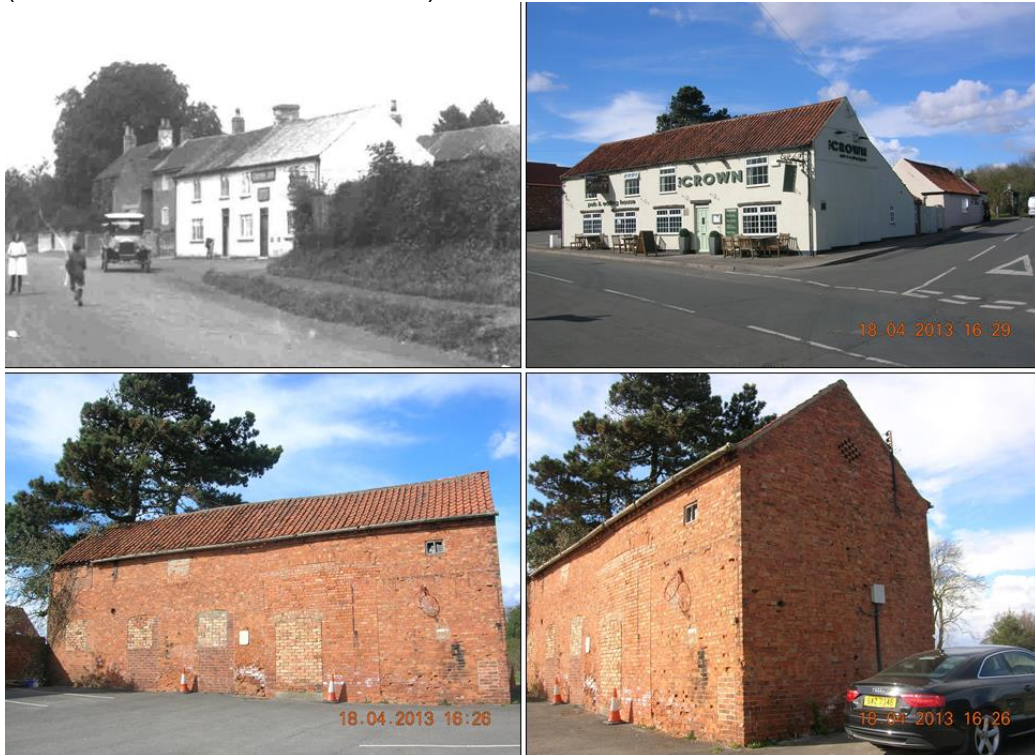
- 3.67 Of the village's commercial and public buildings, the Crown Inn is one of the few to survive in the same use. Originally constructed in the 18th century, this building was extended eastwards in the 19th century (probably around the time Dunham Bridge opened in 1830 and traffic on the route increased) and the ground floor windows were enlarged. Although the windows have been altered, the openings are consistent with the appearance of the building in the early-20th century. Sadly, one of the doors on the frontage and both of the chimney stacks have been lost. To the rear of the adjacent car park is an early-19th century threshing barn. Most of the openings on the frontage have been in-filled, although the brick arches are still visible and features elsewhere on the building (such as the diamond ventilators) and the dentilated eaves have survived.

Figure 3.54: Views of the Crown Inn from c1920 and present day (top) and of the former threshing barn adjacent (bottom). Image source: Bassetlaw Museum, accessed 213.

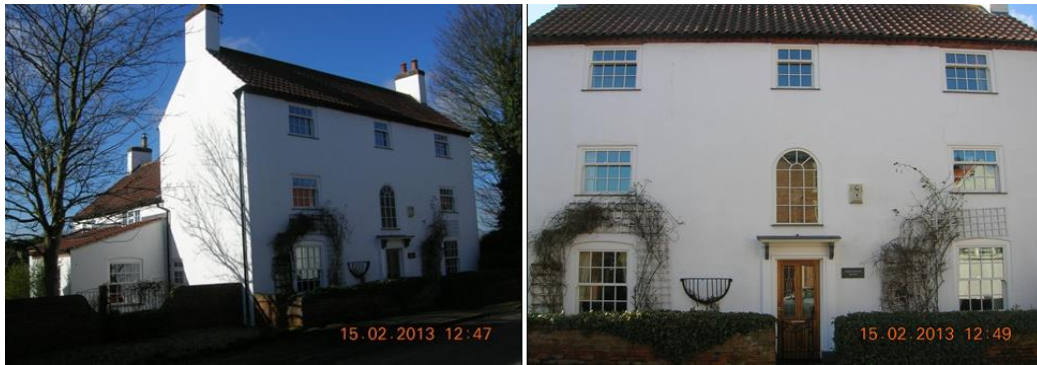
- 3.69 Springfield House is one of the largest houses from the early-19th century, with a similar scale and appearance to those large farmhouses that had been built on the site of existing farms, especially on Plantation Road (discussed earlier). The building is typical of the Regency period, with two and a half storeys, window openings in diminishing scale, gable-end chimney stacks, a pantile roof and a feature half-round first floor window, typical of the later Regency period.

Figure 3.55: The frontage of Springfield House, Church Street.

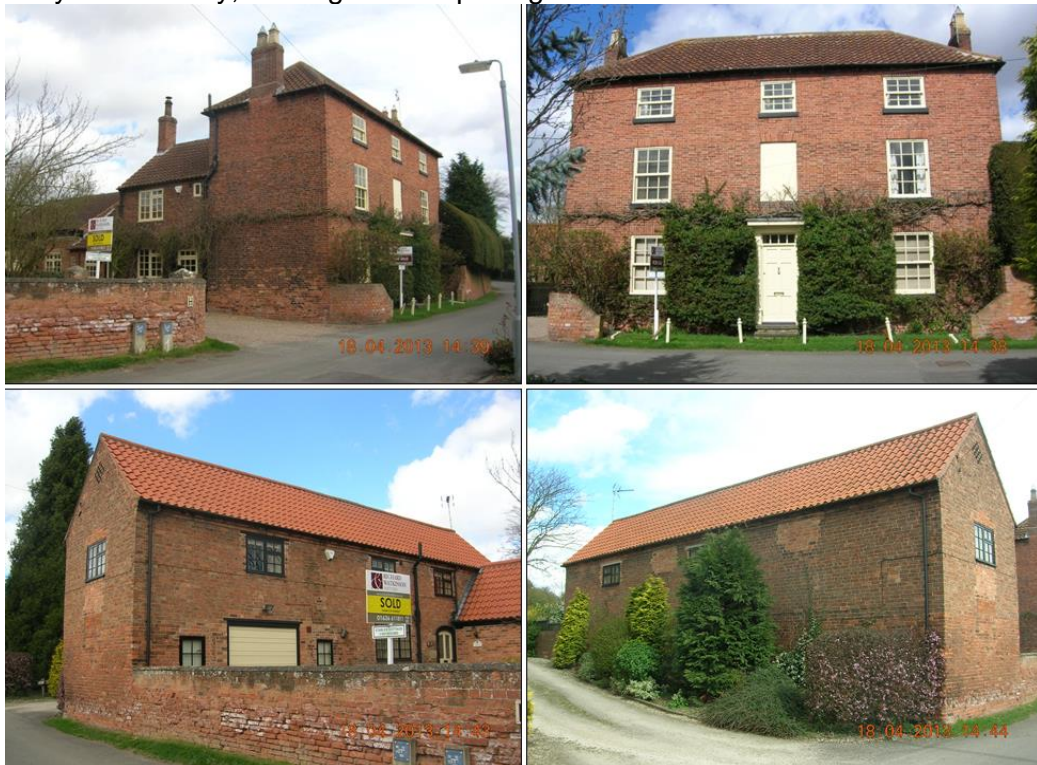
- 3.70 York House (grade II listed) on York Street is on the site of an earlier (17th century) building, although appears to have been largely rebuilt in the early-19th century (elements of the earlier structure survive internally). It has a similar appearance and scale to Springfield House and Cushpool House, with a two and a half-storey façade with timber sashes, although has a false opening at first floor level (similar to Woodward Farmhouse). The rear projection has brick coursing that matches the façade, although contains earlier fabric internally. Flemish bond is used on the frontage with English Garden wall bond used on the sides and rear, this pattern being typical on 18th and 19th century buildings of this type. Next to York House is a large barn (converted) also dating to the early-19th century, although most openings have been altered.

Figure 3.56: Views of York House (top) and Stable Cottage (bottom), York Street.

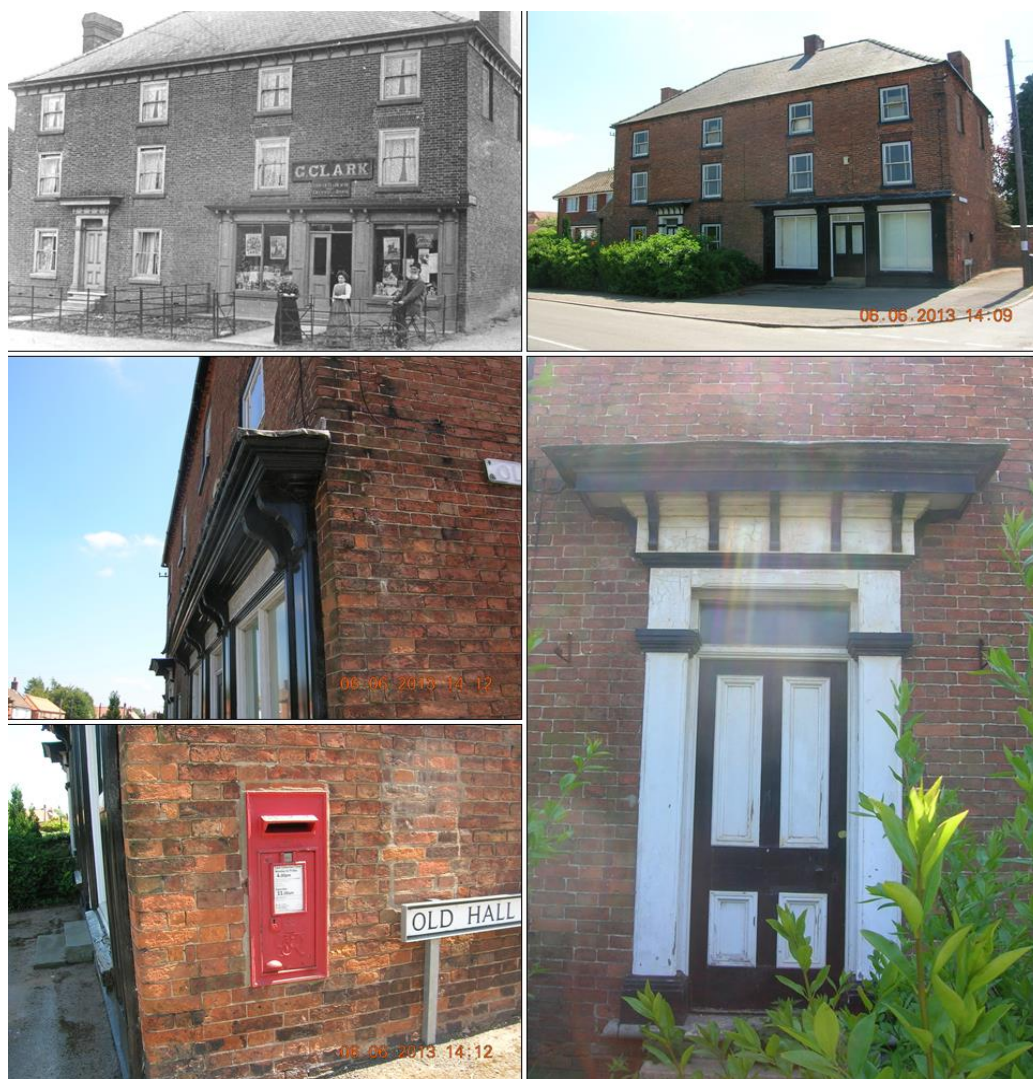
- 3.71 Postleigh is one of the most focal buildings on High Street, with a notable late-19th century shopfront, sash windows with margin lights and impressive door surround. The building was originally a pair of townhouses, although the right-hand unit was converted to a shop and post office in the later part of the 19th century. Indeed, the George VI wall box (by W.T. Allen & Co, London, dating to 1937-1952) is still in situ on the west elevation. Unfortunately the upper portions of the chimney stacks and the eaves brackets were lost in the 20th century.

Figure 3.57: Views of Postleigh, High Street, including from c1910 (top left). Image source: Bassetlaw Museum, accessed 2013.

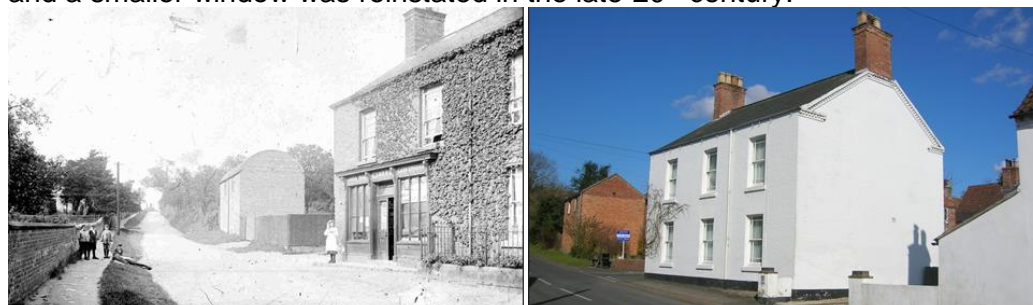
- 3.72 Of those early/mid-19th century buildings of a smaller scale, London House on Beckland Hill is one of the most noticeable. This has the same Regency-style windows to Postleigh (timber sashes with margin lights) although was converted to a shop in the later part of the 19th century. The shopfront was then removed and a smaller window was reinstated in the late-20th century.

Figure 3.58: London House, Beckland Hill, as seen in c1920 (left) and present day (right). Image source: Bassetlaw Museum, accessed 2013.

- 3.73 London House has one of the best examples of the dentilated verge architectural feature which is found on several buildings of this period within the Conservation Area. This feature, of which there are several styles, is found on all types of building including commercial, public, residential and agricultural.

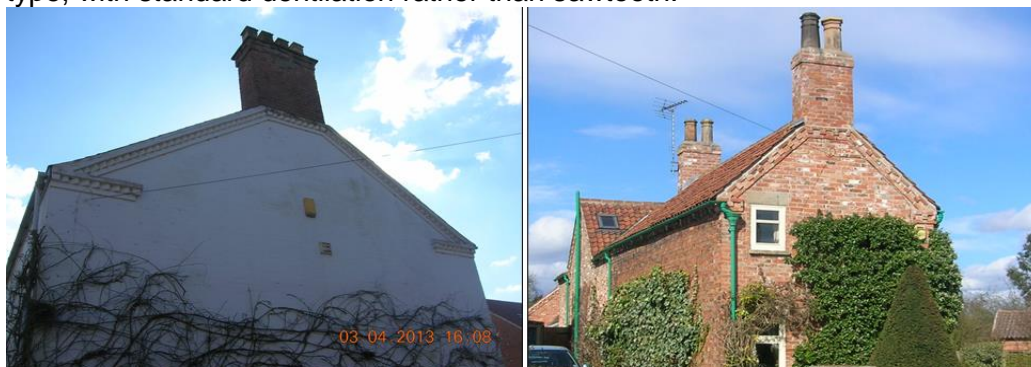
Figure 3.59: Dentilated verges, as seen at London House (left) and Cobweb Cottage (right).

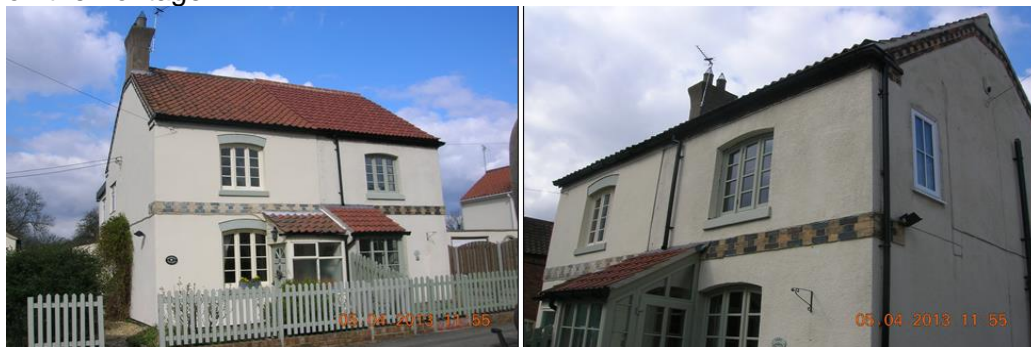
Figure 3.60: Views of 11-12 Farm Lane, with distinctive first floor band.

- 3.74 The dentilated verge feature is also found at 11-12 Farm Lane, again early/mid-19th century, although on this building yellow and blue/engineering bricks are used to highlight the verge further. This palette is also used on the distinctive first floor band. The building is also notable for its tripartite casement windows on the frontage.

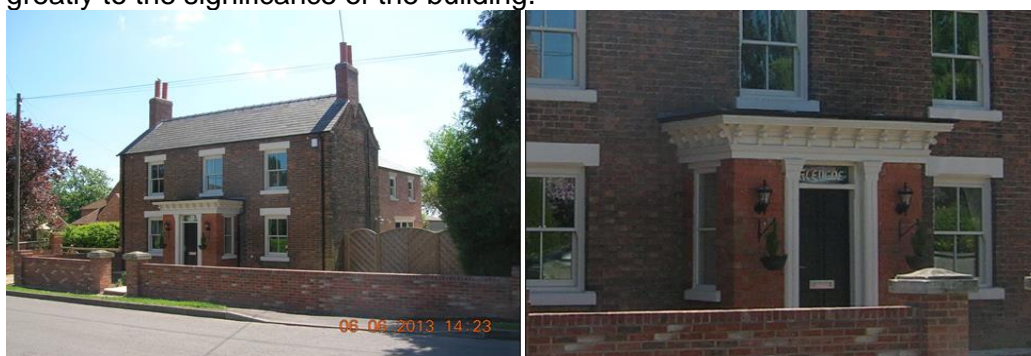
- 3.75 Of the smaller scale houses, Glencoe on High Street is one of the most impressive. The façade is similar to that at High Street Farm (see page 62) although is more decorative, with '2 over 2' sashes and a mid-19th century central porch. The porch contains a decorative cornice with brackets which add greatly to the significance of the building.

Figure 3.61: Views of Glencoe, High Street.

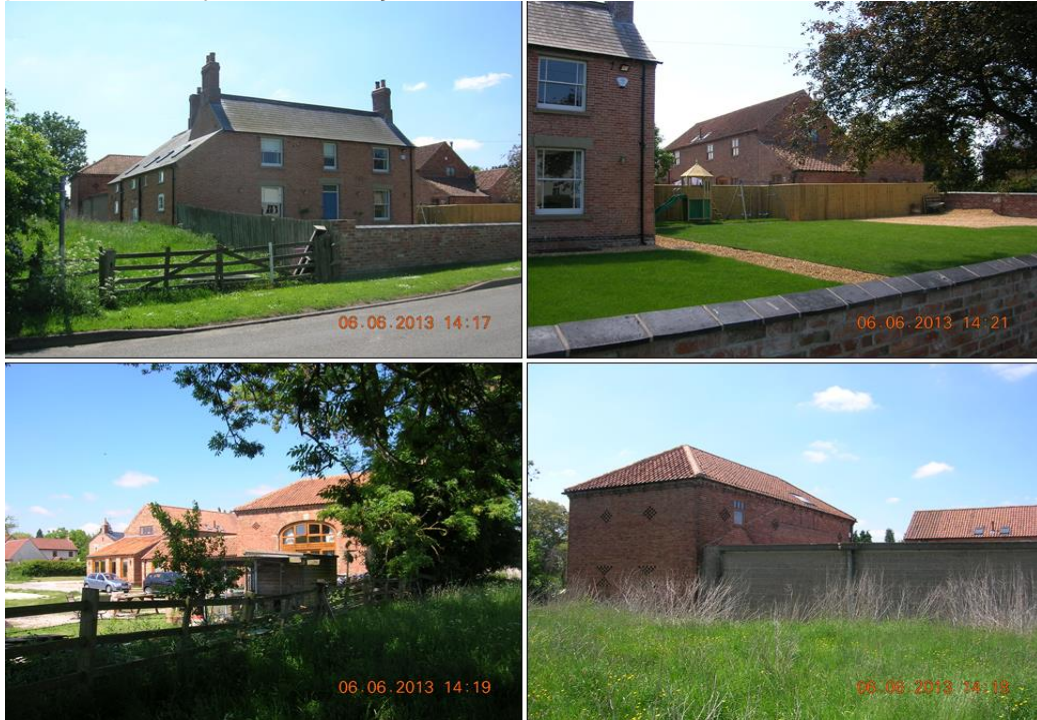
- 3.77 At High Street Farm, a number of buildings are set around a courtyard, including a threshing barn, a granary, a stables/kennels and a farmhouse. All the barns have a similar appearance and construction, with arched openings, pantiled hipped roofs, brick ventilators and dentilated eaves. The ventilators on the threshing barn consist of both diamond and wheat sheaf types. A number of the doorways are also set within recessed brick openings, a common feature on agricultural/equine buildings of this period. The farmhouse is typical of this period, with a symmetrical façade with few embellishments.

Figure 3.62: Views of High Street Farm, including farmhouse (top left), former stables (top right) and former threshing barn (bottom).

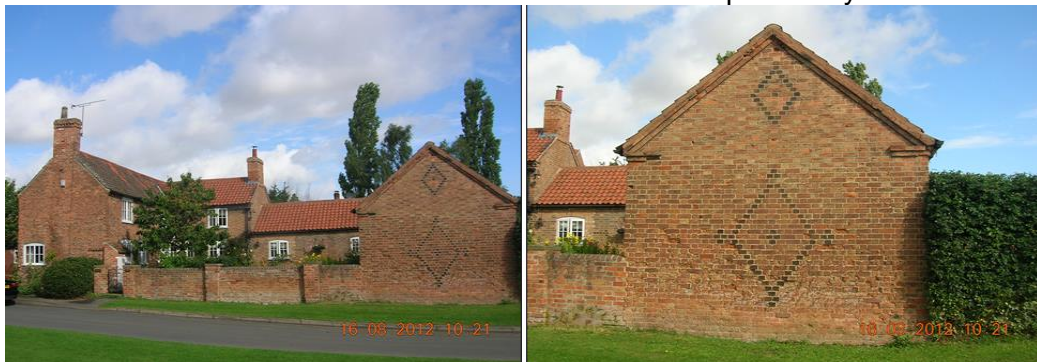
- 3.78 Other notable buildings from the period include Church Farm on Church Street. This group of buildings is prominently sited, being located opposite the church of St John the Baptist. Most notable is the mid-19th century former stables on the east side, with distinctive diapering brickwork on the south elevation, a Victorian style which sought a revival of Tudor diapering brickwork. Also found on this building is a dentilated verge, although being later in date, the dentilation here is much less ornate than on those sites discussed previously.

Figure 3.63: Views of Church Farm, Church Street.

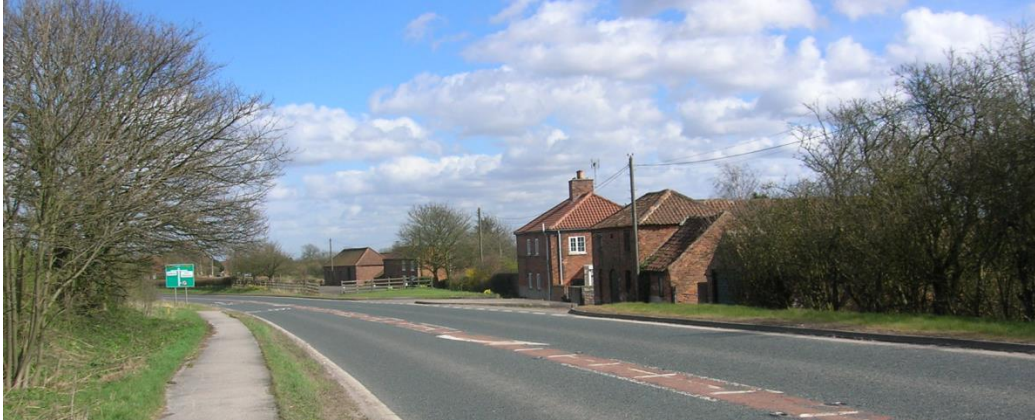
- 3.79 One of the most prominent groups of buildings of this period is Harold House Farm and Hill Top Farm on the south side of High Street (directly off the A57). Both farms are red brick with pantile roofs and have significant outbuildings with a high degree of preservation of historic architectural features.

Figure 3.64: Harold House Farm (left) and Hill Top Farm (right) on High Street (off the A57).

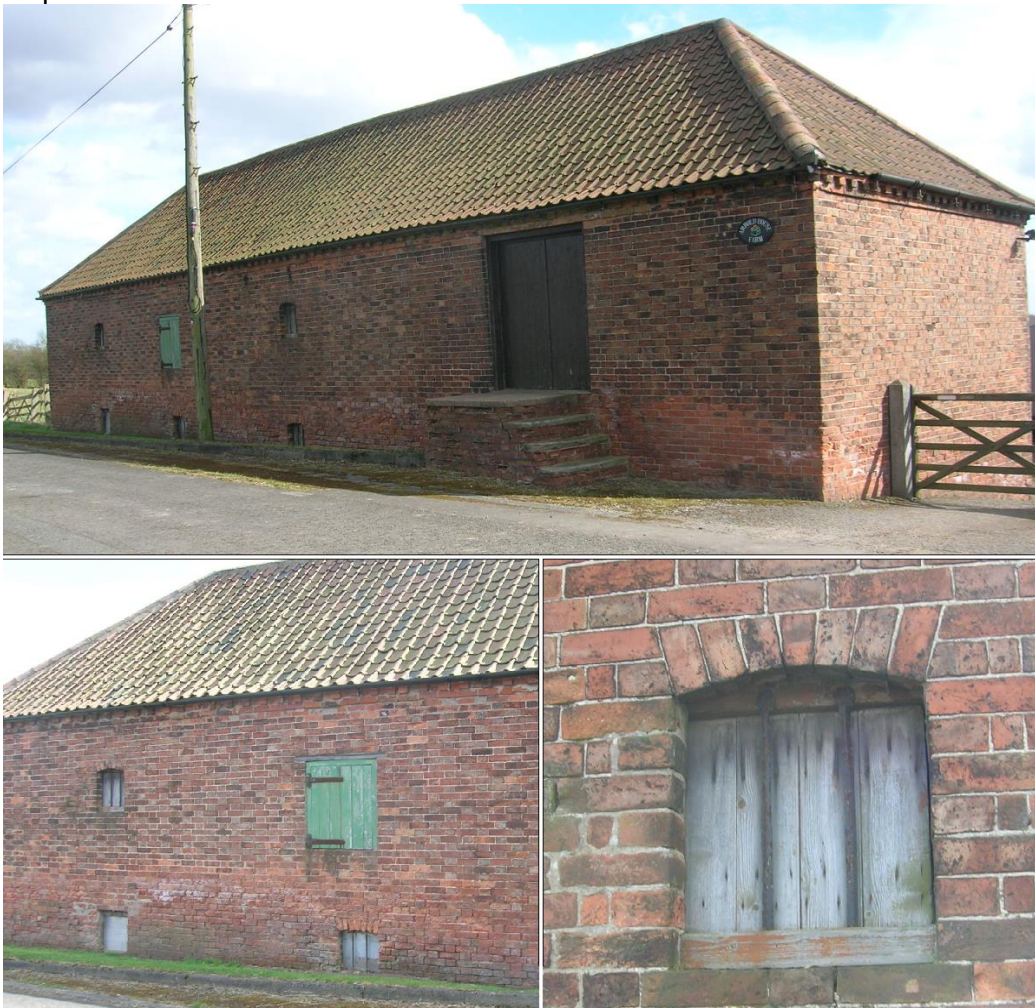
- 3.80 The maltings building at Harold House Farm on High Street is the most significant industrial building within the Conservation Area. Externally, the majority of its original features survive on the front and sides, including the ventilation openings, timber joinery, metalwork and brick detailing. On the rear is a later-19th century extension and on the front is an early-20th century flight of steps.

Figure 3.65: Views of early-19th century maltings building at Harold House Farm, High Street.

- 3.81 The significance of this site to the locality is in part due to the historic importance of the hops and malting industry in the East Markham/Tuxford area during the 17th, 18th and 19th centuries. North Nottinghamshire was, during this period, one of the main hop-producing areas in the country. This is primarily due to the heavy loamy clay soils of the Keuper Marl, which are well suited to the growth of course hops. The local clay is also suited to brick production, with various former brickworks visible on historic maps throughout the East Markham area. One such site was to the south of Hill Top farm (demolished in the mid-20th century).

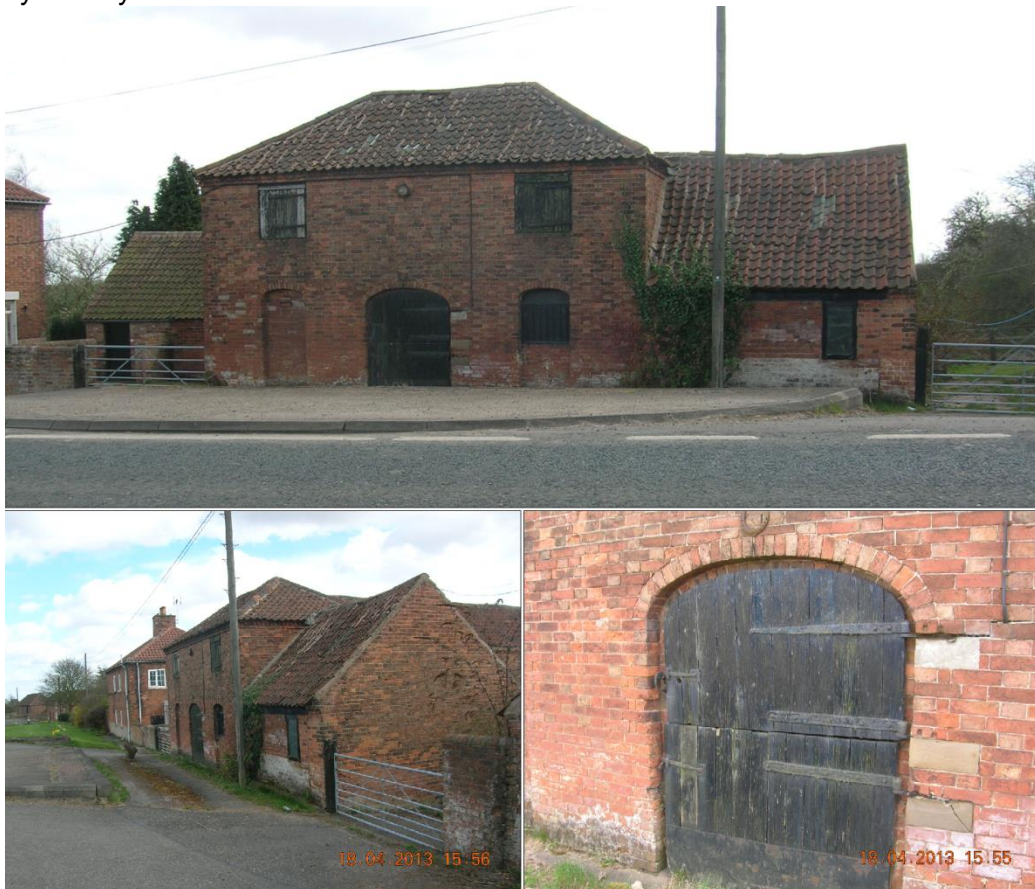
- 3.82 Hill Top Farm, also early-19th century, has a similar construction to Harold House Farm, with red brick with pantile roofs. The farm includes a large 2 storey barn and stables immediately to the west of the farmhouse, which is typical of the period and locality. Key features include the recessed brick arches, timber joinery, hipped pantile roof and use of false openings to achieve symmetry.

Figure 3.66: Views of large barn at Hill Top Farm, High Street.

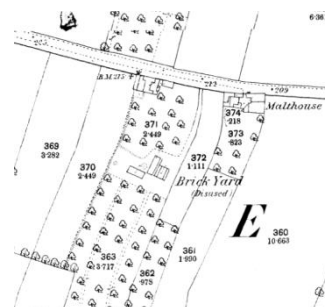
- 3.83 Given the large areas of orchards around this farm (visible on historic maps and some still surviving to the south), fruit growing is likely to have been the focus of much of this farm's efforts during the 19th century. Orchards covered much of the surrounding area until the mid-20th century, again, ideally suited to the loamy clay soils of the Keuper Marl.

Map 42: Extract from 1886 O.S. Map, showing orchards around Hill Top Farm.

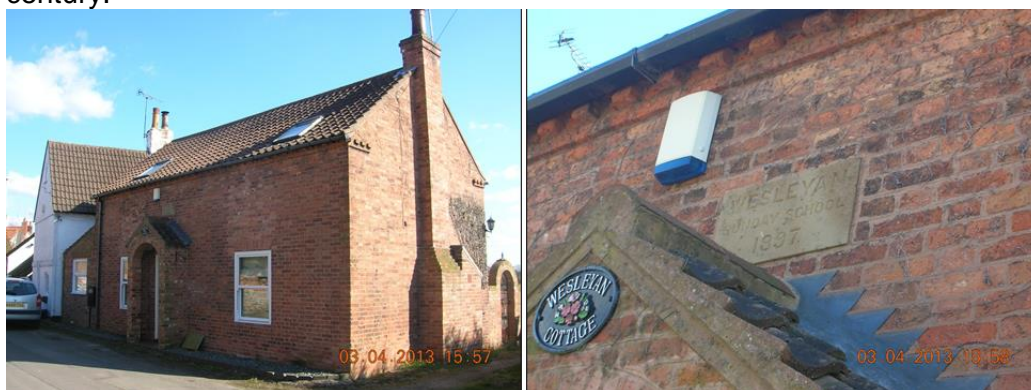
- 3.84 Aside from residential and agricultural buildings, East Markham also contains several early/mid-19th century buildings constructed for public and commercial uses. The first Wesleyan Methodist Chapel to be built in the village is located on Low Street, constructed in 1822. The building has very few decorative elements, this plain appearance being typical of early Methodist village chapels. There are, however, dentilated eaves and verges, in addition to a date stone above the door (which commemorates the conversion of the chapel into a school in 1897). Sadly the original window openings were in-filled and new windows inserted below when the building was converted to a house in the 20th century.

Figure 3.67: Former Wesleyan Methodist Chapel (and later the Methodist School), Low Street.

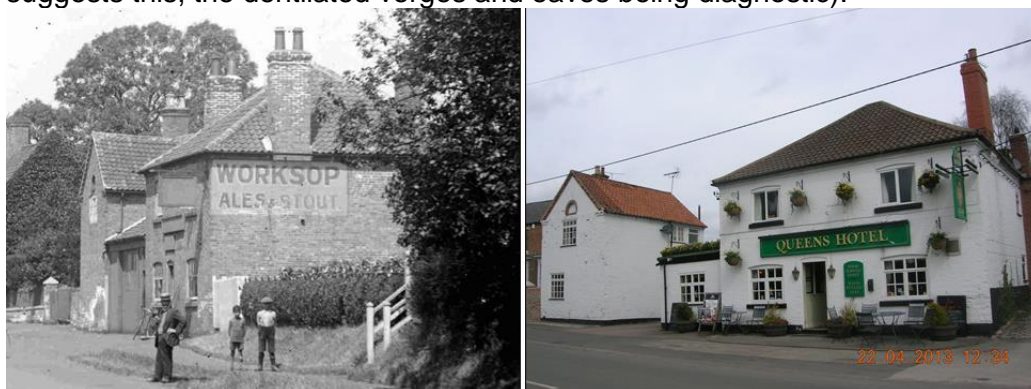
- 3.85 The Queens Hotel on High Street dates to the mid-19th century, the building almost certainly being erected shortly before or after the completion of Dunham Bridge in 1830. The façade still retains its original brick arches, although with later replacement windows. The pyramidal roof and tall eastern chimney stack also survive, although the corresponding chimney has been lost. Adjacent to the main building is a former stable building which appears to be early-19th century and thus predates the public house (the architectural details also suggests this, the dentilated verges and eaves being diagnostic).

Figure 3.68: Views of the Queens Hotel, High Street, from c1920 (left) and present day (right). Image source: Bassetlaw Museum, accessed 2013.
