East Markham Conservation Area Appraisal & Management Plan

December 2014

Title: Bassetlaw District Council: East Markham Conservation Area Appraisal and Management Plan.

Summary: This document is the Council's appraisal of the special architectural and historic interest of East Markham Conservation Area and a management plan with proposals for enhancement and preservation.

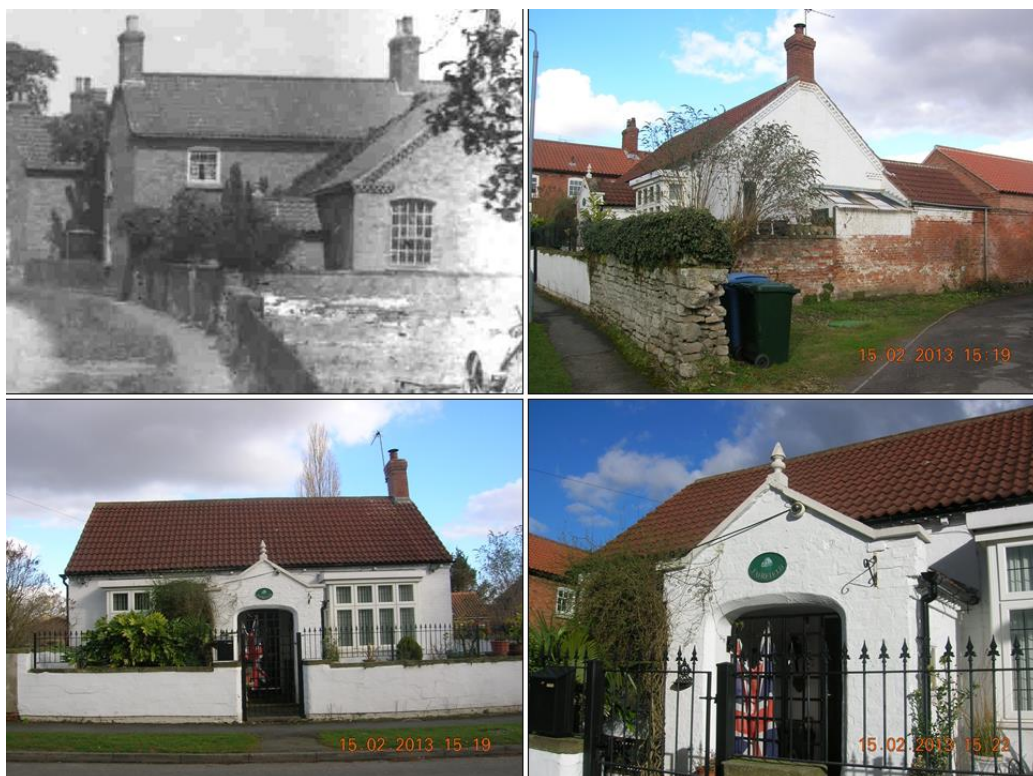
- 3.86 The last of the public buildings from the early-mid-19th century period is the former school on Church Street (now a residence called Fairfield). Built in 1842, the former school has many similarities with buildings discussed previously such as London House (Beckland Hill), the former stable at Church Farm (Church Street) and the former Wesleyan Chapel (Low Street). Like the former chapel, the former school is only single storey and contains dentilated eaves and verges (sawtooth type). The front porch also appears to be original and has a stone-coped parapet on the front with decorative finial above.

Figure 3.69: Views of former village school (now Fairfield) on Church Street, including from 1914 (top left) and present day. Image source: Bassetlaw Museum, accessed 2013.

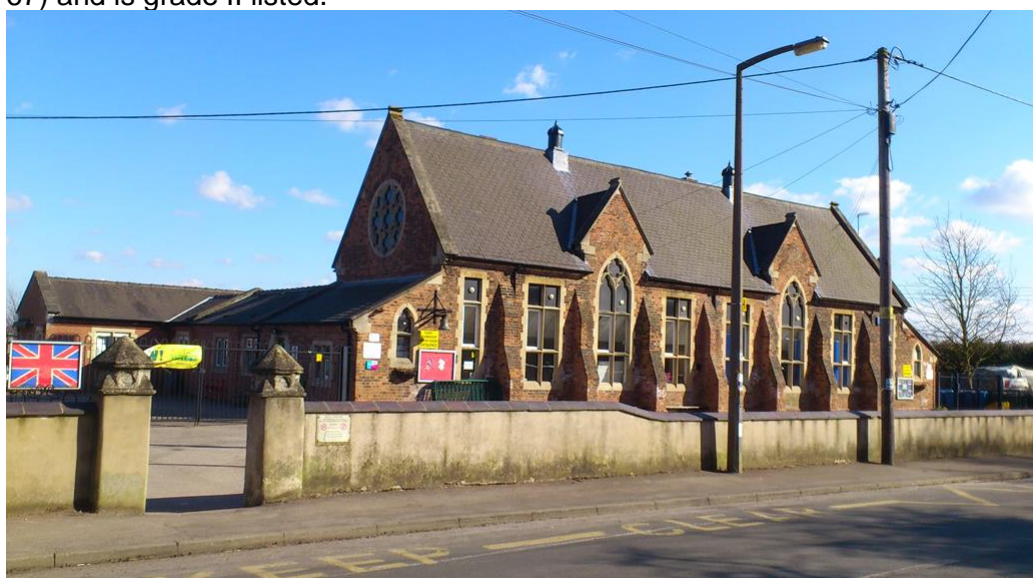
- 3.87 The above school was replaced in 1878 by a building on Askham Road, in a style of architecture not previously seen in East Markham, that of Gothic Revival. This architectural style became popular during the Victorian period, particularly for public buildings such as schools and churches. The replacement school, begun in February 1877 and opened in January 1878, was designed by the noted Nottingham architect Robert Clarke & Son (see date stone on page 67) and is grade II listed.

Figure 3.70: View of East Markham Primary School, Askham Road.

- 3.88 The school has a number of embellishments characteristic of the Gothic Revival architectural style. Significant features include the elaborate window tracery (including the circular openings on the side gables), the steeply-pitched roof

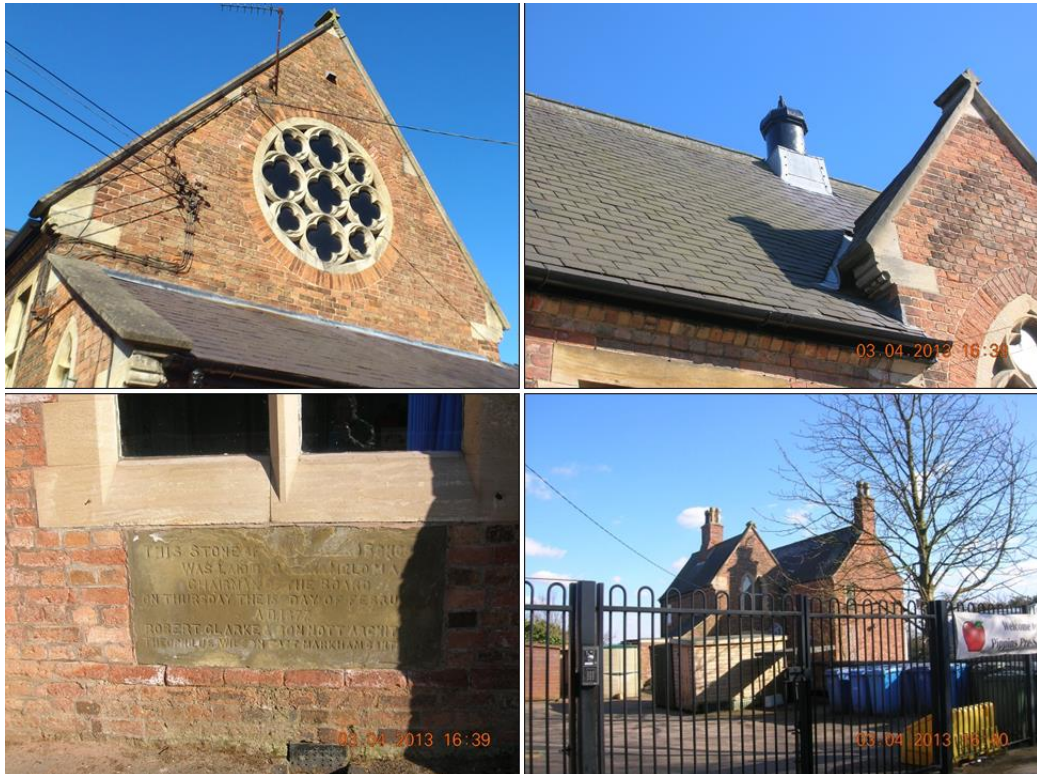
Figure 3.71: Views of East Markham Primary School including circular gable window with elaborate tracery (top left), ventilator cowl (top right), date stone (bottom left) and adjacent school house (bottom right).

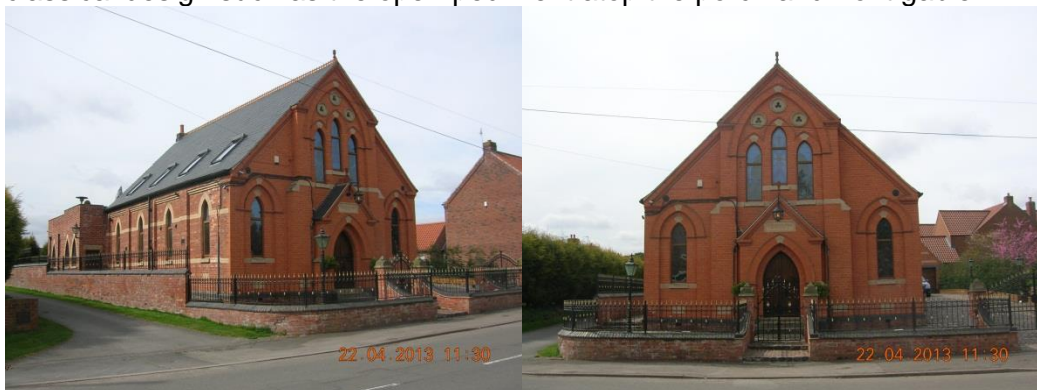
- 3.89 The replacement Wesleyan Methodist Chapel on High Street (now in use by a spa business) was completed in 1893 and also has a number of Gothic Revival features. The pointed arches and deeply-recessed windows and doors are characteristic of this style. This, however, contrasts with the elements of neo-classical design such as the open-pediment atop the porch and front gable.

Figure 3.72: Former Wesleyan Methodist Chapel, High Street.

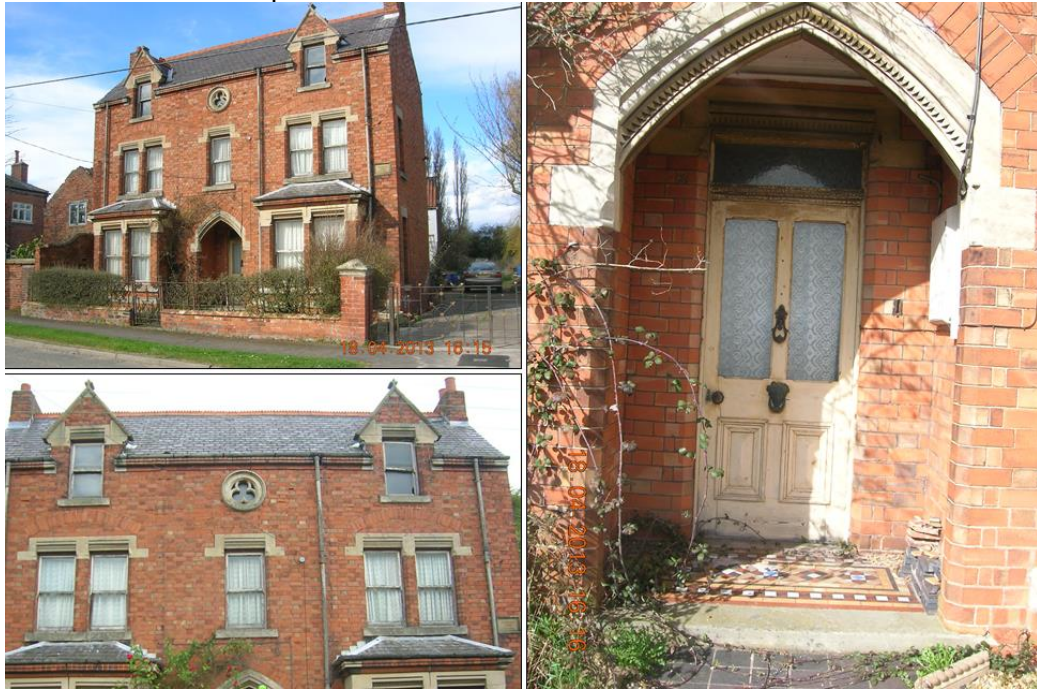
- 3.90 Domestic architecture of this period is less ornate and Gothic Revival is not common. One outstanding example is Cleveland View on High Street (built in 1878), which has a similar appearance to manses (the Methodist version of a vicarage or rectory) found elsewhere in the district. The Gothic features include a pointed arch above the doorway, a trefoil (circular opening with 3-pointed tracery) and cross-finials on both dormer windows. Other decorative elements

include the sawtooth-moulded window lintels, the ground floor windows bays and the Minton-tiled porch floor.

Figure 3.73: *Cleveland View, High Street.*

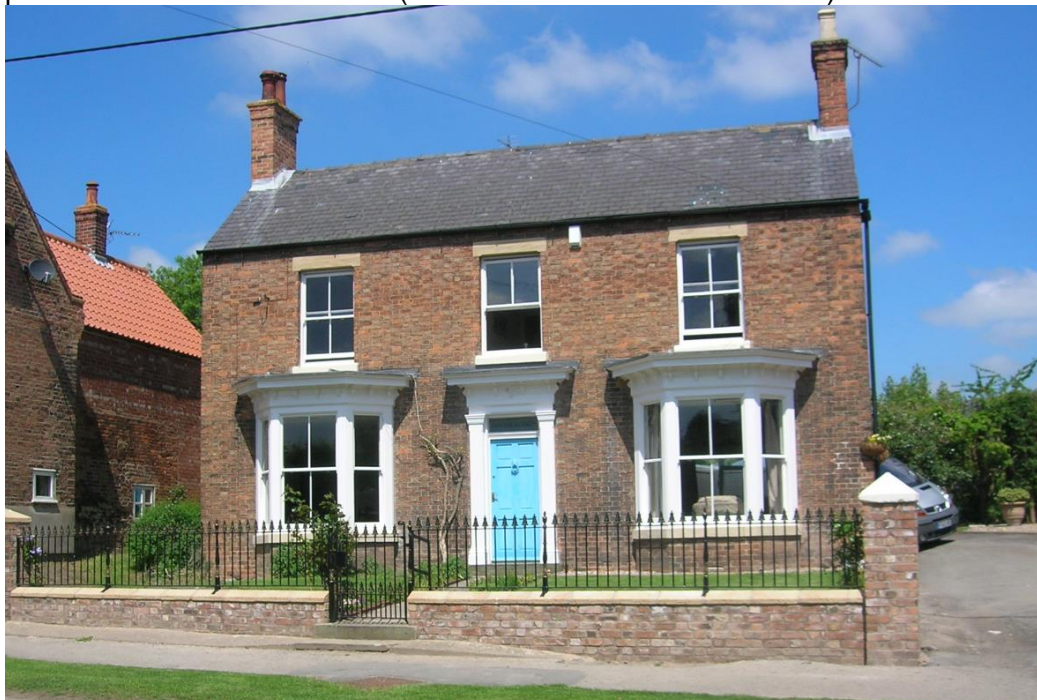
- 3.91 The majority of residences constructed in the mid/late-19th century period were much less ornate than Cleveland View. Houses such as Southwinds (on High Street) illustrate the more common style in the village at the time, with a more-Neo-Classical influence over its design although using some of the mass-produced materials of the time (such as the stone window lintels).

Figure 3.74: *View of Southwinds, High Street.*

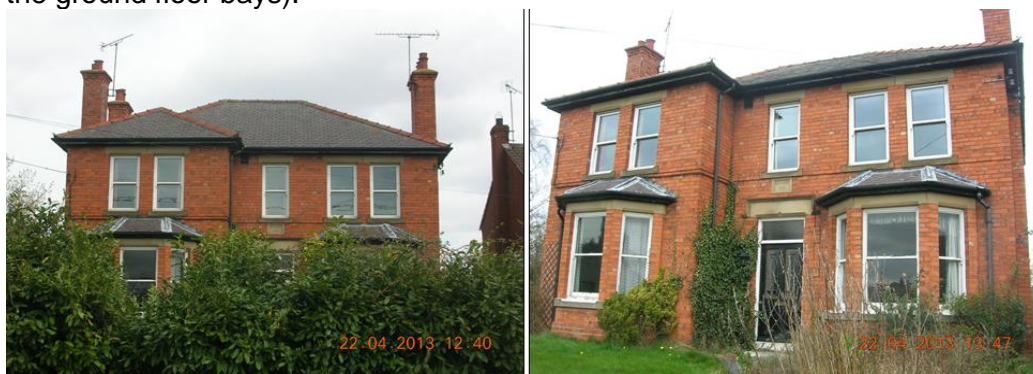
- 3.93 Highcroft (on High Street, adjacent to the Queens Hotel) was built in 1915 and is a typical early-20th century villa, built of red brick with stone detailing. The building has timber sash windows throughout (including the original sashes in the ground floor bays).

Figure 3.75: Views of Highcroft, High Street.

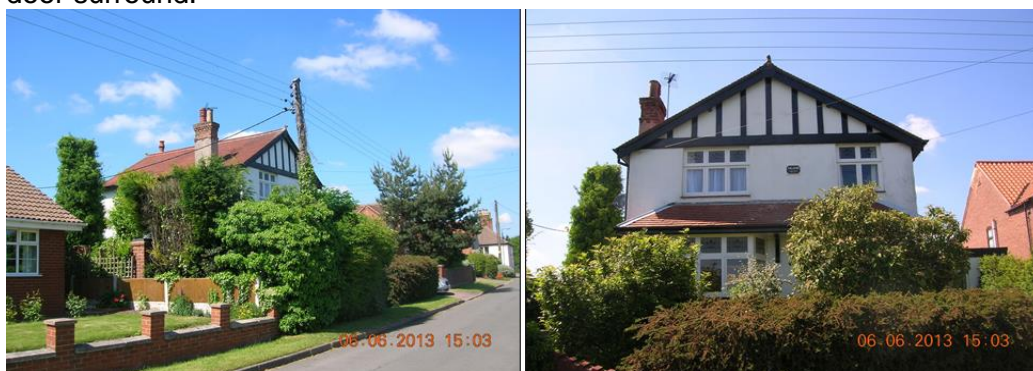
- 3.94 Of the 1920s buildings, Melrose (built 1925) on Old Hall Lane is arguably the most characterful, featuring mock-Tudor timber work on the front gable, timber bargeboards, a tall brick chimney stack with sawtooth dentilation and roof finials. The façade also retains its original part-leded casement windows and door surround.

Figure 3.76: Views of Melrose, Old Hall Lane.

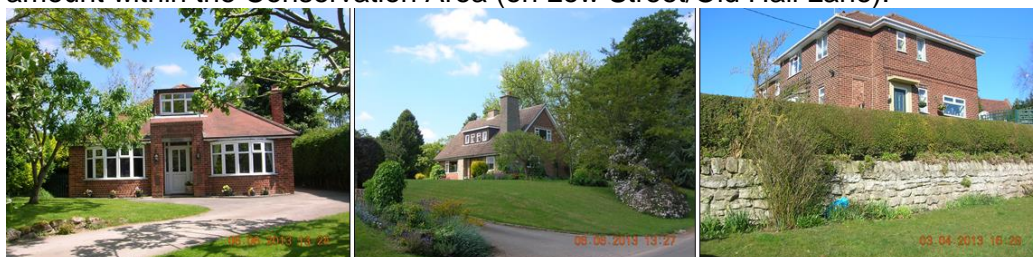
- 3.95 From the 1920s onwards, developments within the Conservation Area mostly comprised speculative infilling of open spaces (particularly bungalows) and local authority social housing schemes. Large bungalows were concentrated on the main thoroughfares of High Street and Plantation Road, whilst the majority of local authority housing was built on a new estate to the east of Plantation Road (outside of the present Conservation Area boundary) with only a small amount within the Conservation Area (on Low Street/Old Hall Lane).

Figure 3.77: 1950s housing in East Markham Conservation Area, including bungalows on Plantation Road (left and centre) and local authority housing on Low Street (right).

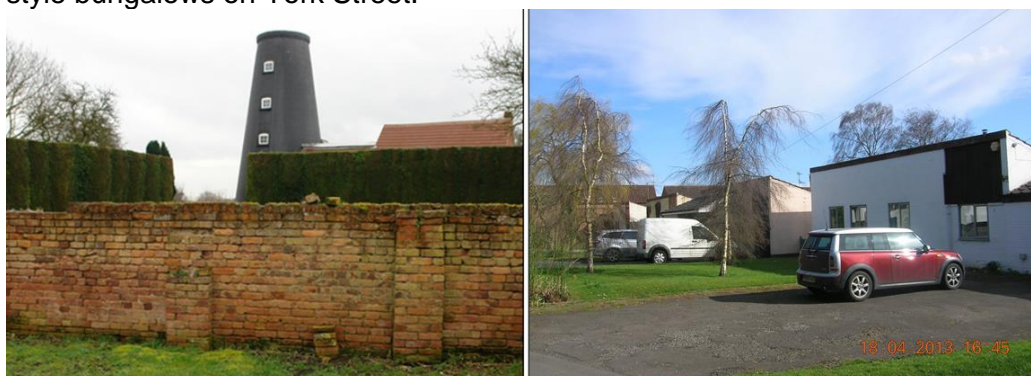
- 3.96 Outside of the Conservation Area boundary, a number of buildings contribute to the setting of East Markham Conservation Area. This setting includes several buildings on Priestgate including the grade II listed Windmill, 19th century buildings around the western end of Mark Lane and the 1960s Scandinavian-style bungalows on York Street.

Figure 3.78: Views of buildings within the setting of East Markham Conservation Area, showing the Windmill on Priestgate (left) and 1960s dwellings on York Street (right).

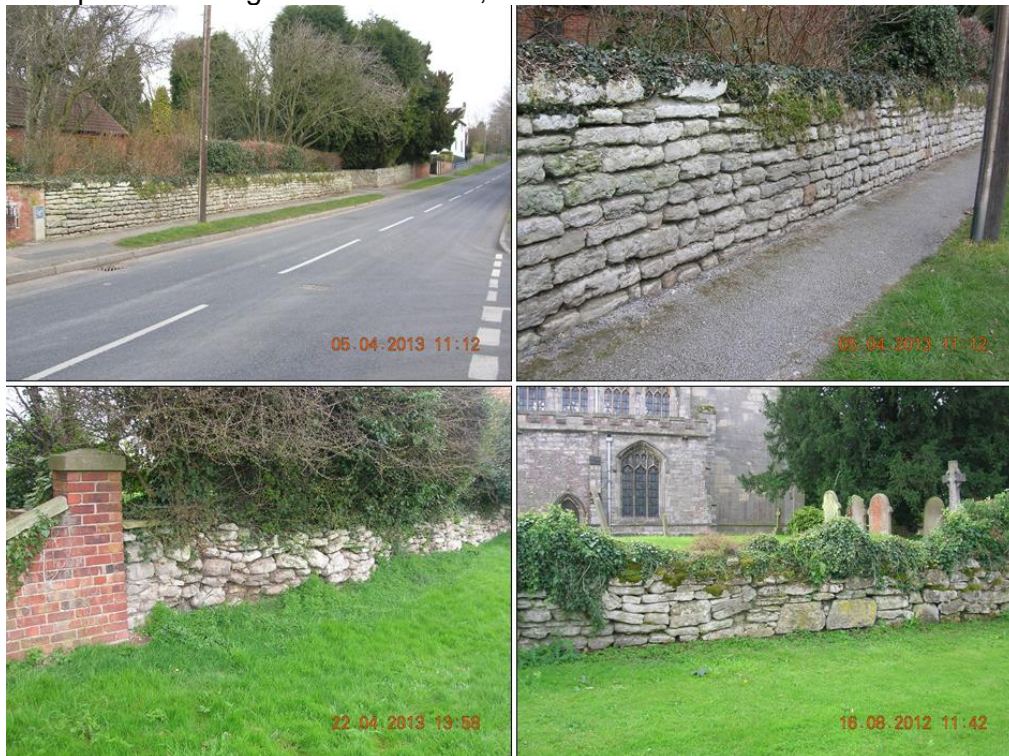
Figure 3.79: Skerry Sandstone walls at Farm Lane (top), Plantation Road (bottom left) and Church Street (bottom right).

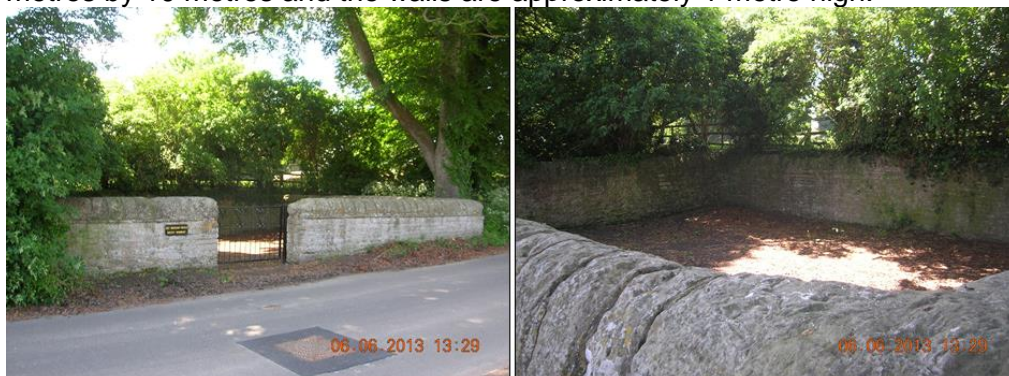
- 3.99 The village Pinfold (grade II listed) on Plantation Road, erected in the late-18th century, is also built of the local Skerry. The Pinfold measures around 12 metres by 10 metres and the walls are approximately 1 metre high.

Figure 3.80: Views of the village Pinfold, Plantation Road.

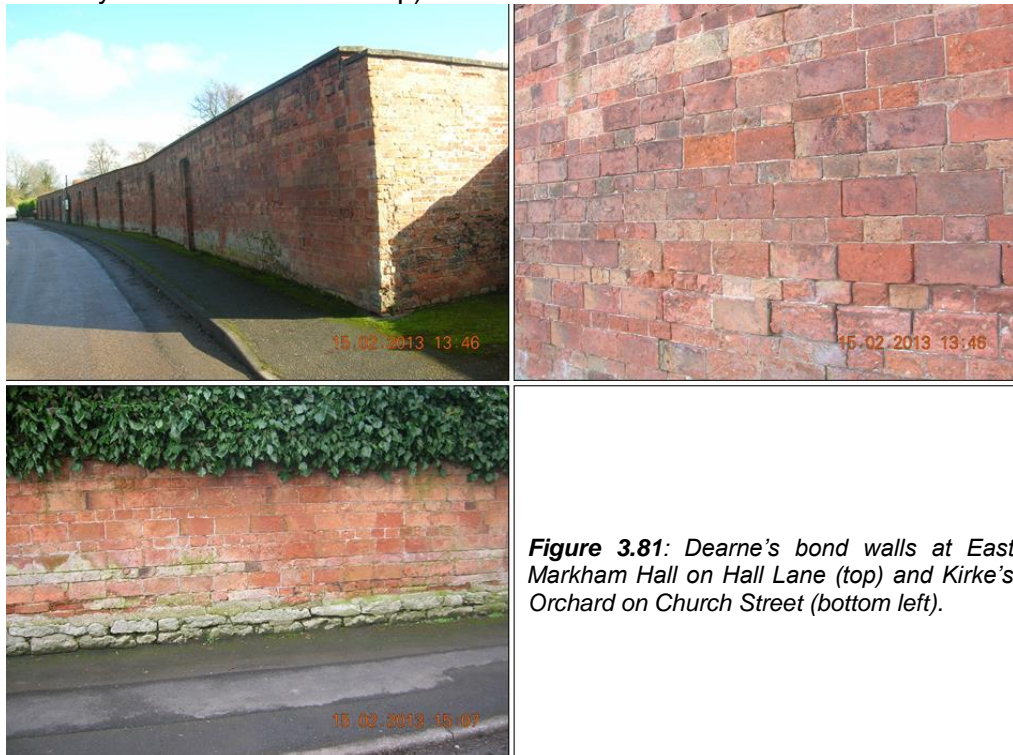
Figure 3.81: Dearne's bond walls at East Markham Hall on Hall Lane (top) and Kirke's Orchard on Church Street (bottom left).

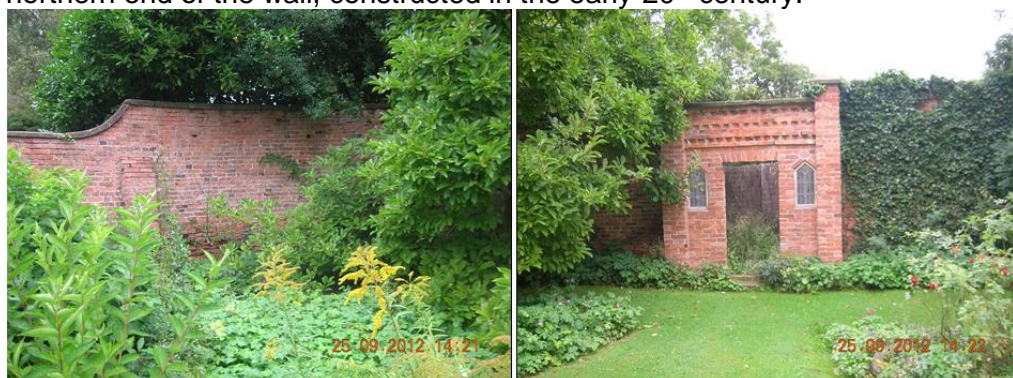
- 3.101 Holly House on High Street also has a kitchen garden wall, although is of a more common style. The wall is U-shaped, with the curve at the northern end. Much of the wall would have been used for the growing of fruit trees, with several of the iron pegs still in situ on the wall. A small folly exists at the northern end of the wall, constructed in the early-20th century.

Figure 3.82: Early-19th century kitchen garden wall at Holly House, High Street.

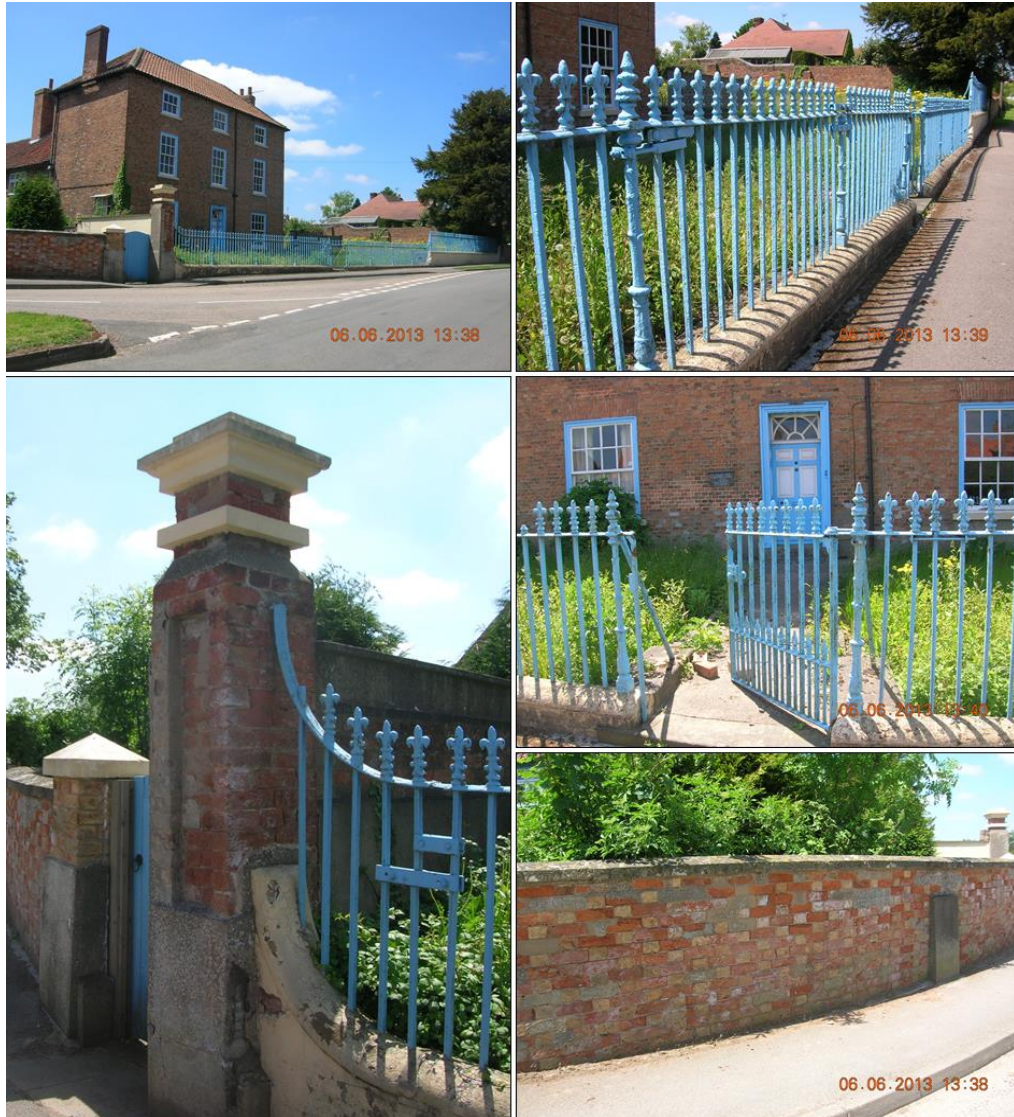
- 3.102 Brick boundary walls from the 18th, 19th and early-20th century can be found throughout the Conservation Area. Of these, the wall around Cushpool House is one of the most significant, dating to the 19th century and being grade II

listed. The wall is primarily rendered and painted and has decorative iron railings on top (with fleur-de-lis finials) with a similarly-decorated iron gate affording access to the house. The wall terminates in brick piers with ashlar mouldings. Attached to the southern end of the wall is further walling faced in Flemish bond.

Figure 3.83: Brick walls with iron railings/gate at Cushpool House, Plantation Road.

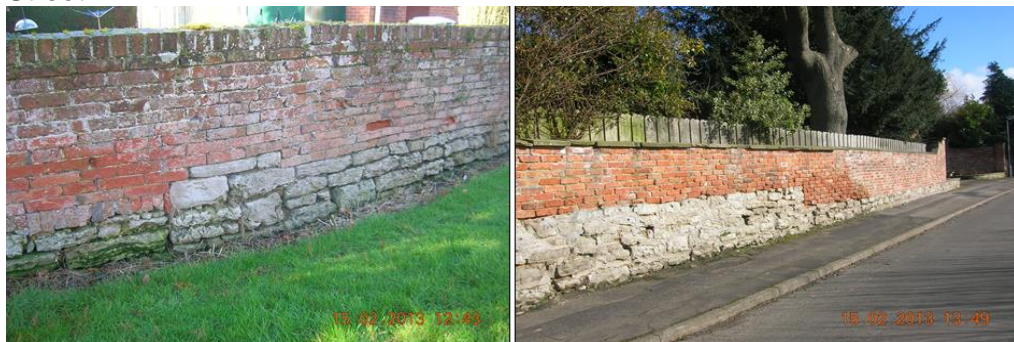
- 3.103 Other walls of note include a number of part brick and part Skerry walls which are found throughout the Conservation Area. In some cases, these relate to earlier buildings. The most substantial walls of this type are found on Church Street.

Figure 3.84: Part brick and part Skerry walls on Church Street.

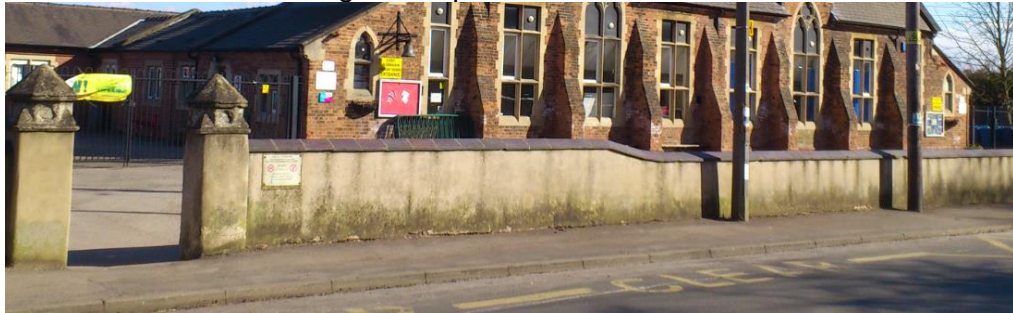
- 3.104 The brick wall and stone gate pillars at East Markham Primary School are also of significance. The wall is rendered, although the tile copings remain in situ and the stone detailing on the piers is intact.

Figure 3.85: Boundary wall at East Markham Primary School, Askham Road.

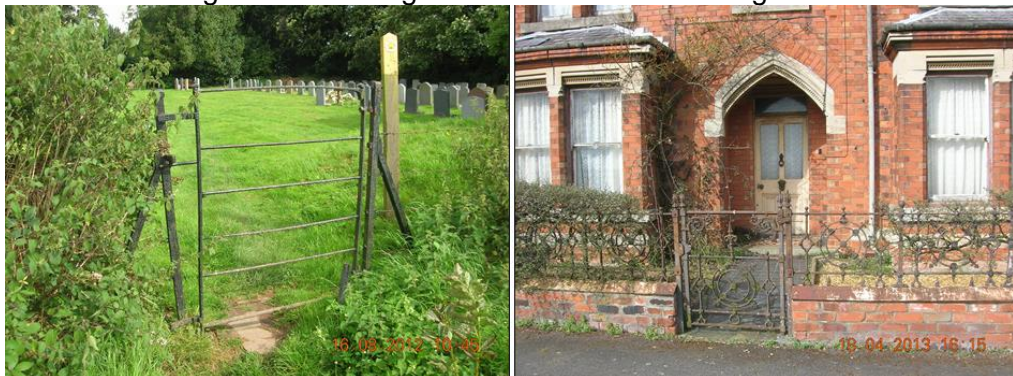
- 3.105 A number of gate styles exist within the Conservation Area, utilising both metal and timber. Five bar type gates are common, especially on High Street and Church Street. Several styles of metal gates are present (sometimes with corresponding railings), such as the estate-type to the rear of the church or the ornate iron gates and railings at Cleveland View on High Street.

Figure 3.86: Iron gates at the rear of the churchyard (left) and at Cleveland View on High Street (right).

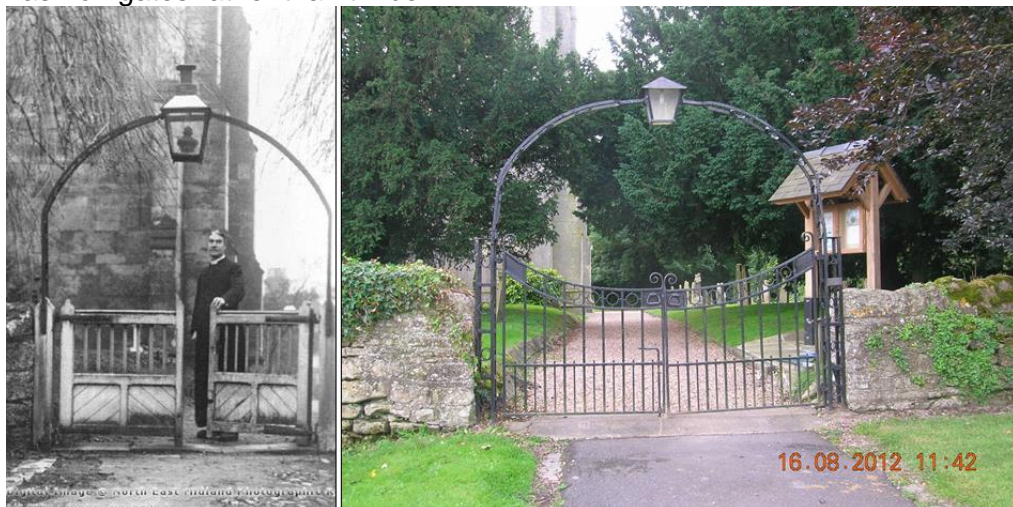
- 3.106 To the front of the churchyard off Church Street is the main entrance gateway, comprising a pair of iron gates below an iron archway with central lantern. The present gateway is of a similar scale to the 19th century gateway, although is slightly wider than previously, has a less ornate lantern and now has iron gates rather than timber.

Figure 3.87: Gateway into churchyard from c1920 (left) and present day (right). Image source: www.picturethepast.org.uk, accessed 2013.

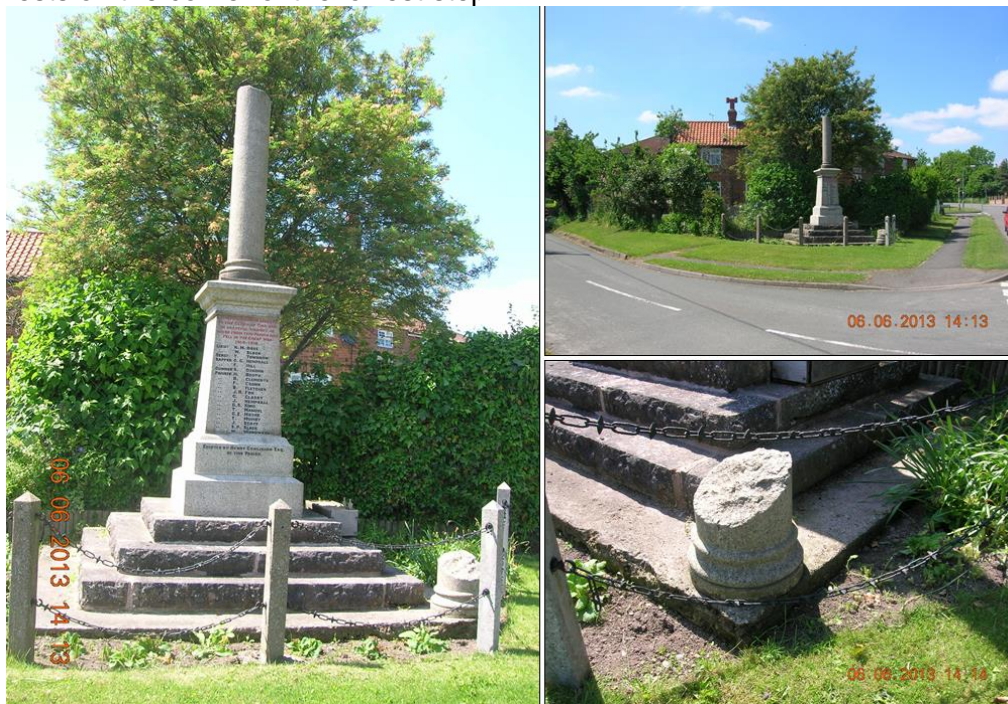
- 3.107 Within the East Markham Conservation Area are a number of structures in the public realm which add greatly to the character and appearance of the Conservation Area. The most prominent of these structures is the grade II listed War Memorial on High Street, unveiled 21st September 1920, made by Sharpe and Hoggard (of Retford) and paid for by Henry Cowlshaw Esq, a local landowner and farmer. The memorial is primarily of polished pink granite, set onto a stone plinth of four steps. The memorial is of the broken column type, the column top broken deliberately (to signify the lives lost) and rests on the corner of the lowest step.

Figure 3.88: Views of War Memorial on High Street.

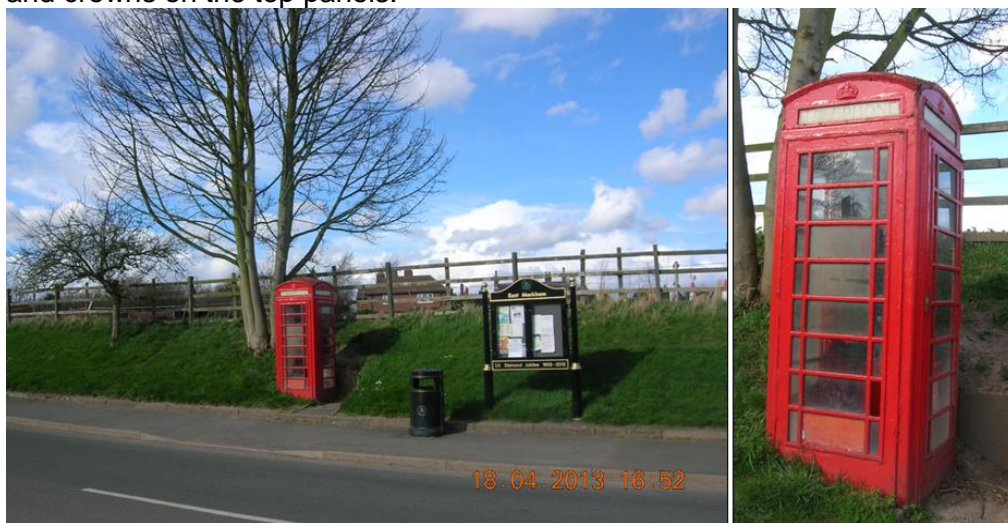
- 3.108 Opposite the War Memorial is a K6 telephone box, which was designed by Sir Giles Gilbert Scott in 1935. The box has a shallow domed roof, margin glazing and crowns on the top panels.

Figure 3.89: Views of K6 Telephone Kiosk, High Street.

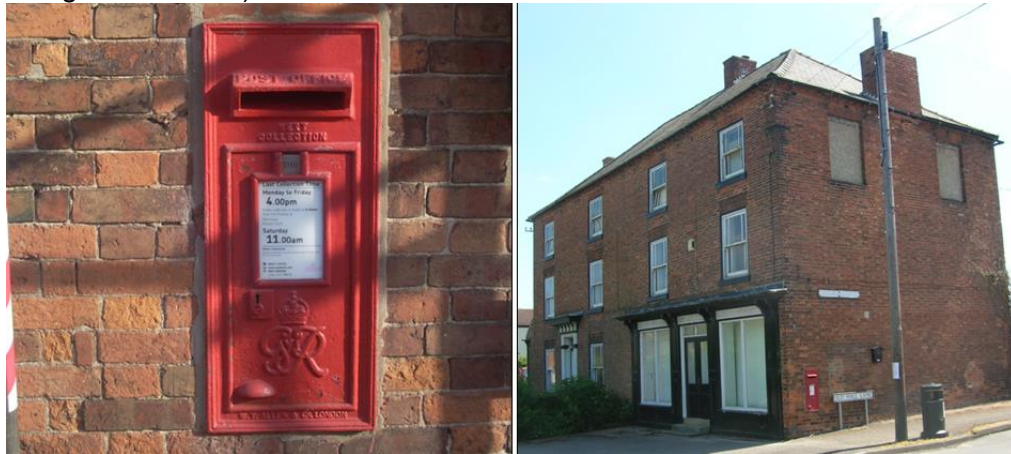
- 3.109 Also in the vicinity is the King George VI wall box situated in the west side of Postleigh (facing Old Hall Lane). The wall box dates to 1937-1952 and has the inscription "W.T. Allen & Co. London". Interestingly, whilst W.T. Allen & Co

supplied the boxes, it is likely that the casting was made for them by the James Maude Sherwood Foundry of Mansfield. This wall box is the most common size known as a type B (with type A being the largest and Type C being the smallest).

Figure 3.90: Type B King George VI wall box at Postleigh, High Street (wall box facing onto Old Hall Lane).

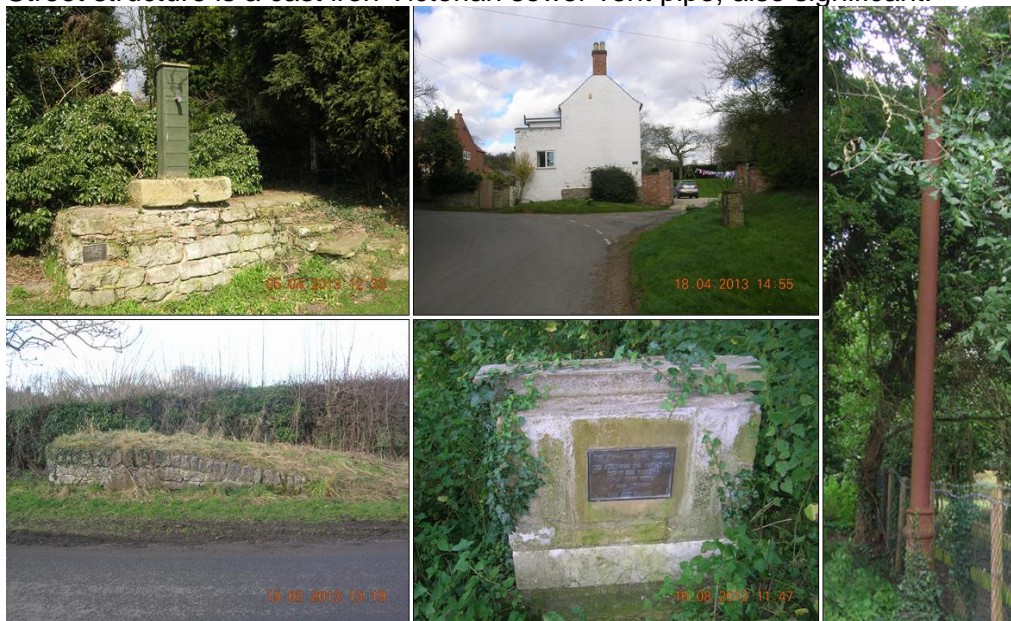
- 3.110 Other significant structures include the four village water pump sites, two being located on York Street, one on Mark Lane the other off Church Street. All four sites were restored in 2000, with the larger York Street structure and the Mark Lane structure being the most substantial. Adjacent to the Church Street structure is a cast iron Victorian sewer vent pipe, also significant.

Figure 3.91: Water pump sites at York Street (top), Mark Lane (bottom left) and Church Street (bottom centre), with sewer vent pipe also on Church Street (right).

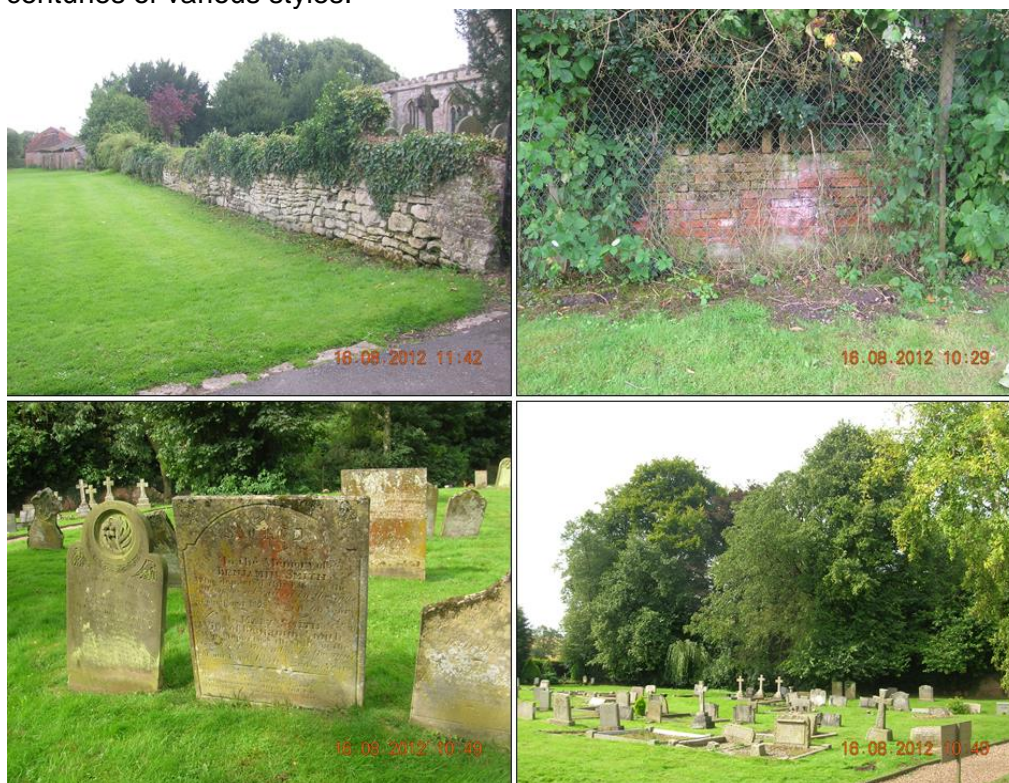
- 3.111 Aside from the structures, East Markham Conservation Area contains various open spaces which contribute to the area's significance and to the setting of the historic buildings. These open spaces include the churchyard, The Green, a number of roadside verges, historic landscaped gardens, orchards and other areas of open space with archaeological interest.
- 3.112 The most notable open spaces within the Conservation Area are the churchyard at the Church of St John the Baptist and The Green at the corner of Low Street and Hall Lane. At the churchyard, along with the historic

boundary treatments (brick and stone walls and estate-type fencing), there are a wide range of significant monuments from the 18th, 19th and 20th centuries of various styles.

Figure 3.92: Stone and brick boundary walls (top) and 18th, 19th and 20th century monuments and gravestones at the Church of St John the Baptist.

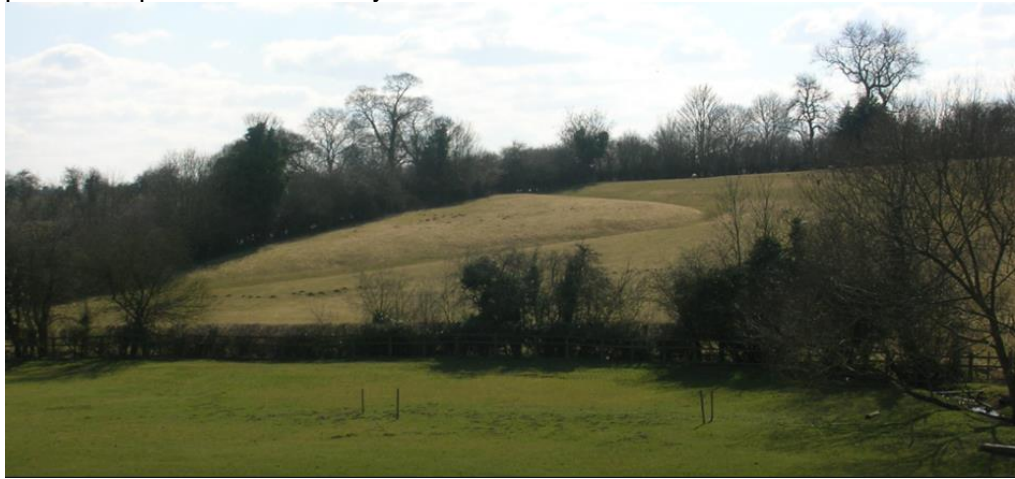
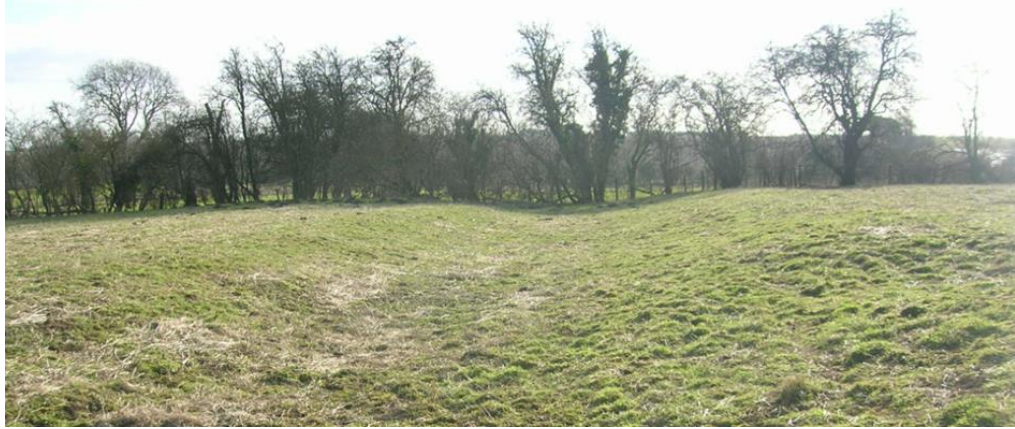
- 3.116 Aside from the churchyard, The Green and the various verges, the Conservation Area contains a range of open spaces with archaeological and/or historic interest. The most significant of these is probably the open space to the north/west and south/east sides of Mark Lane, which contains large ditch-like features of archaeological interest. The L-shaped ditch feature to the north/west of Mark Lane appears on the 1712 and 1816 maps as part of the road network at those times (with the 1816 map also showing the present course of the road bypassing the old route). However, it is unclear as to whether the ditch feature was constructed as a road or whether it relates to an earlier phase of occupation, possibly being a defensive feature or a means of land division. On the opposite side of Mark Lane, further ditches appear to be contiguous with that on the north/west side and are similar in scale and form. Most of these ditches (shown on map 5, page 14) are visible from public

vantage points along Mark Lane, Low Street, Hall Lane and from the various public footpaths in the vicinity.

Figure 3.96: Ditch features off Mark Lane, with site to north/west as viewed from Low Street (top) and site to south/east (bottom).

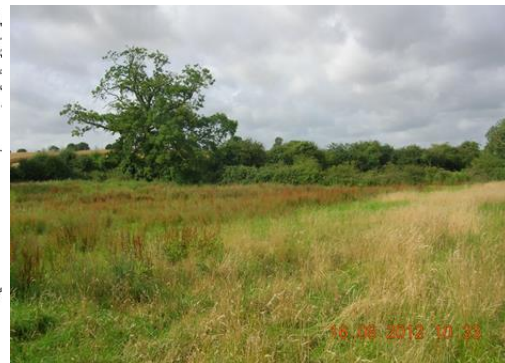
- 3.117 A possible moat (or at least a much larger ditch) also exists to the south and south west of the church and manor site. The date of this feature is not known and it is unclear as to whether there is any relationship between this site and the ditches visible off Mark Lane. In addition, very little of the church/manor moat/ditch is now visible due in part to much of the area to the south of the Old Vicarage being covered in vegetation and also due to the excavation of large fishing lakes to the south of the church.

Figure 3.97 (right): Visible remains of moat/large ditch feature within area of open space to south/south west of church and manor site (field 580 on the historic map).

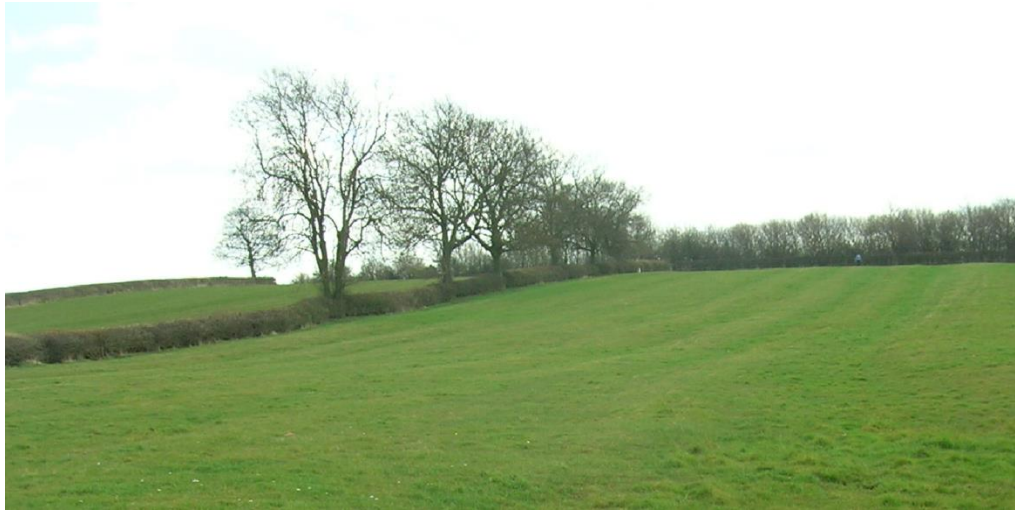
- 3.120 Some areas of ridge and furrow also survive within this area of open space. The best preserved ridge and furrow is in the area to the south of Harold Lane on the north-facing slope of the valley. This area is visible along much of Harold Lane and from parts of High Street.

Figure 3.99: View of ridge and furrow area to south of Harold Lane.

- 3.121 'Ridge and Furrow' is the term given to the remains of historic (usually medieval) ploughing, which comprises patterns of ridges and troughs stretching across a field. Often these remains have been ploughed out by mechanical ploughs from the late-19th century onwards. Survival is therefore rare and in the context of historic settlements, contributes greatly to their settings.

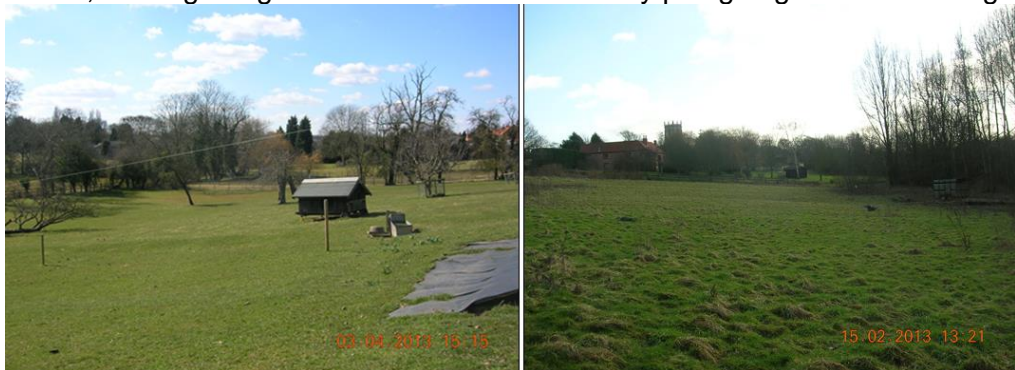
- 3.122 A number of other open spaces within the Conservation Area also have remains of ridge and furrow ploughing. The open space either side of Mark Lane (to the south of Low Street and Church Street) contains evidence of ridge and furrow, although large areas have been eroded by ploughing and weathering.

Figure 3.101: Remains of ridge and furrow ploughing to south of Low Street.

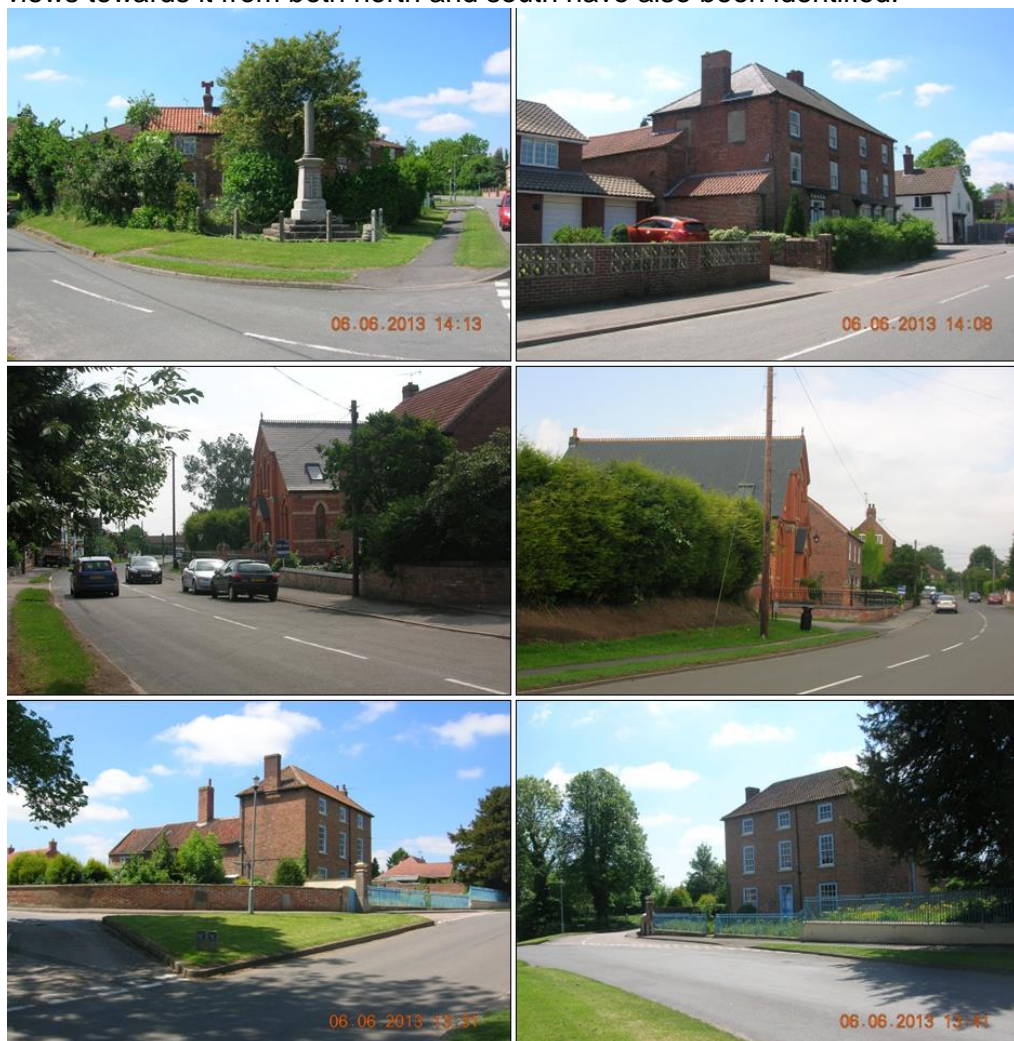
Figure 3.113: Views of the War Memorial (top left), Postleigh (top right) and the former Methodist Chapel (centre) on High Street and of Cushpool House on Plantation Road (bottom).

- 3.135 Along High Street, views of the War Memorial, the former Methodist Chapel and of Postleigh are regarded as the most important. To the south east along Plantation Road, Cushpool House is the largest building of its type and the views towards it from both north and south have also been identified.

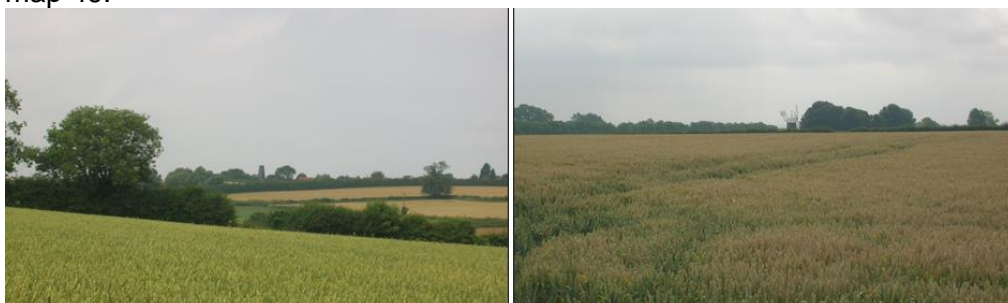
Figure 3.115: East Markham Windmill as viewed from footpath between Mark Lane and the church (left) and Tuxford Windmill as viewed from Priestgate (right).

- 3.137 Outside of the Conservation Area, the grade II listed Windmill on Priestgate, the grade II listed windmill in Tuxford and the grade I St Nicholas' Church in Tuxford are also important focal buildings when viewed from sites within the East Markham Conservation Area and its setting. These are also indicated on map 49.

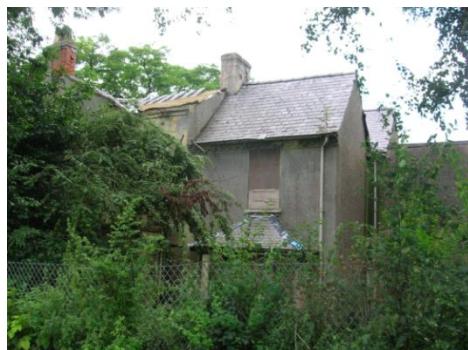
Figure 4.1: Former vicarage, currently undergoing repairs (photograph taken August 2013 from adjacent churchyard).

- 4.22 At the time of publishing, there is one listed building identified as being 'at risk' within the East Markham Conservation Area. This is the former Vicarage (Honeysuckle House) off Church Street. The Conservation Team is currently seeking the repair and/or restoration of this building, in line with the Council's wider strategy for dealing with listed buildings 'at risk'.

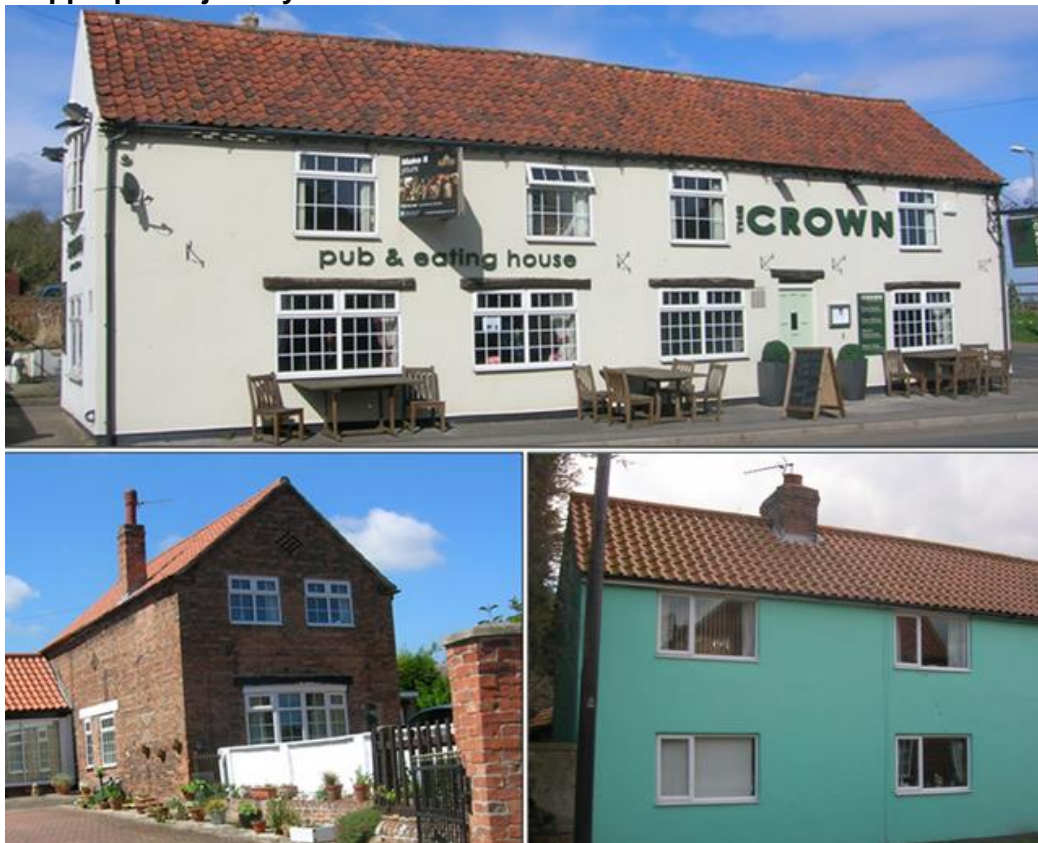
Figure 4.2: Inappropriate joinery on High Street (top), Hall Lane (bottom left) and Farm Lane (bottom right).
