East Markham Conservation Area Appraisal & Management Plan

December 2014

Title: Bassetlaw District Council: East Markham Conservation Area Appraisal and Management Plan.

Summary: This document is the Council's appraisal of the special architectural and historic interest of East Markham Conservation Area and a management plan with proposals for enhancement and preservation.

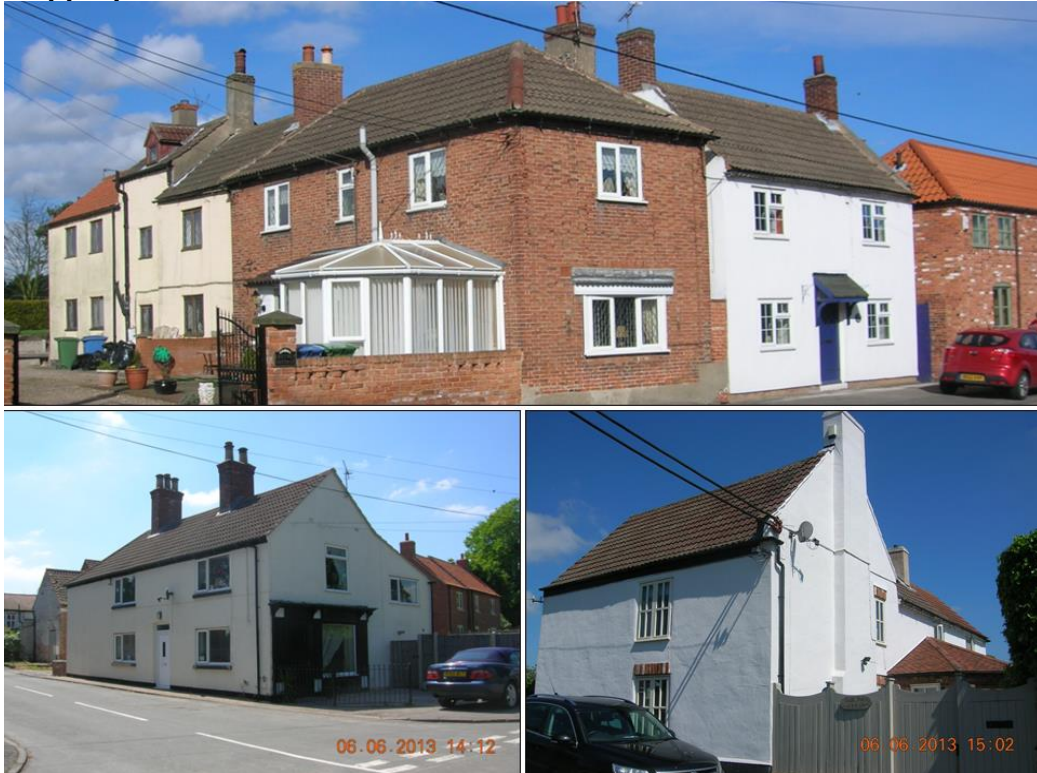
Figure 4.3: Inappropriate roof materials on High Street (top and bottom left) and Old Hall Lane (bottom right).

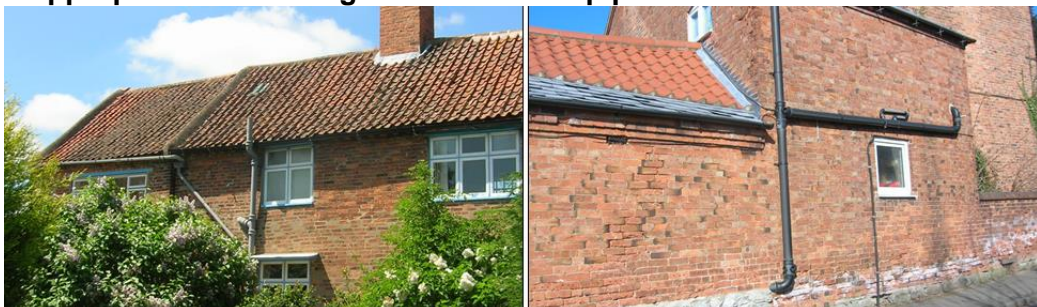
Figure 4.4: Plastic guttering and waste pipes on Plantation Road (left) and Low Street (right).

Plastic guttering and waste pipes have harmed the character of these 18th century (left) and 19th century (right) buildings. Traditional waste pipes and guttering was cast metal, with gutters usually being half-round in profile and fixed on rise and fall brackets.

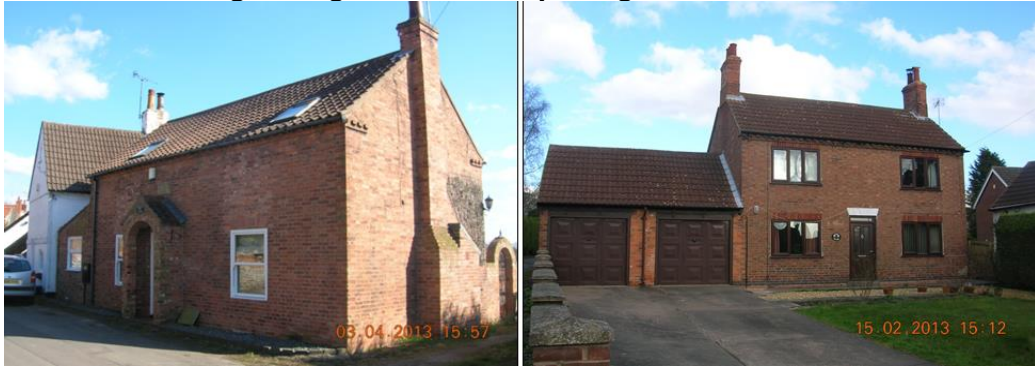
Figure 4.5: Loss of original window openings on Low Street (left) and enlargement of original openings on Church Street (right).

The unsympathetic alterations to the window openings on these early-19th century buildings have harmed the character and appearance of the Conservation Area. On the former chapel, the infilling of the original window openings and installation of new windows below has resulted in the loss of a crucial part of the character of the chapel. The enlarged openings on the building on Church Street, together with flat soldier coursed brick arches, have given this historic cottage a modern suburban appearance, much to the detriment of local character.

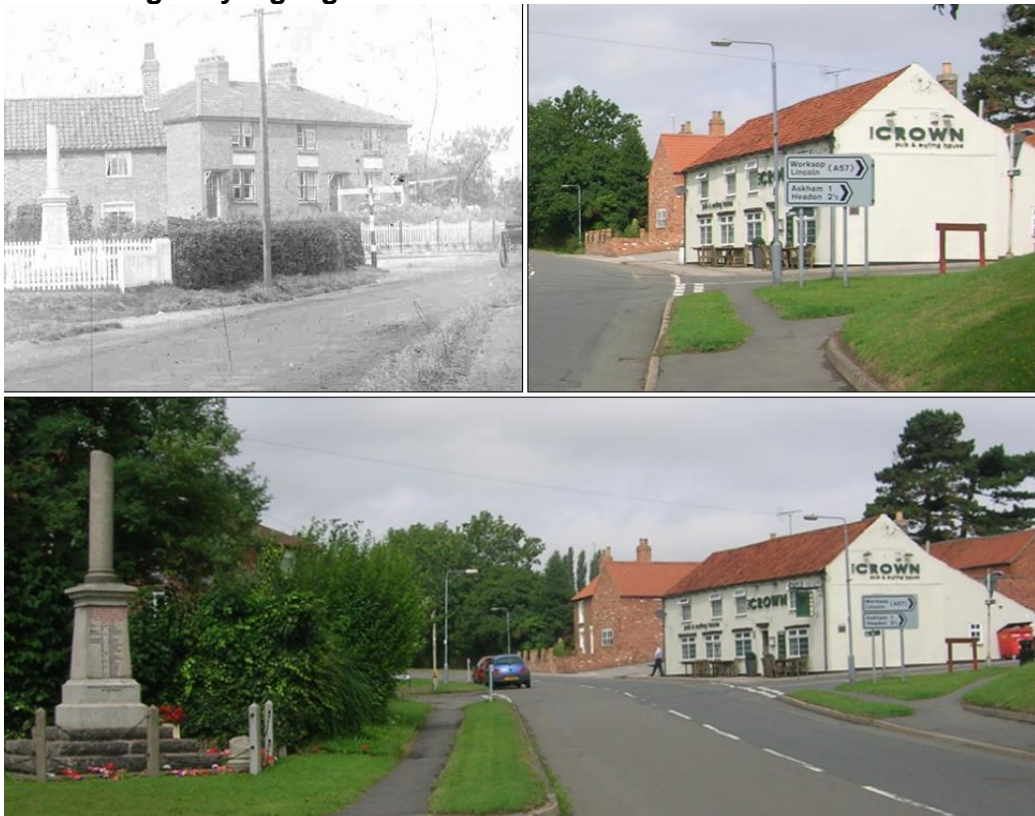
Figure 4.6: Previous finger post sign on High Street and large modern highway signs which replaced it. Image source: Bassetlaw Museum, accessed 2013.

These large signs replaced a finger post sign previously located on the opposite side of High Street. The large signs cause harm to the character and appearance of the Conservation Area and to the setting of the listed War Memorial opposite.

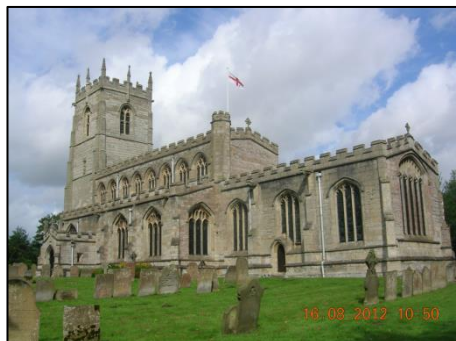
Primarily c15, although with c13 coffin lid with effigy and c14 chancel arch/windows/inverted font. Ashlar walls, lead roofs. Angled buttressed tower in 3 stages, with crocketed pinnacles and gargoyles. Embattled parapets,

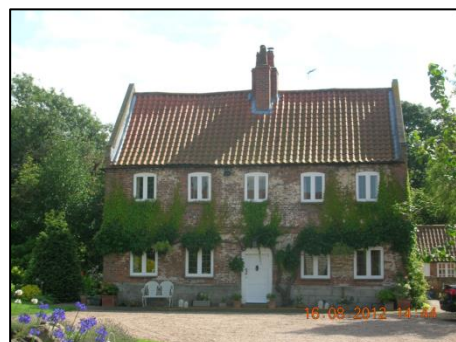
The Manor

Probably late-medieval stone foundations, current house primarily c17, with 1703, later-c18 and early-c20 alterations. Majority is red brick with pantile roof.

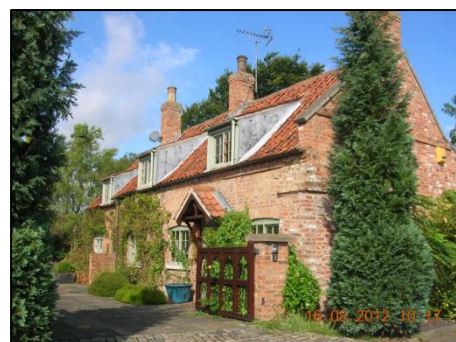
Norwood Cottage, Church Street

Early c17 cottage with c18 addition, red brick with pantile roof and catslide dormers, substantially rebuilt in late-c20 although some original fabric remains.

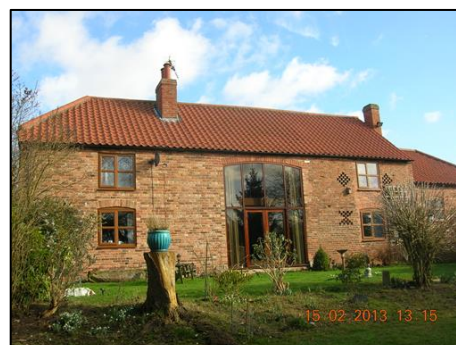
Barn at Springfield Farm, Church Street

Barn with internal c17 timber framing, altered early-c19. Red brick with pantile roof, diamond and cross brick ventilators.

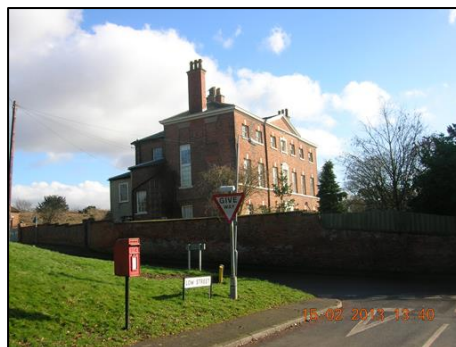
East Markham Hall & Markham Hall Cottage

Early-c18 house, refronted c1770. 3 storeys, 7 bay frontage. Red brick with ashlar dressings, rubbed brick window arches with ashlar keystones, central pediment with ashlar surround, timber door within ashlar surround.

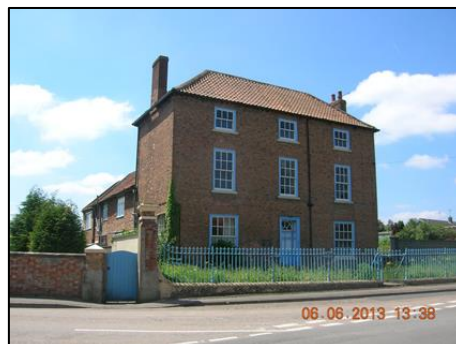
Cush Pool House, Plantation Road

Early-c18 house, later-c18 frontage with header bond. Red brick with pantile roof, two outer brick chimney stacks, timber sashes and timber panelled door with traceried fanlight within timber surround. Early-c18 two storey wing to rear.

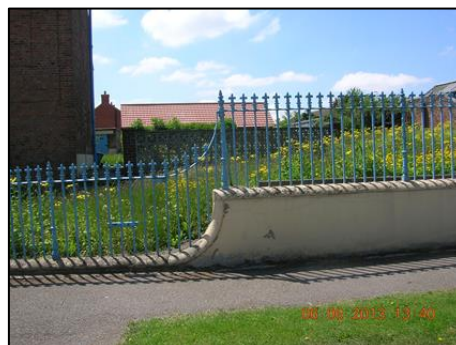
Wall, Railings and Gates at Cush Pool House

Late-c19, low brick wall, rendered, with stone coping (also rendered), iron railings and similar gate. Single brick piers with stone copings and recessed panels to front.

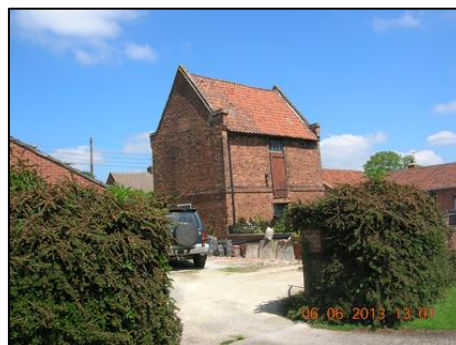
Pigeoncote at Bowerhayes, Plantation Road

Mid-c18 pigeoncote, 2 storeys plus garret. Red brick on rubble plinth, pantile roof, brick coped gables with kneelers. Interior has brick nesting boxes on all 4 sides.

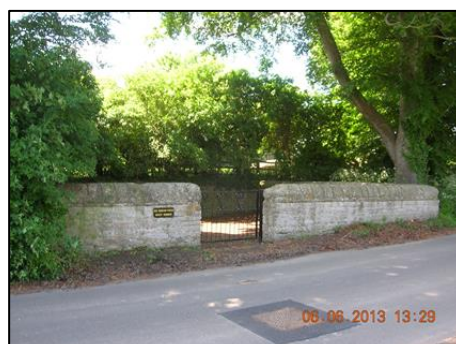
Pinfold, Plantation Road

Pinfold, c18, dressed coursed rubble with rounded ashlar coping, 12m x 10m, with small c20 iron gateway. Built into shallow bank.

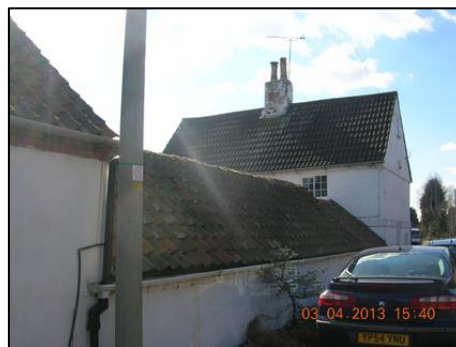
Woodliffe's Cottage, Low Street

Cottage, mid-c18, red brick with pantile roof, remnants of render and whitewash. Two storeys, three bays, central brick chimney stack, Yorkshire sashes. Now called 'December Cottage'.

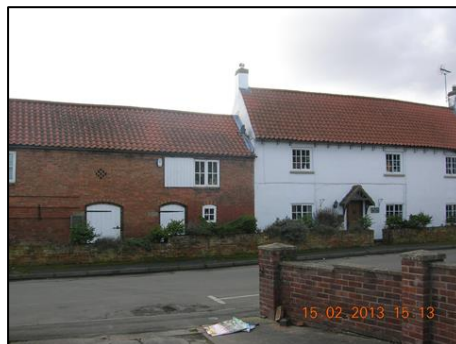
Whitehouse Farm and Barn, Church Street

C18 farmhouse with attached c19 barn. Farmhouse (originally the Greyhound Inn) is red brick, rendered, with pantile roof, Yorkshire sashes, modern timber plank door, 2 gable chimney stacks. Barn is red brick with pantile roof, diamond ventilators, arched timber plank doors with iron brackets, dentilated eaves.

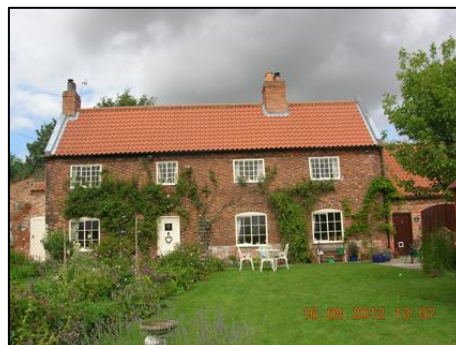
The Rosary, Church Lane

C18 house, red brick (including render and colourwash to base) with pantile roof, dentil eaves, brick stacks, slate-coped gables with kneelers, glazing bar Yorkshire sashes.

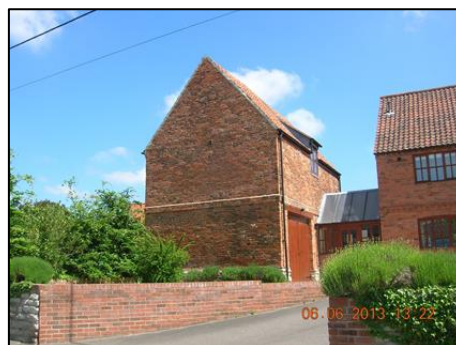
Pigeoncote at Woodward Farm, Plantation Road

Late-c18 pigeoncote, red brick on rubble plinth, pantile roof, two storeys, central band, central blocked doorway, timber plank doors with small glazing bar opening.

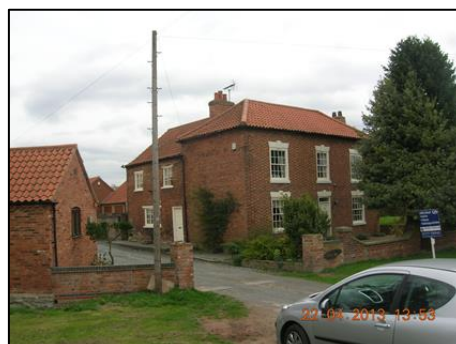
Pond Farmhouse, Plantation Road

C18 with early-c19 frontage. Red brick (frontage has Flemish bond, with pink headers and red stretchers) pantile roof, brick stacks, dentil eaves. Front has glazing bar sashes and 4-panel timber door with overlight.

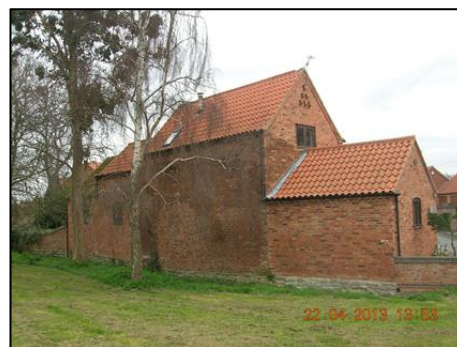
Pigeoncote, Stables, Cowhouse and Barn at Pond Farm

Late c18, mid & late c19 and early-c20. Red brick, rubble plinth in parts, pantile roofs.

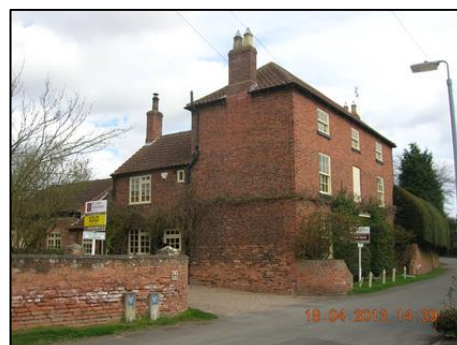
York House, York Street

Early c19 house, red brick with pantile roof, dentil eaves, brick stacks. Front (two and a half storeys) has glazing bar sashes and timber panel door with glazing bar overlight. First floor has blind recessed panel.

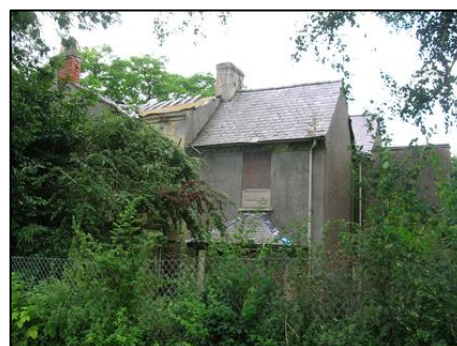
Honeysuckle House (Former Rectory), Church Street

Mid-c19, former Rectory, red brick (rendered) on stone plinth, slate roof, stone-coped gables, rendered gable stacks.

- 4.22 At the time of publishing, there is one listed building identified as being 'at risk' within the East Markham Conservation Area. This is the former Vicarage (Honeysuckle House) off Church Street. The Conservation Team is currently seeking the repair and/or restoration of this building, in line with the Council's wider strategy for dealing with listed buildings 'at risk'.

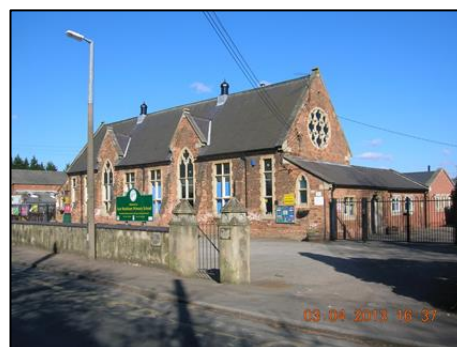
East Markham Primary School, Askham Road

Foundation stone laid 15th February 1877, school opened 7th January 1878. Red brick with ashlar detailing and slate roof. Decorated revival style. Elaborate window tracery. By Robert Clarke & Son.

- 3.87 The above school was replaced in 1878 by a building on Askham Road, in a style of architecture not previously seen in East Markham, that of Gothic Revival. This architectural style became popular during the Victorian period, particularly for public buildings such as schools and churches. The replacement school, begun in February 1877 and opened in January 1878, was designed by the noted Nottingham architect Robert Clarke & Son (see date stone on page 67) and is grade II listed.

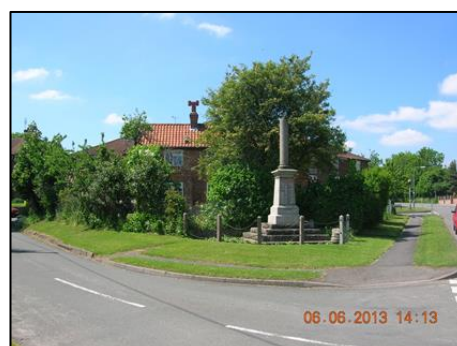
War Memorial, High Street

Paid for and designed by Henry Cowlshaw, on land donated by a Mr Drinkwater. Polished pink granite, square plan with 4 lower steps, tall broken Doric column.

- 3.107 Within the East Markham Conservation Area are a number of structures in the public realm which add greatly to the character and appearance of the Conservation Area. The most prominent of these structures is the grade II listed War Memorial on High Street, unveiled 21st September 1920, made by Sharpe and Hoggard (of Retford) and paid for by Henry Cowlshaw Esq, a local landowner and farmer. The memorial is primarily of polished pink granite, set onto a stone plinth of four steps. The memorial is of the broken column type, the column top broken deliberately (to signify the lives lost) and rests on the corner of the lowest step.

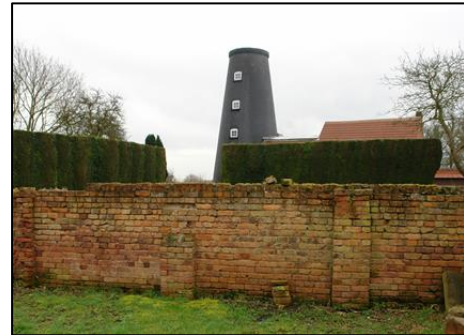
Windmill, Priestgate (outside of the CA)

C1820 (appears on Stevens' 1820 map), tarred brick, raised eaves band, 4 storeys. 20th century additions not included in listing.
